**ALERT SERVICE BULLETIN**

NO. 427-08-20  
DATE Feb 27, 2008  
PAGE 1 of 5

**SUBJECT:** COLLECTIVE CONTROL IDLER LINK ASSEMBLY P/N 427-001-532-101 INSPECTION AND MODIFICATION OF

**HELICOPTERS AFFECTED:** Model 427 helicopters serial number 56001 through 56069 and 58001 and 58002.

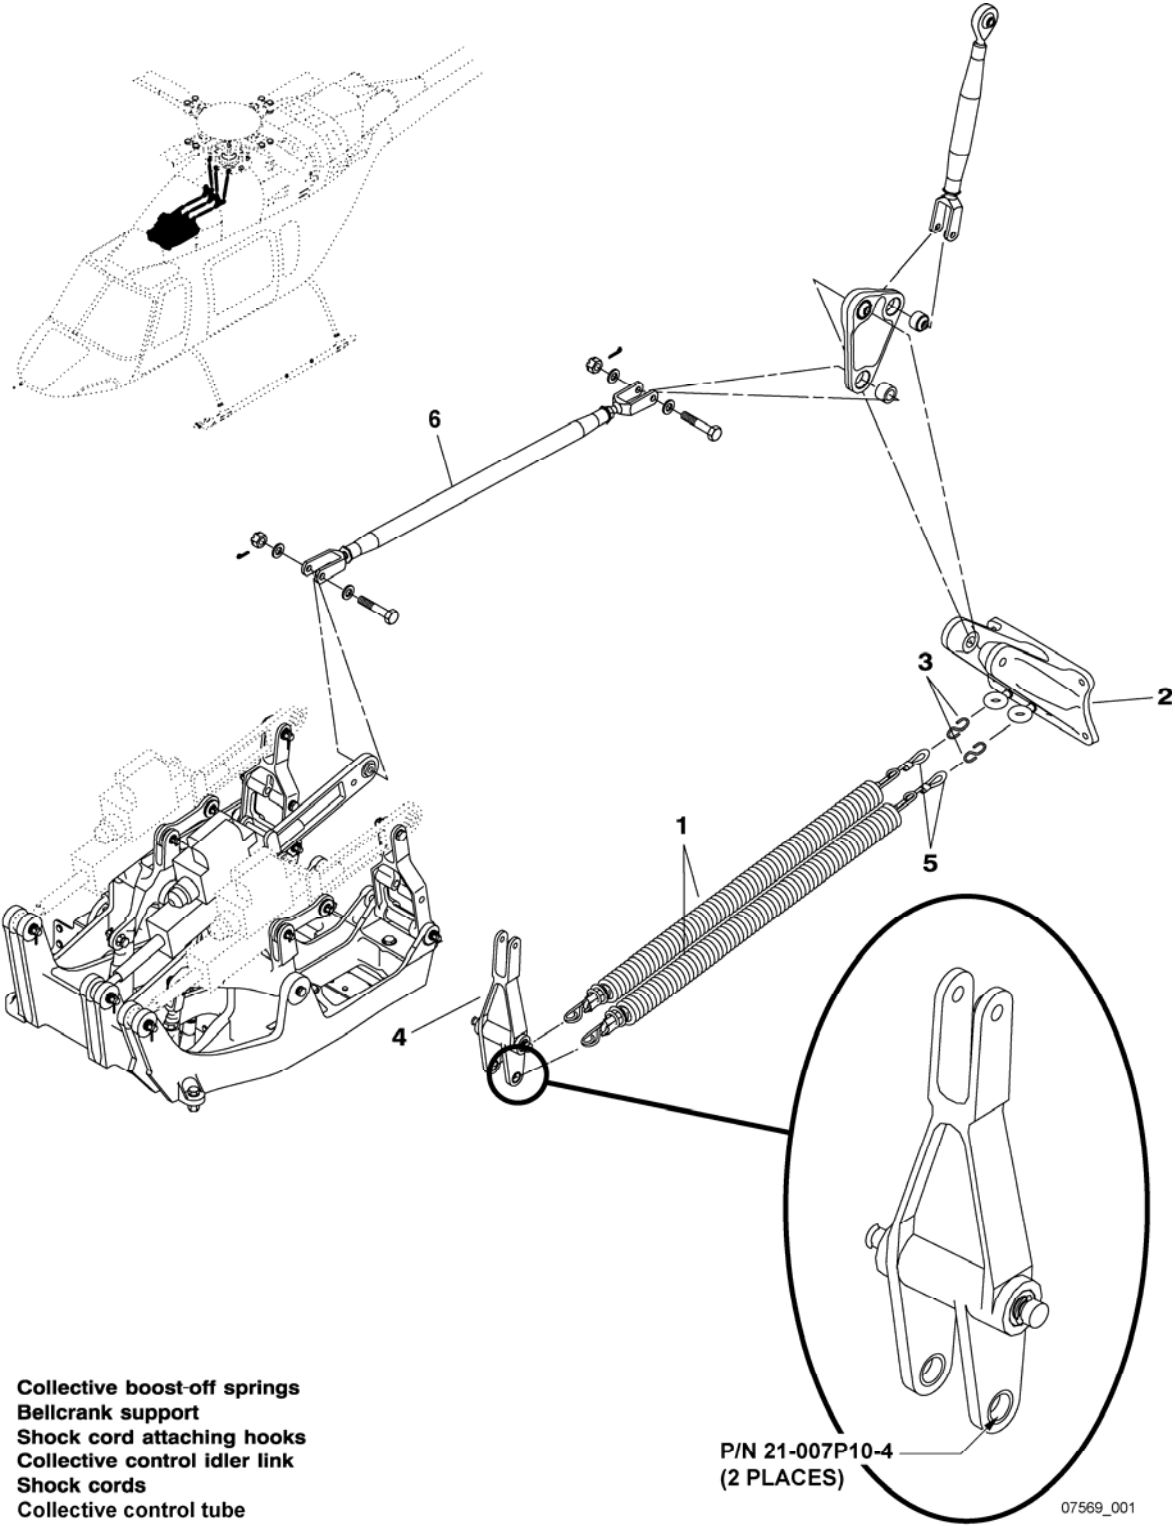
Figure 1

Bell Helicopter has received reports of worn bushings P/N 21-007P10-4 installed in the collective control idler link P/N 427-001-532-101. The bushings are used as the attachment pivot point for the two collective boost-off springs.

Wear or damage in the aluminum forging parent material of the collective control idler link P/N 427-001-532-101 is cause for rejection and replacement of the link

8. Inspect idler link for condition. Replace the two existing bushing P/N 21-007P10-4 in the collective control idler link P/N 427-001-532-101 with new bushing P/N 21-007K10-4. Apply MIL-PRF-23377 epoxy primer to outside diameter of the new bushing. Refer to the BHT-ALL-SPM, chapter 9 for bushing installation.

9. Re-identify the modified collective control idler link with P/N 427-001-532-105.
10. Install the collective control idler link with P/N 427-001-532-105. Refer to the BHT-427-MM, chapter 67.
