**ALERT SERVICE BULLETIN**

**NO.** 427-08-22

**MODEL AFFECTED:** 427

**SUBJECT:** HYDRAULIC PUMP DRIVESHAFT ASSEMBLY  
P/N 406-040-072-105, ONE TIME INSPECTION OF

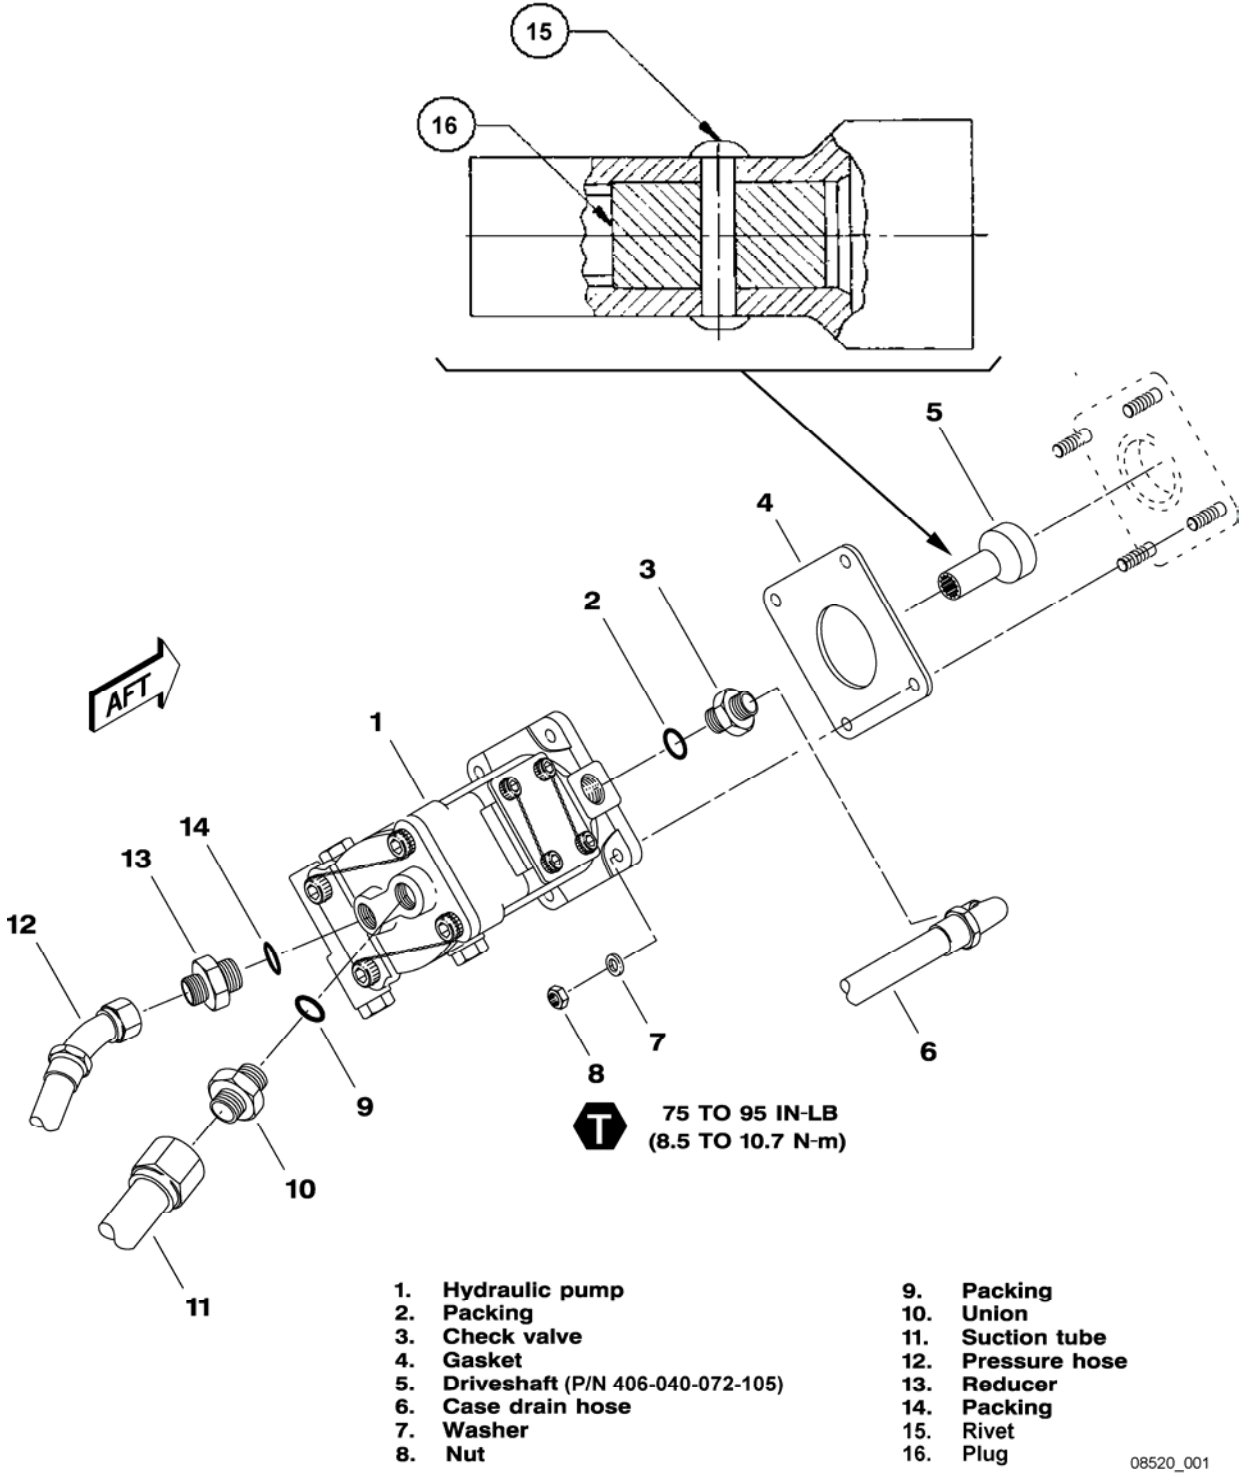
**Figure 1**  
**Hydraulic pump driveshaft assembly**

Bell Helicopter has received reports of hydraulic pump driveshaft assemblies P/N 406-040-072-105 that may have been delivered with missing internal plug or fastening rivet. This condition could lead to a loss of hydraulic pressure.

1. Gain access to the hydraulic pump P/N 206-076-030-ALL. Refer to the BHT-427-MM, chapter 29.
2. Remove hydraulic pump and driveshaft assembly P/N 406-040-072-105. Refer to figure 1 and to BHT-427-MM, Chapter 29.
3. Inspect hydraulic pump driveshaft assembly (item 5) for condition and missing rivet (item 15) or plug (item 16). Refer to figure 1 and BHT-427-MM, Chapter 29.

- a. Inspect hydraulic pump driveshaft assembly (item 5) for missing rivet (item 15) or plug (item 16). Refer to figure 1.
  - b. If rivet (item 15) or plug (item 16) are missing. Submit a completed MMIR to BHTI Warranty Department and order parts listed in the Material section of this bulletin.

4. If rivet (item 15) or plug (item 16) are missing proceed as follow:
  - a. Submit a completed MMIR to BHTI Warranty Department.
  - b. Obtain parts listed in the material section of this bulletin and comply with Technical Bulletin 427-05-19.
