ALERT SERVICE BULLETIN

NO. 427-09-25

MODEL AFFECTED: 427

SUBJECT: STAKED BEARINGS, ONE-TIME INSPECTION OF.

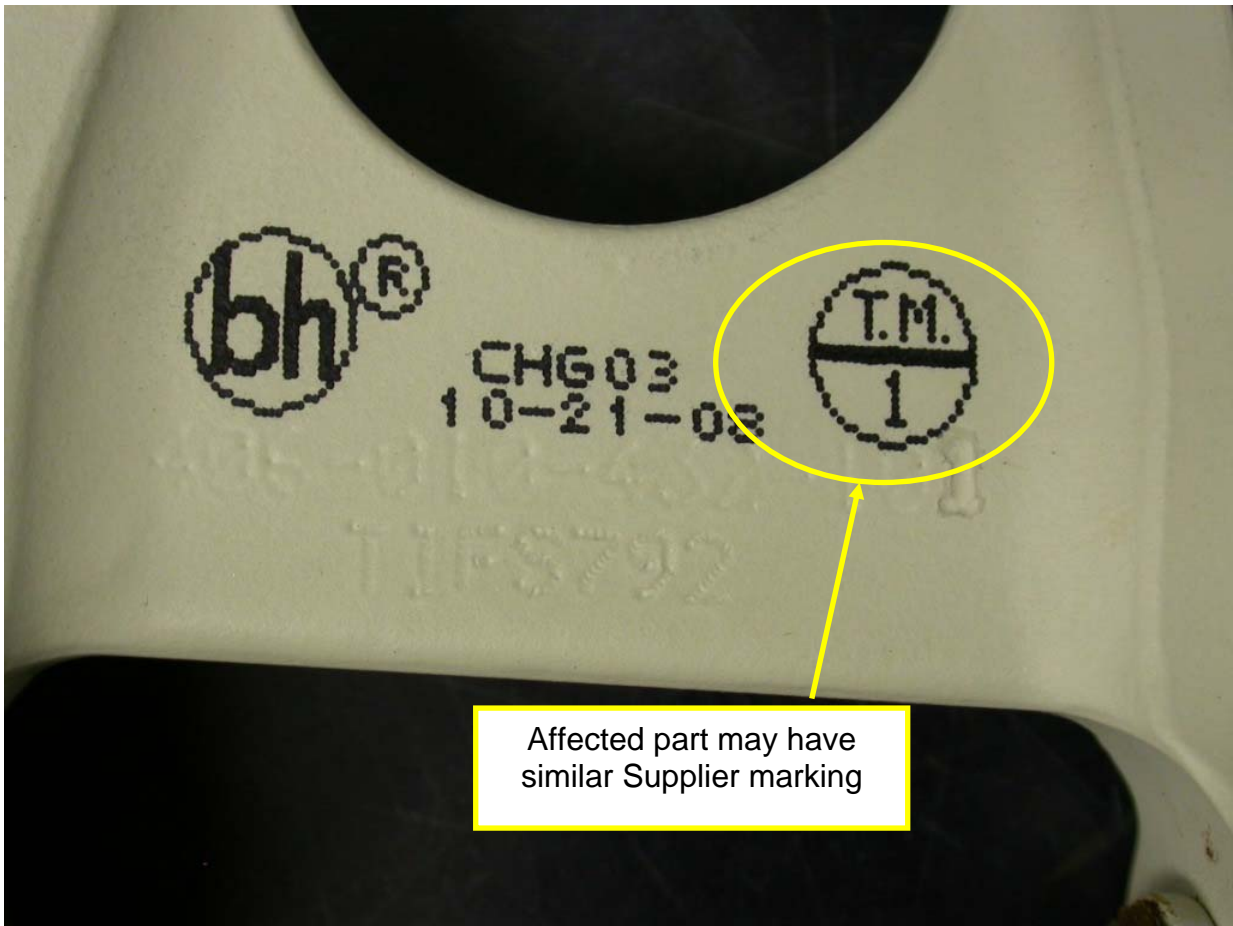
Bell Helicopter issues this bulletin to accomplish a one-time inspection of various parts that could potentially exhibit the same defect. The affected parts are listed in Table 1. Parts in service and all spare parts are affected. When serialized, only parts with serial number prefix TI or TIFS are affected. However, affected part not serialized, may have Supplier marking as shown on Figure 1.

Figure 1. Affected part Supplier marking.

1. Gain access to the affected parts. See Table 1 for the list.
2. Using a 10X magnifying glass or other suitable means such as a boroscope, inspect parts for bearings that have not been staked. Refer to Standard Practices Manual (SPM). If a bearing is not visible, apply hand pressure to the part to detect any axial movement. If still in doubt, remove the part from the aircraft to inspect.
3. Should you find a part with a discrepant bearing, replace the bearing or the assembly and contact Product Support Engineering to report finding.
4. Make an entry in the helicopter historical records indicating compliance with this Alert Service Bulletin.
