**ALERT SERVICE BULLETIN  
REVISION NOTICE**

**SUBJECT: REVISION "A" TO ALERT SERVICE BULLETIN 427-09-26:  
TAIL ROTOR GEARBOX P/N 406-040-400-ALL AND TAIL ROTOR  
GEARBOX CASE ASSEMBLY P/N 406-040-406-ALL, ONE TIME  
INSPECTION**

NO. 427-09-26

**SUBJECT:** TAIL ROTOR GEARBOX P/N 427-042-400-ALL AND TAIL ROTOR GEARBOX CASE ASSEMBLY P/N 406-040-406-ALL, ONE TIME INSPECTION OF.

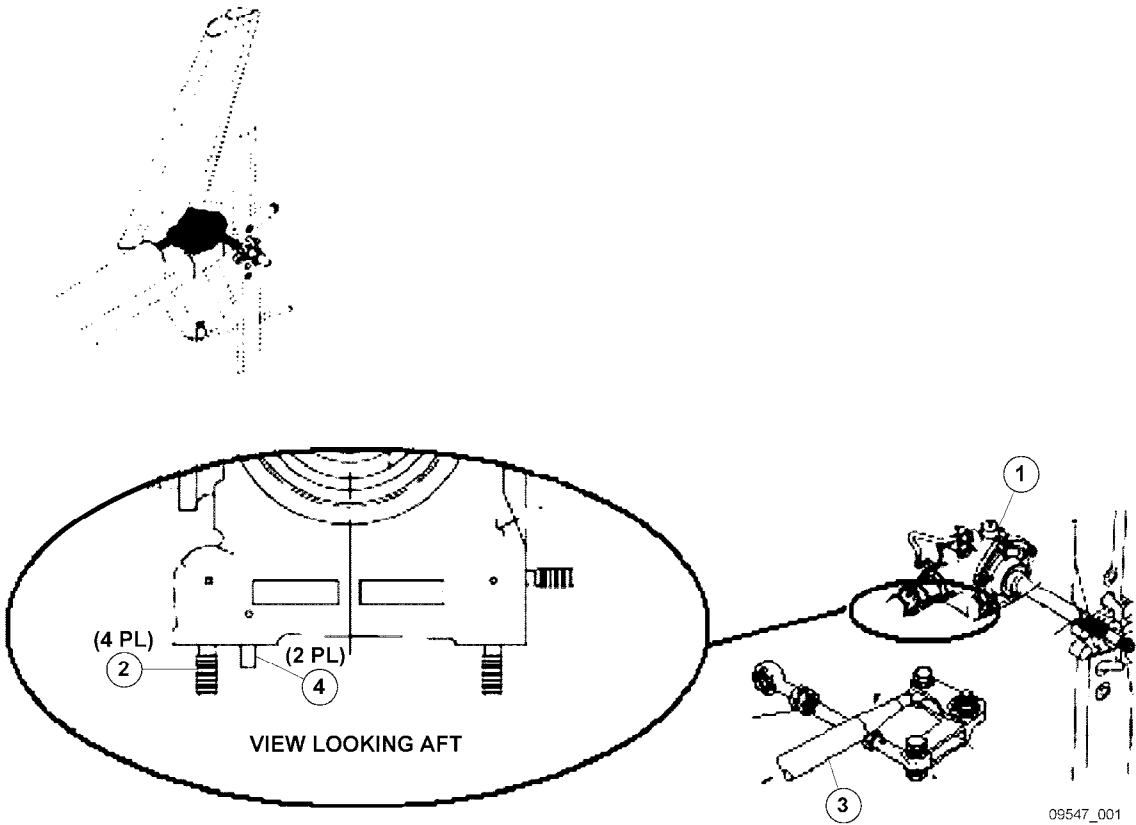
Figure 1. Studs and dowel pins location

Bell Helicopter has received reports of tail rotor gearbox assembly found with mounting studs incorrectly installed. This condition could lead to low clearance or fouling condition between the forward right hand stud and the aft end upper surface of the tail rotor control tube assembly 407-001-026 (long tube). Reports of dislodged or missing dowel pin in the gearbox case were also received.

1. Inspect the installation of the four tail rotor gearbox assembly and/or case assembly mounting studs (2, Figure 1). Measure all four studs for proper length. Refer to BHT-427-CR&O, Chapter 65 for stud installation height except the installation tolerance is +/- 0.030 inch.

3. If the length of all four studs is within limit, proceed to next step.
4. Inspect the installation of the two dowel guide pins (4, Figure 1). Inspect the tail rotor gearbox assembly and/or case assembly to insure that the two dowel guide pins are properly installed and have not become dislodged from the tail rotor gearbox assembly and/or case assembly.

1. Using a flashlight and inspection mirror inserted through the side opening in the gearbox support casting. Inspect the forward right hand mounting stud (2, Figure 1) of the tail rotor gearbox (1) for fouling with the directional control tube (3). Refer to BHT-427-MM, Chapter 53.

3. Using a flashlight and inspection mirror, inspect all four of the tail rotor gearbox mounting studs (2, Figure 1) to ensure that no more than four threads of the stud extend beyond the end of the attaching nut.

6. Using a flashlight and inspection mirror, inspect the tail rotor gearbox (1, Figure 1) for proper installation of the two dowel pins (4).
7. If either of the two guide pins are missing or have become dislodged, remove the tail rotor gearbox and rework the installation of the dowel pins. Refer to BHT-427-CR&O, Chapter 65.

2. If the length of any of the four studs is not within limit, rework the installation of the defective stud. Refer to BHT-427-CR&O, Chapter 65 for stud installation height except the installation tolerance is +/- 0.030 inch.

5. If either of the two dowel guide pins are missing or have become dislodged, rework the installation of the dowel guide pin (4, Figure 1). Refer to BHT-427-CR&O, Chapter 65.

2. If the directional control tube (3, Figure 1) shows any evidence of fouling with gearbox stud, proceed as follow:
  - a. Remove the tail rotor gearbox fairings and inspect tube for mechanical damage. Refer to BHT-427-MM, chapter 67. Repair tube assembly in accordance with the BHT-427-MM, chapter 67.

- b. If damage limits are exceeded, discard and replace with a serviceable tube.
  - c. Remove the tail rotor gearbox (1) and accomplish PART I of this bulletin.

4. If more than four threads are exposed beyond the end of attaching nut on any of the tail rotor gearbox mounting studs (2, Figure 1), remove the tail rotor gearbox (1) and rework the installation of the mounting studs. Refer to BHT-427-CR&O, Chapter 65 for stud installation height except the installation tolerance is +/- 0.030 inch.
