ALERT SERVICE BULLETIN

NO. 427-09-28

SUBJECT: HYDRAULIC SERVOACTUATOR P/N 206-076-062-111, INSPECTION OF

FLIGHT CONTROLS – HYDRAULIC SERVOACTUATOR, PART NUMBER
41011300-103-101

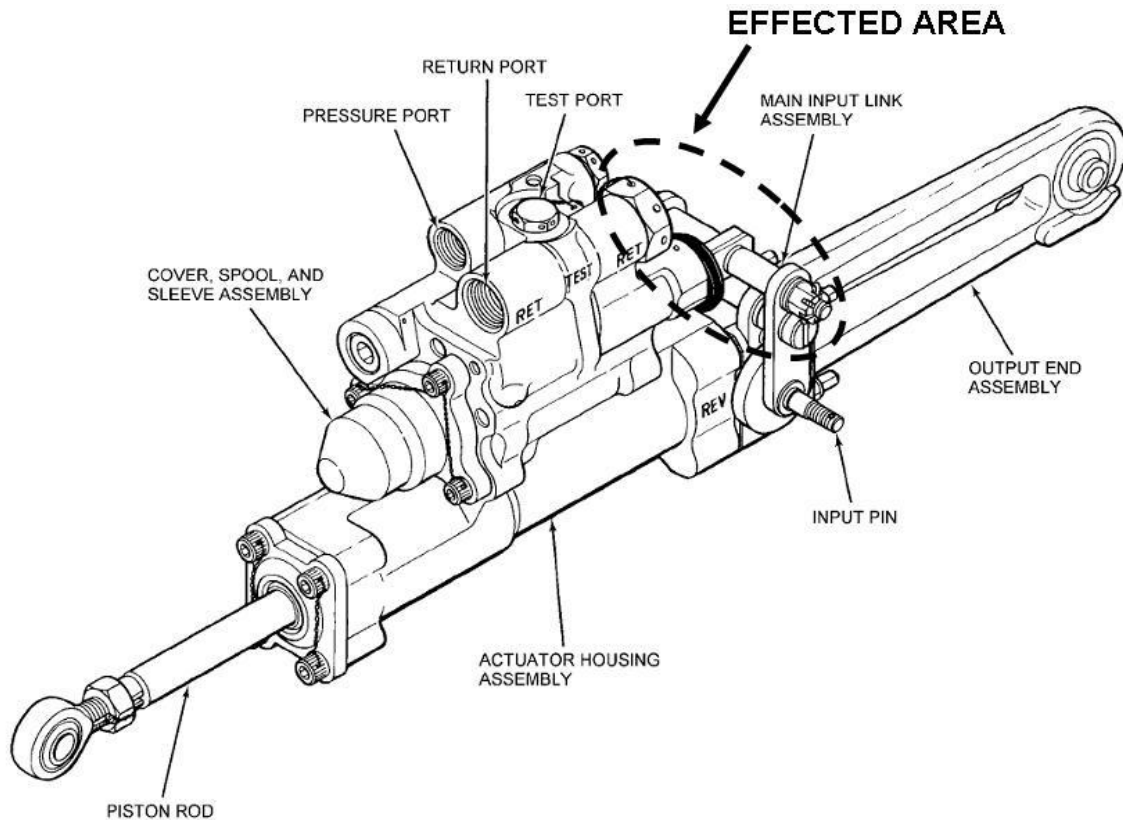
Hydraulic Servo Actuator P/N 41011300
Figure 1

A small number of hydraulic servoactuators 41011300-103 have been discovered with limited clearance between two bolt flanges on output end assembly 41009852-101 or -102 and spacer 41003289. This limited clearance has the potential to create increased pilot input force (see Figures 1 and 2).

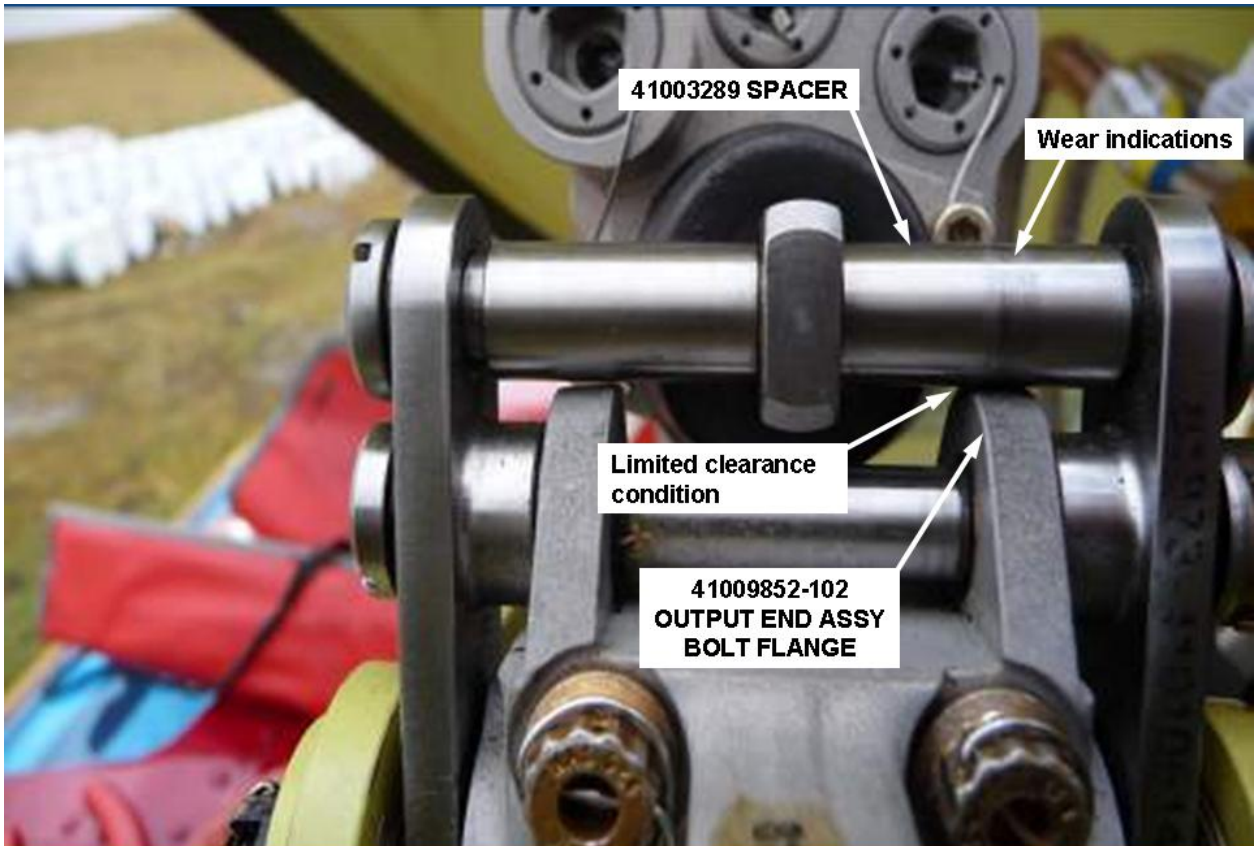
Wear Indications
Figure 2

contact or abrasion on either of the two spacers 41003289 curved surfaces in proximity to limited clearance with one of the output end bolt flanges.

4. If the hydraulic servo actuator has a serial number affected by this bulletin, proceed as follows.
5. Verify that spacers 41003289 (two locations) show no evidence of contact as shown on Figure 2.

6. If the spacer shows evidence of contact at one of the two locations and does not rotate freely or offers sufficient resistance so it cannot be rotated by fingers, remove the hydraulic servo and send to a HRT approved service facility for rework before further flight. If the condition described in this step is found but no excessive force or feedback is reported by the pilot, a onetime ferry flight to nearest maintenance facility is allowed. Make appropriate entry in the helicopter and component records to show accomplishment of this bulletin and indicate findings.

7. If the spacer shows evidence of contact but rotates freely at both locations, send the servo actuator to a HRT approved service facility within the next 600 flight hours or 6 months whichever comes first for accomplishment of Part II of this bulletin. Make appropriate entry in the helicopter and component records to show accomplishment of this bulletin and indicate findings.

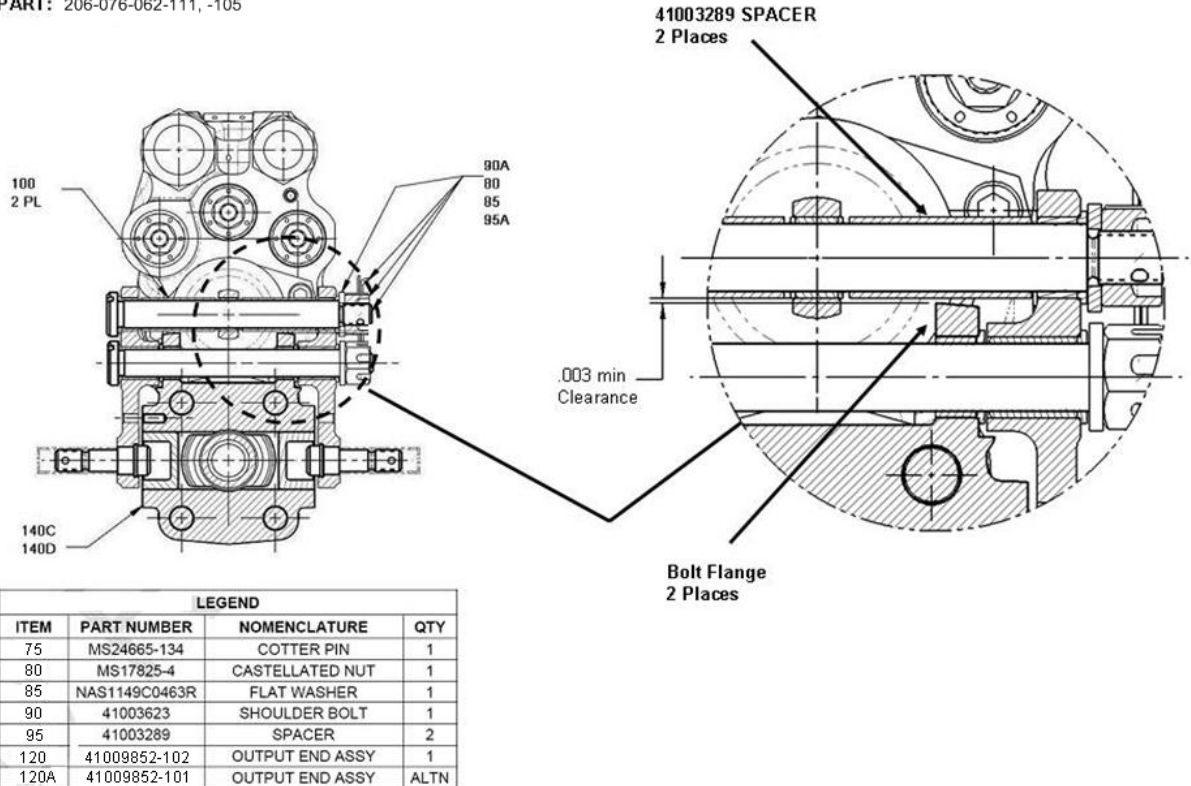
Clearance Data
 Figure 3

8. If the spacer does not show evidence of contact, use a feeler gauge and verify the clearance between the output end assembly bolt flange and the upper bolt spacer 41003289 as shown on Figure 3.

9. If the clearance is less than 0.003 inch, send the servo actuator to a HRT-approved service facility within the next 1200 flight hours or 12 months whichever comes first for accomplishment of Part II of this bulletin. Make appropriate entry in the helicopter and component records to show accomplishment of this bulletin and indicate findings.

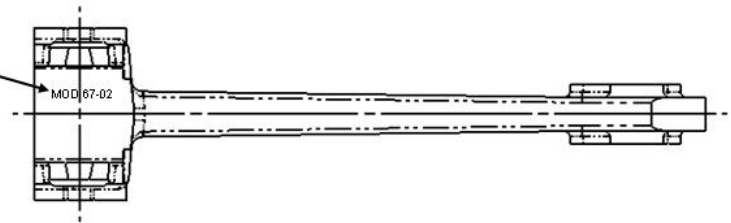
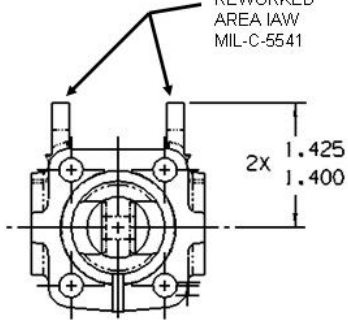
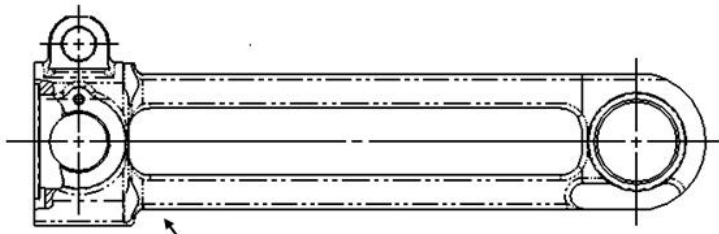
Rework Instructions
 Figure 4

Output end assembly 41009852-101 and -102 are built using Output End 41009851-001 or -002, which are made from an aluminum forging 41009471-001 or 41009471. The ensuing investigation found flange height had not been controlled adequately on component drawings, in particular improper control of the forging draft angle.

2. Rework bolt flange height (2 places) to 1.400-1.425 dimension shown on Figure 4. Rework form may be a straight cut or a blended radius.
 3. Identify with identification "MOD 67-02" located on the underside of the 41009852-102 or -101 Output End as shown on Figure 4.

4. Chem-film reworked and identification area in accordance with MIL-C-5541 Class 1A.

IDENT WITH "MOD 67-02"
 .09 MIN HIGH CHARACTERS
 APPROX WHERE SHOWN.
 CHEM ETCH OR LASER ENGRAVE
 CHEM FILM REWORKED
 AREA IAW MIL-C-5541
