ALERT SERVICE BULLETIN

NO. 427-09-29
DATE Oct 19, 2009
PAGE 1 of 7

MODEL AFFECTED: 427

SUBJECT: TAIL ROTOR DRIVESHAFT HANGER BEARING BRACKET P/N 427-044-223-101, REWORK OF.

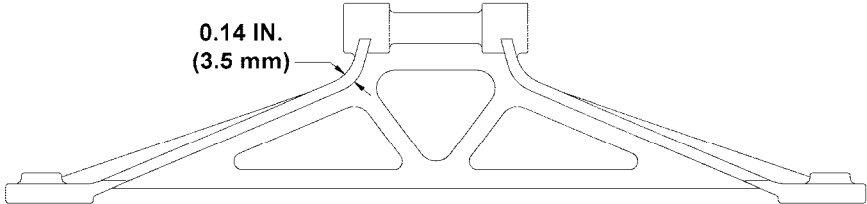
Figure 2

Bracket P/N 427-044-223-101

View looking forward

7. Rework both side of bracket P/N 427-044-223-101 as follows:
 - a) Using 180 grit sand paper, polish out the noted machining step smooth with the adjacent surfaces. Remove minimum material needed to remove the machining marks in the radius area. Maintain existing 0.50 radius and minimum web thickness of 0.140 inch. Refer to Figure 2.

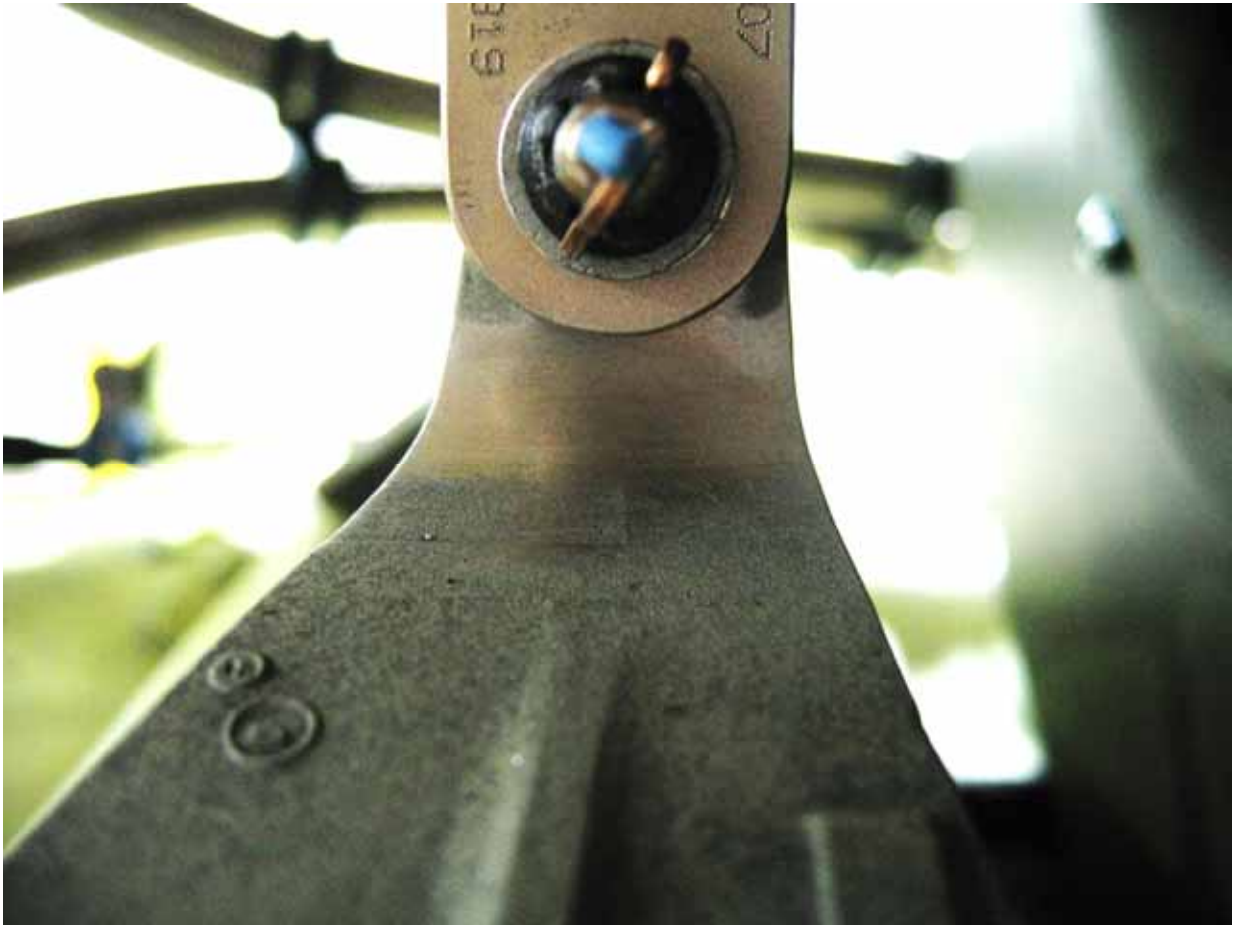
Figure 3

View of reworked bracket assembled on aircraft

Bracket P/N 427-044-223-101

- b) Polish reworked area using 280 grit sand paper. Final polish smooth reworked area using scotchbrite (C-407).
 - c) Apply chemical film material (C-100) to reworked areas. Refer to BHT-ALL-SPM. Refer to Figure 3.
