**ALERT SERVICE BULLETIN
REVISION NOTICE**

**SUBJECT: REVISION A TO ALERT SERVICE BULLETIN 427-09-29:
TAIL ROTOR DRIVESHAFT HANGER BEARING BRACKET P/N 427-
044-223-101, REWORK OF.**

NO. 427-09-29

MODEL AFFECTED: 427

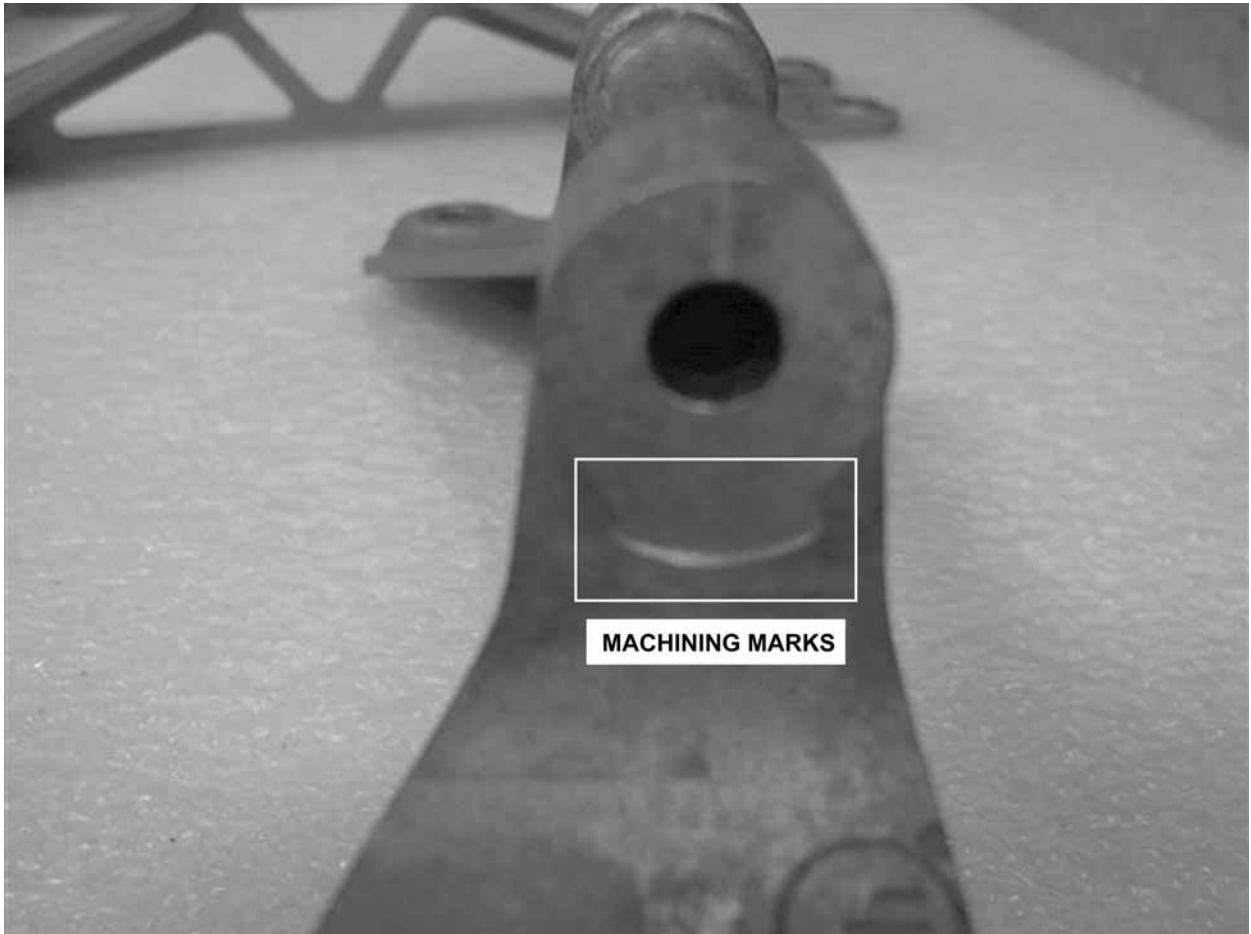
Figure I

Bell Helicopter received a report of a broken tail rotor driveshaft hanger bearing bracket P/N 427-044-223-101. Investigation revealed that the part fractured due to fatigue. The crack originated in the radius near an area where a tool had cut into the bracket for a flat faying surface. Refer to Figure 1 for details.

Machining marks on bracket P/N 427-044-223-101

This Bulletin introduces a one time inspection of the bracket and provides rework procedures for the polishing of both sides of the bracket. The rework will eliminate the tooling marks and increase the fatigue strength to reduce the potential for cracking in service.

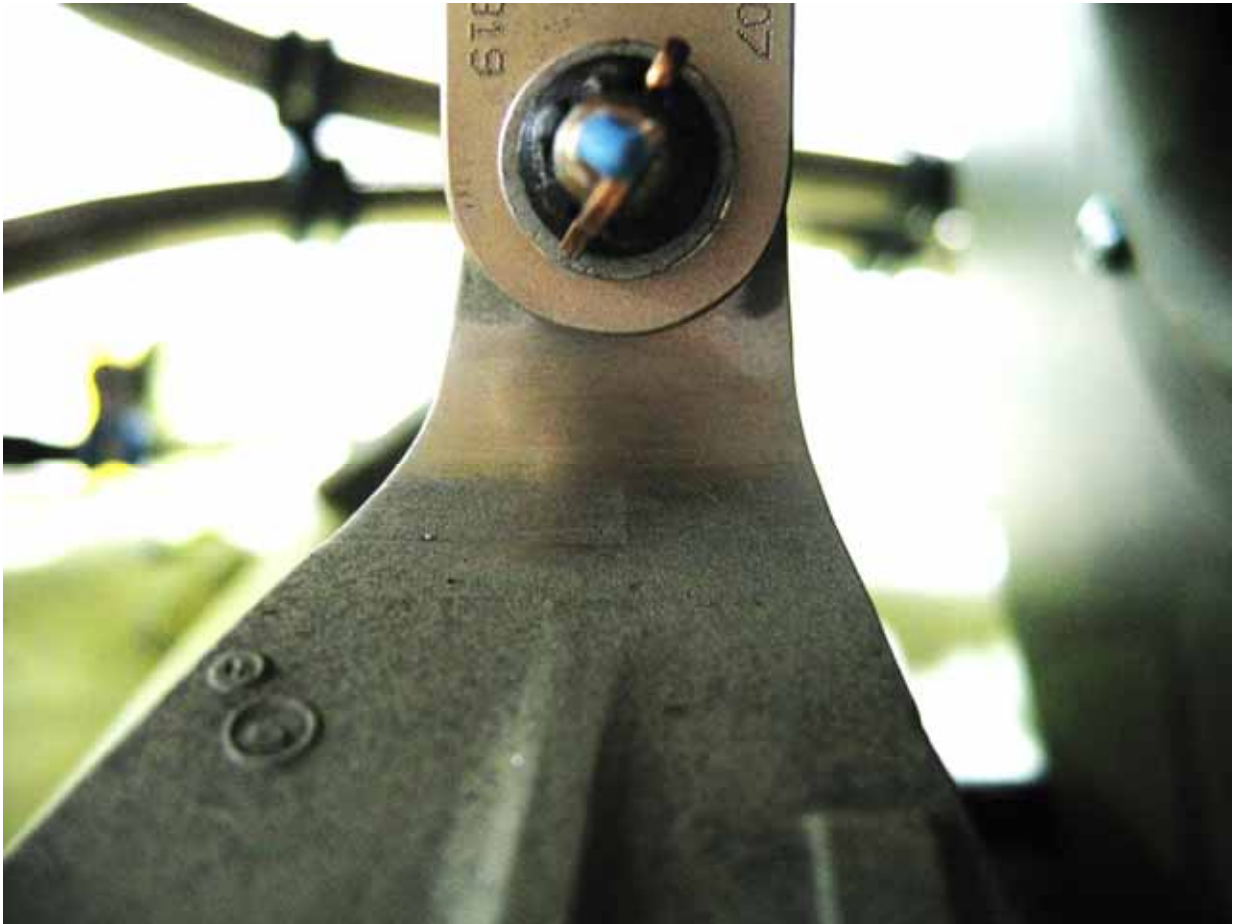
Figure 3

View of reworked bracket assembled on aircraft

- b) Polish reworked area using 280 grit sand paper. Final polish smooth reworked area using scotchbrite (C-407).
 - c) Apply chemical film material (C-100) to reworked areas. Refer to BHT-ALL-SPM. Refer to Figure 3.
