ALERT SERVICE BULLETIN

NO. 427-10-32

MODEL AFFECTED: 427

SUBJECT: TAIL ROTOR BLADES P/N 427-016-001-109 AND 427-016-001-109L, INSPECTION OF.

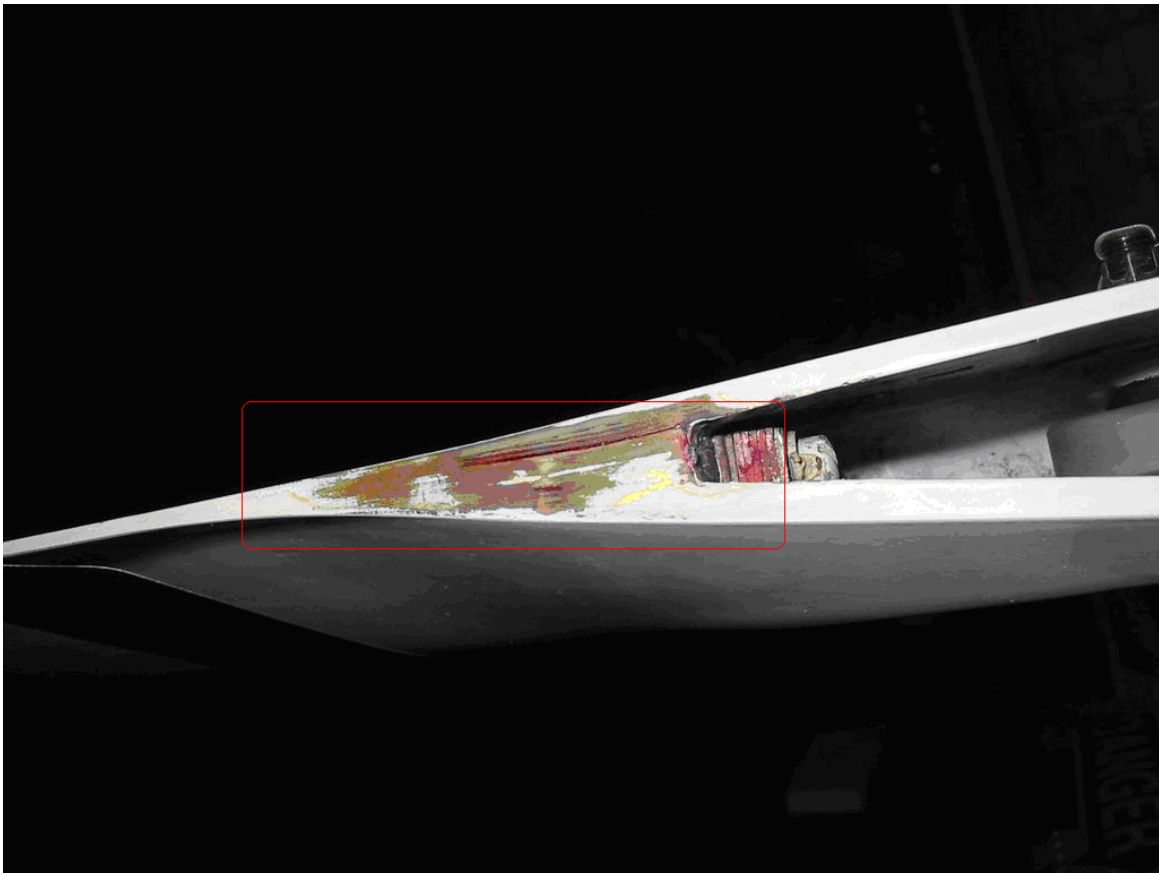
1. Use detergent (C-318) and thoroughly clean the tail rotor blade in the area to be inspected. Refer to Figure 1.
2. Using a 10 X magnifying glass, inspect tail rotor blade(s) for evidence of separation between skin plies and root end block at trailing edge.
 - If cracks are found, remove tail rotor blade from the aircraft and proceed with PART II and Part III of this bulletin.
 - If no crack is found but the tail rotor assembly has history of balance change or balance difficulties for unknown reason, remove tail rotor blade from the aircraft and proceed with PART II and Part III of this bulletin.
 - If no crack is found and the tail rotor assembly has no history of balance change or balance difficulties, blade may be returned to service.
3. Make an entry in the tail rotor blade historical record to reflect compliance with Part I of this bulletin.

Figure 1. Blade area to be inspected

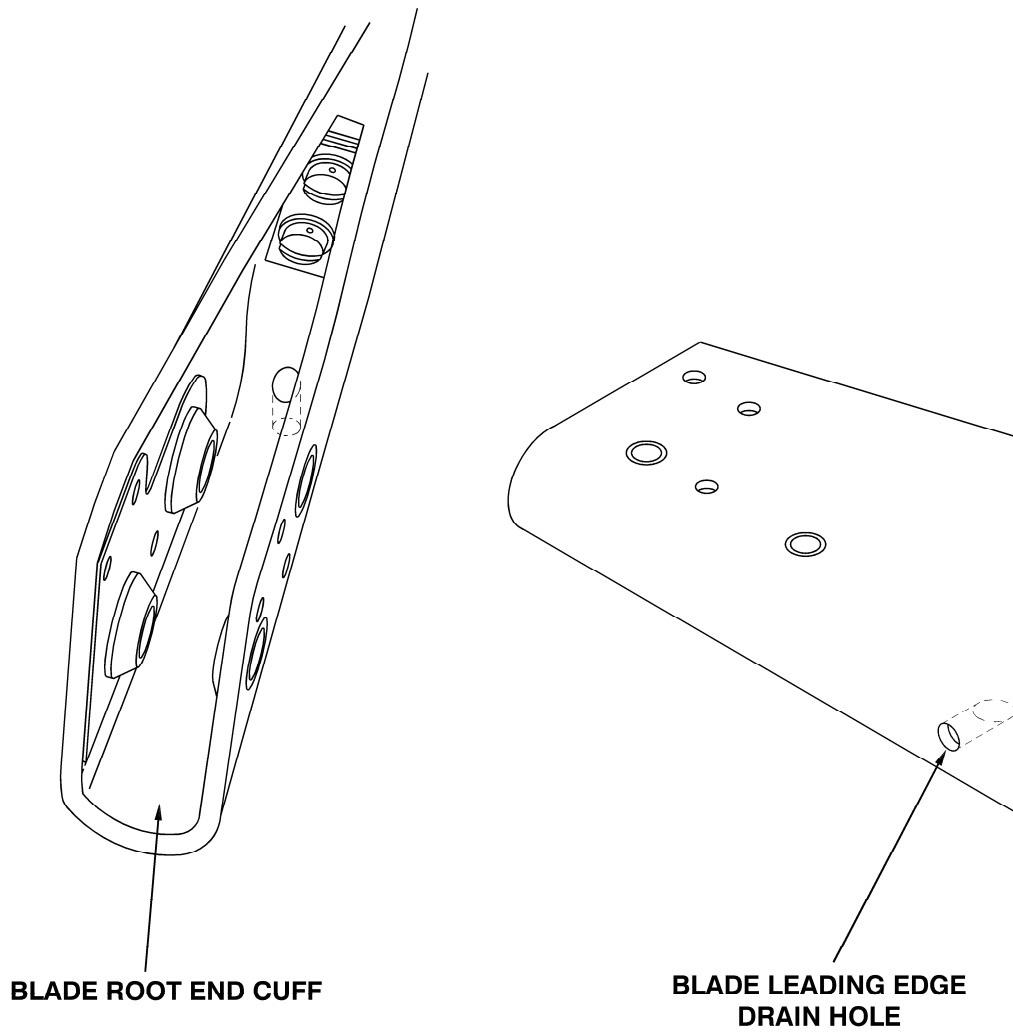
6. With the blade under water, check for air leaks that will be indicated by a steady stream of fine bubbles originating from a single point.
7. Gently rotate blade back and forth to allow a thorough inspection of all the blade surfaces. Pay particular attention to the root end cuff and around the leading edge drain hole. Refer to the Figure 2.

Figure 2. Areas to verify during leak check

8. The blade should be left in hot water for a minimum of 1 minute and a maximum of 2 minutes.
9. If an air leak is found on a tail rotor blade, send the blade to a Bell Helicopter Approved Blade Repair Facility for evaluation and possible repair as water may have entered the blade.
10. If no air leak is found on a tail rotor blade, repair the defects on the blade per Part III of this bulletin.

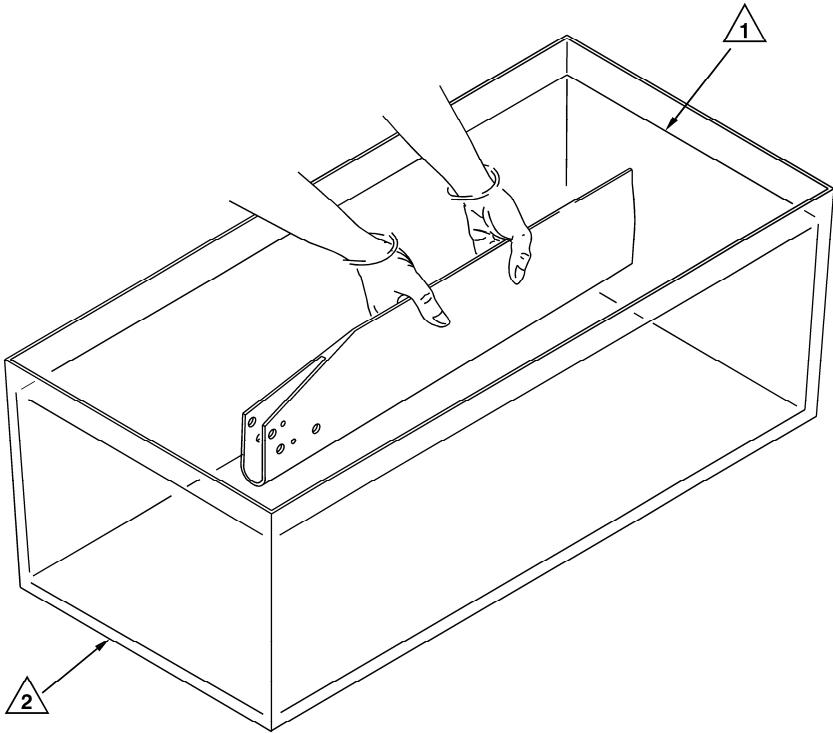
1. Thoroughly clean the blade including the surfaces of the root end cuff with cleaning detergent (C-318). Rinse with clear water.
2. Cool the blades in a refrigerator for a minimum of 1 hour at a temperature of -1°C to 7°C (30°F to 45°F).
3. Fill the water tank with clean clear water. For best results the water should be maintained at 60°C to 80°C (140°F to 175°F).
4. Wearing protective gloves, place the cool blade into the heated water. The blade will float, so it will be necessary to manually submerge the blade. Refer to Figure 3

Figure 3. Water tightness check
