ALERT SERVICE BULLETIN

429-11-04  
21 December 2011

**MODEL AFFECTED:** 429

**SUBJECT:** EXHAUST EJECTOR P/N 429-363-111-101/-102,  
INSPECTION AND REPAIR OF.

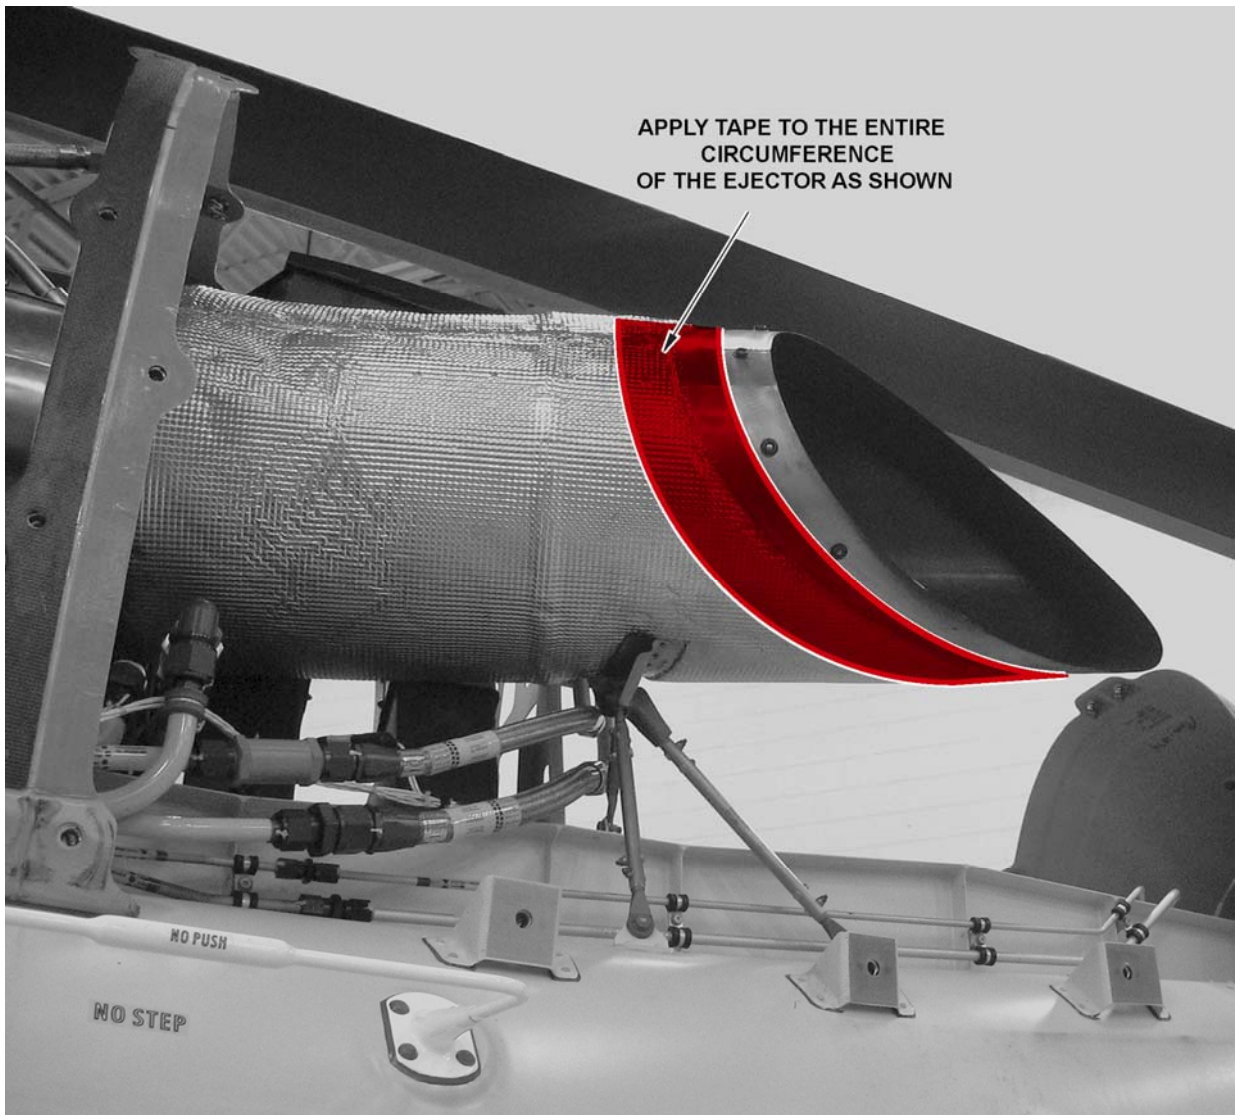
**Figure 1**  
Ejector assembly

1. Prepare helicopter for maintenance.
2. Gain access to the exhaust ejectors by removing both forward exhaust fairings (700GL and 700GR). Refer to BHT-429-MM-1, Chapter 53.
3. Inspect the exhaust ejector assembly paying particular attention to the condition of the stainless steel blanket at and around the weld joint at the aft section of the ejector.
  - a. If the blanket is securely attached to the ejector and there is no sign of damage, crack or tear, no further action required. Repeat inspection of ejectors every 10 hours of operation until Part II of this bulletin is accomplished.
  - b. If the blanket is damaged and/or is separated from the ejector at the weld joint, accomplish Part II of this bulletin before next flight.

5. Apply 3M high temperature aluminum foil/glass cloth tape P/N 363, 2.00" WIDE to the ejector and blanket. Refer to Figure 1 for application details.
  - a. Start the first layer of tape at the edge of the ejector doubler. Run the tape around the entire circumference of the ejector. Overlap end of tape by approximately 2 inches.
  - b. Apply the second layer of tape around the entire circumference of the ejector overlapping by approximately 1 inch the first layer of tape. Overlap end of tape by approximately 2 inches.
  - c. Repeat sub-step 5b until reaching approximately 6 to 8 inches from the edge of the ejector doubler. Refer to Figure 1.
6. Reinstall both forward exhaust fairings (700GL and 700GR). Refer to BHT-429-MM-1, Chapter 53.
7. Make an entry in helicopter historical service records indicating compliance with this bulletin.
