**SUBJECT: REVISION "A" TO ALERT SERVICE BULLETIN UH-1H-II-09-16:  
TAIL ROTOR BLADE P/N 210-010-750-ALL, INSPECTION OF.**

NO. UH-1H-11-09-16

**MODEL AFFECTED:** UH-1H-II

**SUBJECT:** TAIL ROTOR BLADE P/N 212-010-750-ALL, INSPECTION OF.

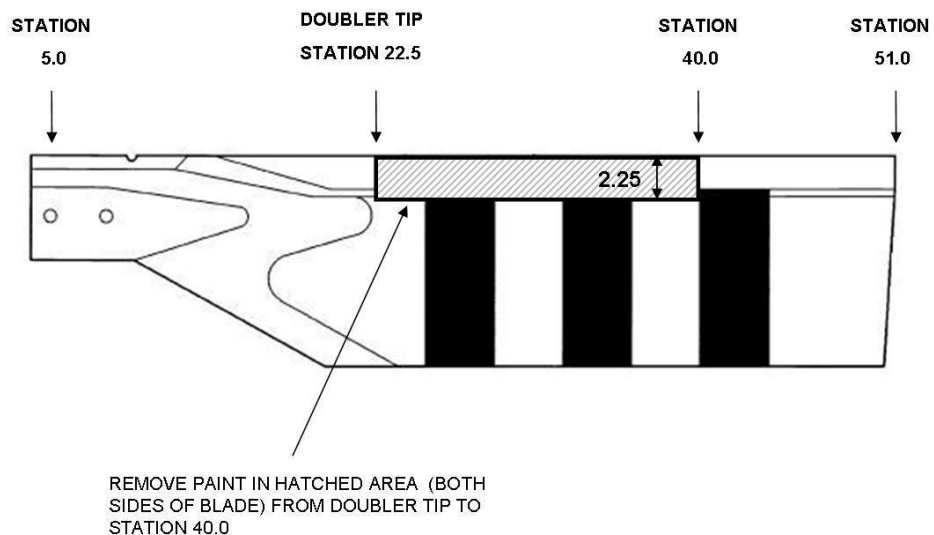
**Figure 1**

Bell Helicopter has discovered that certain tail rotor blades may have manufacturing anomalies in the spar area as a result of the chemical milling process. The anomalies may be identified as pits and/or corrosion on the spar. Serviceability of the spar will consist of removing the paint on the spar between blade stations 22.5 and 40.0 and carrying out a detailed visual inspection with a 3-power or higher magnifying glass. A fillet filled with adhesive runs spanwise between the blade spar and the skin 2.25 inches aft of the blade leading edge, both inboard and outboard sides. The primary area to be inspected runs along the edge of the spar fillet and a half inch forward of this point. (Between 1.75 and 2.25 inch from the leading edge of the blade and from Blade Stations 22.5 to 40.0, both inboard and outboard sides).

4. Ensure that all paint (on the spar only) is removed from the first 2.25 inches of the leading edge (chordwise) and from the B.S 22.5 (doubler tip) to B.S. 40.0. Refer to Figure 1. This will expose the spar up to the fillet between the blade spar and skin. A fillet filled with adhesive runs spanwise between the blade spar and the skin 2.25 inches aft of the blade leading edge, both inboard and outboard sides. The primary area to be inspected runs along the edge of the spar fillet and a half inch forward of this point. (Between 1.75 and 2.25 inch from the leading edge of the blade and from Blade Stations 22.5 to 40.0, both inboard and outboard sides).

5. Wipe area with a clean cloth dampened with alcohol (C-385) or aliphatic naphtha (C-305) and dry thoroughly.
6. Carry out a detailed visual inspection of the spar for corrosion and/or pitting using a 3-power or higher magnifying glass. Anomalies on the steel spar 0.003 inch deep or less must be polished out in accordance with BHT-PUB 92-004-23 MM.

Any defect greater than 0.003 inch deep is cause for rejection and the blade must be removed from service.
