**SUBJECT: REVISION "A" TO ALERT SERVICE BULLETIN UH-1H-II-09-17:
205-030-856-157/-159 ELEVATORS, ONE TIME INSPECTION OF.**

NO. UH-1H-II-09-17

MODEL AFFECTED: UH-1H-II

SUBJECT: 205-030-856-157/-159 ELEVATORS, ONE TIME INSPECTION OF.

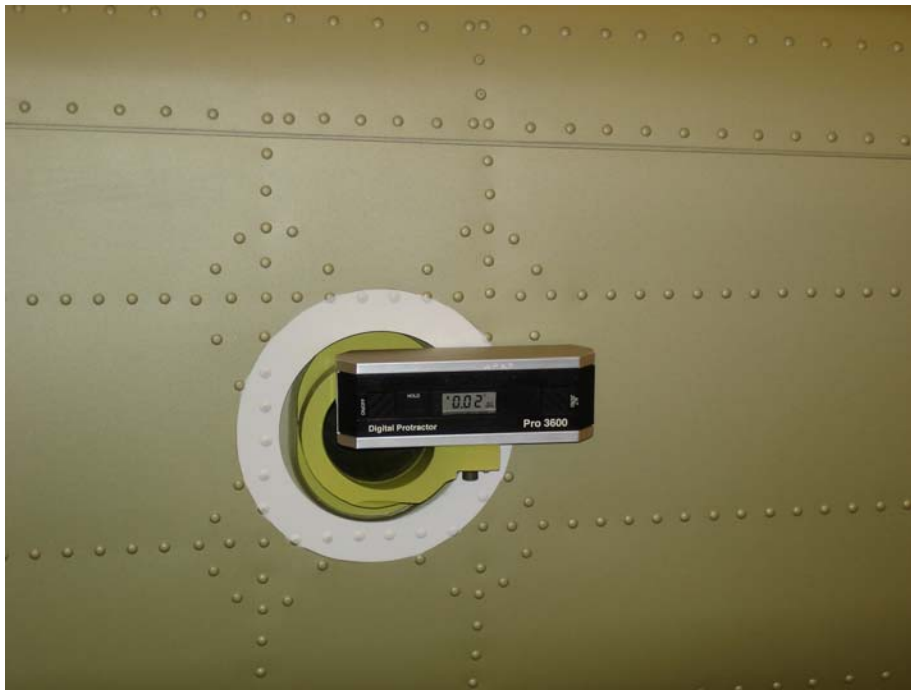
Figure 1
Angle A

- Place digital protractor on elevator horn fitting, zero protractor and record as Angle "A". (ref Fig 1)

- a. If the difference between Angle "A" and Angle "B" is not within the allowable difference ($2.0^{\circ} \pm 0.3^{\circ}$), replace the RH elevator as per Maintenance Manual within the next 100 flight-hours.
 - b. If the difference between Angle "C" and Angle "D" is not within the allowable difference ($3.0^{\circ} \pm 0.75^{\circ}$) replace the LH elevator as per Maintenance Manual within the next 100 flight-hours.
10. Make an entry in helicopter historical records indicating compliance of this bulletin.

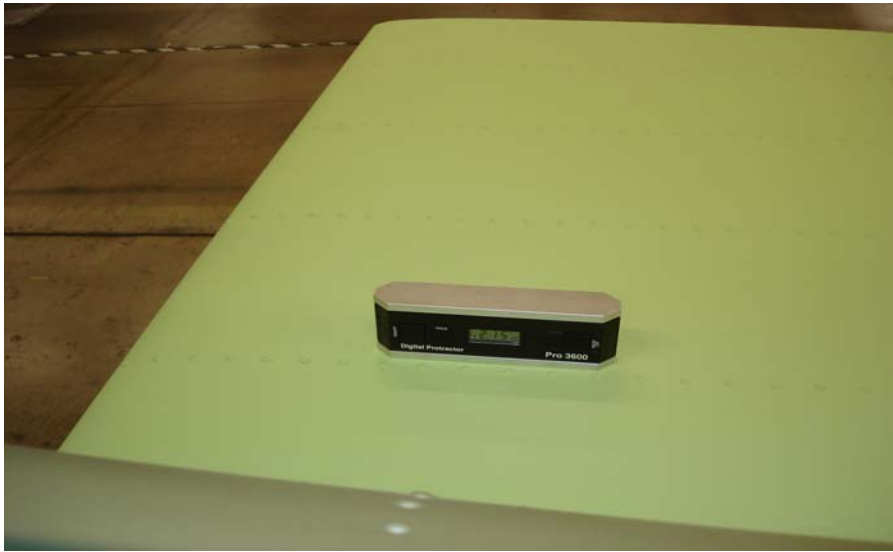
Figure 2
Angle B

- Move protractor to top skin of RH elevator second rib, edge of protractor should be aligned with the 8th rivet from the leading edge of the elevator. Record relative angle as Angle "B". (ref Fig 2)
- Install L/H Elevator per Maintenance Manual.
- Position protractor to top skin of RH elevator second rib, edge of protractor should be aligned with the 8th rivet from the leading edge of the elevator. Zero protractor and record as Angle "C". (ref Fig 3)

The allowable difference from A to B = $2.0^{\circ} \pm 0.3^{\circ}$
 The allowable difference from C to D = $3.0^{\circ} \pm 0.75^{\circ}$

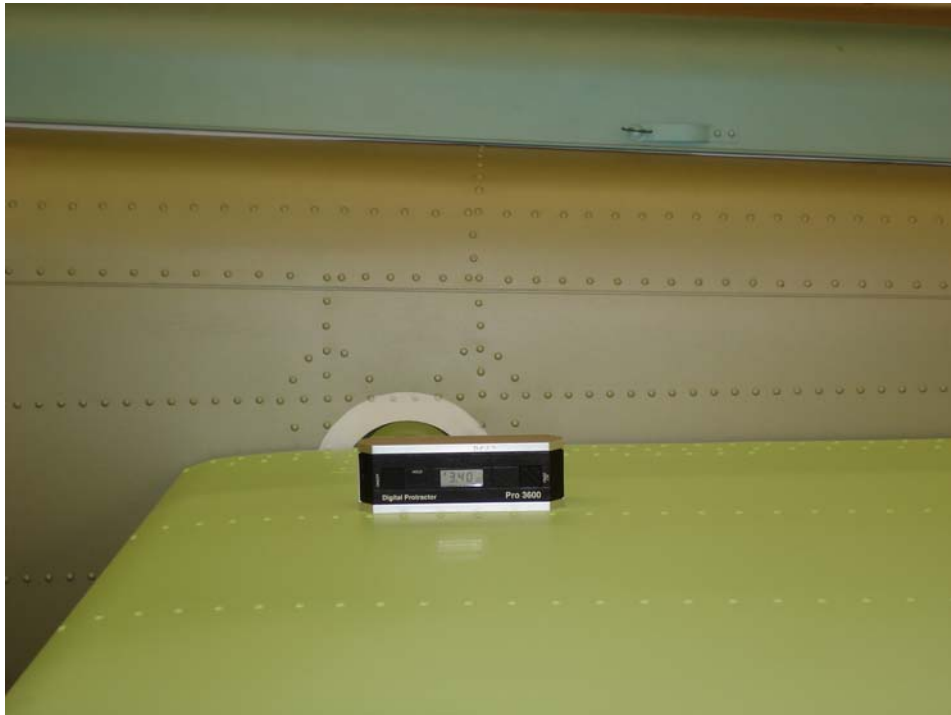
Figure 4
Angle D

- Position protractor to top skin of LH elevator second rib, edge of protractor should be aligned with the 8th rivet from the leading edge of the elevator. Record relative angle as Angle "D". (ref Fig 4)
