ALERT SERVICE BULLETIN

UH-1H-II-17-28

MODEL AFFECTED: UH-1H-II

SUBJECT: MAGNETIC BRAKE ASSEMBLY 204-001-376-003
INSPECTION AND REPAIR OF.

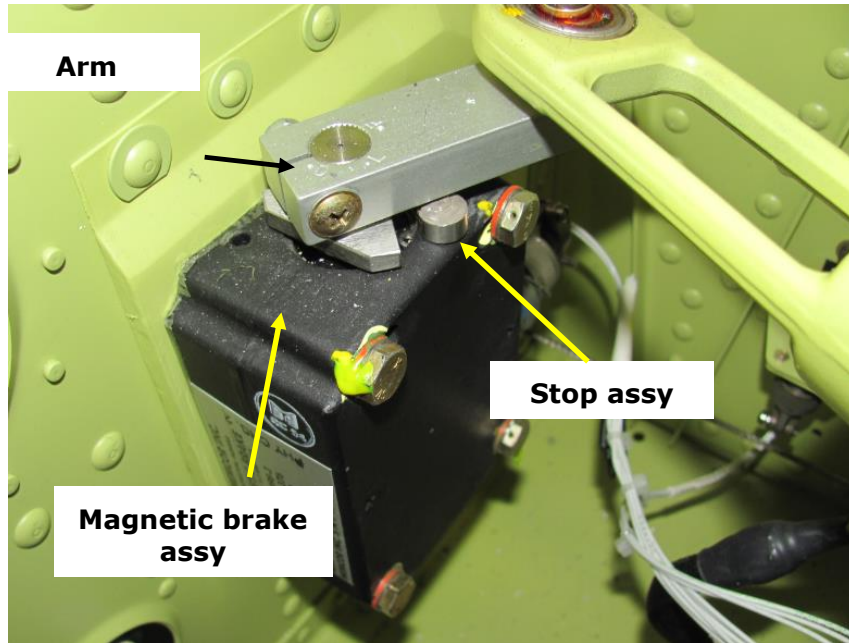
Figure 1. Magnetic brake assembly.

1. Prepare the helicopter for maintenance.
2. Gain access to the cyclic and anti-torque magnetic brake assembly.
3. Perform a detailed visual inspection of the stop assemblies (Figures 1 and 2). Figures 3 and 4 show a stop assembly found debonded.

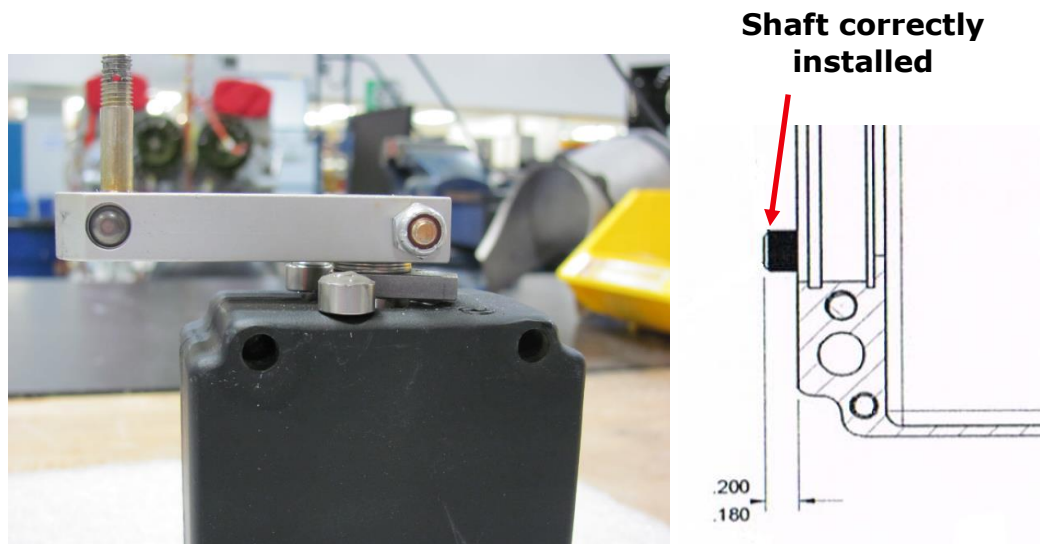
Figure 2. Magnetic brake assembly with stops correctly installed.
 (Magnetic brake 204-001-376-003 shown as an example Figures 1 to 4)

8. The shaft should protrude from the housing surface between 0.180 inch and 0.200 inch. (Figure 2).
9. Allow sufficient time for the adhesive (C-317) to cure (24 hours at 70 to 95 °F)

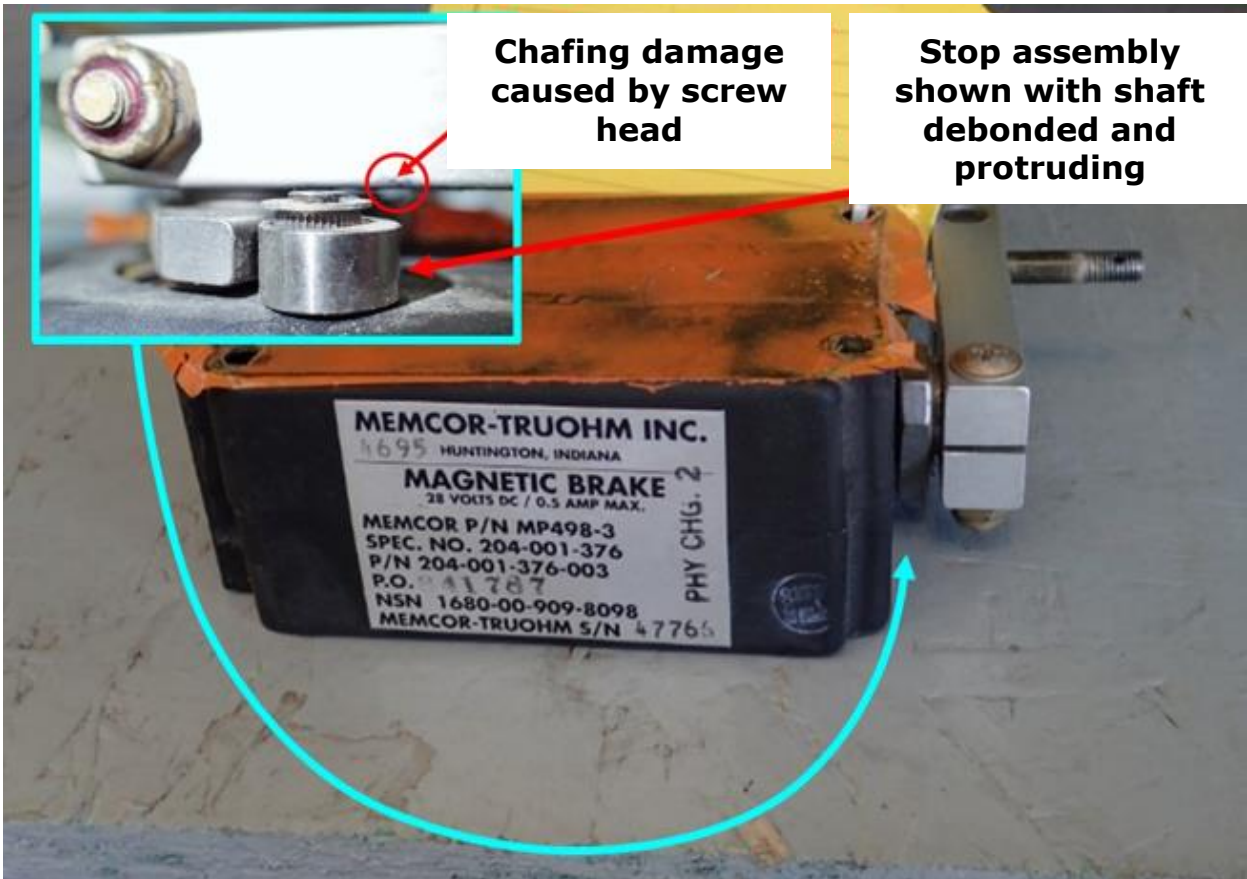
Bell Helicopter has received reports of magnetic brake assembly P/N 204-001-376-003 (Memcor-Truohm P/N MP498-3) adjustable stop assembly contacting the magnetic brake arm. With time in service, the stop assembly shaft may debond from the housing, back out and cause interference or limit the magnetic brake arm range of motion. This condition, although not desirable, will not affect the proper function of the flight controls.

Figure 3. Stop assembly with debonded shaft.

4. Pull on the stop assembly by hand to verify if the stop shaft is debonded from the housing assembly. If the shaft shows evidence of debonding, inspect the lower side of the arm for possible chafing damage. Repair allowable damage and then accomplish Part II. The maximum allowable mechanical damage is 0.030 inch. Repair allowable chafing damage as follows:

- a. Using 220 grit of finer abrasive cloth or aluminum oxide paper, polish out mechanical damage found within the allowable 0.030 inch
 - b. Apply aluminum alloy chemical film treatment to the repaired area (BHT-ALL-SPM).

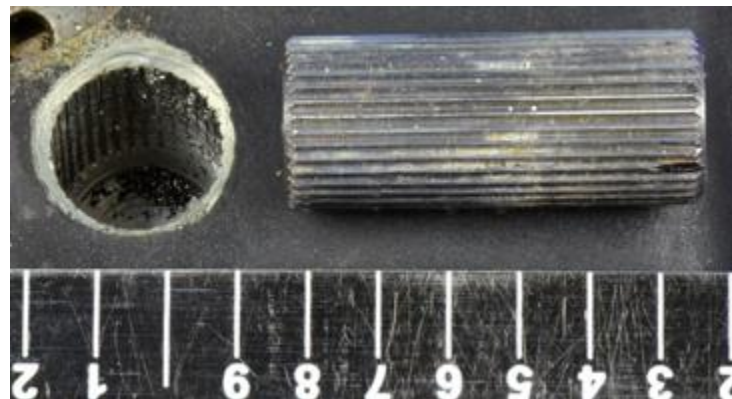
Figure 4. Shaft removed from housing.

4. Remove the stop assembly from the housing. (Figure 4)
5. Thoroughly clean adhesive residue from the shaft and the housing bore. If the splined stop requires removal from the shaft, index mark the stop, the shaft and the housing to ensure installation at the same location.
