## **INFORMATION LETTER 206-02-86**

**TO: All Owners/Operators of Bell 206 series Helicopters**

**SUBJECT: MAIN ROTOR FLAP RESTRAINT KIT 206-706-013 CHANGE IN INSTALLATION PROCEDURE**

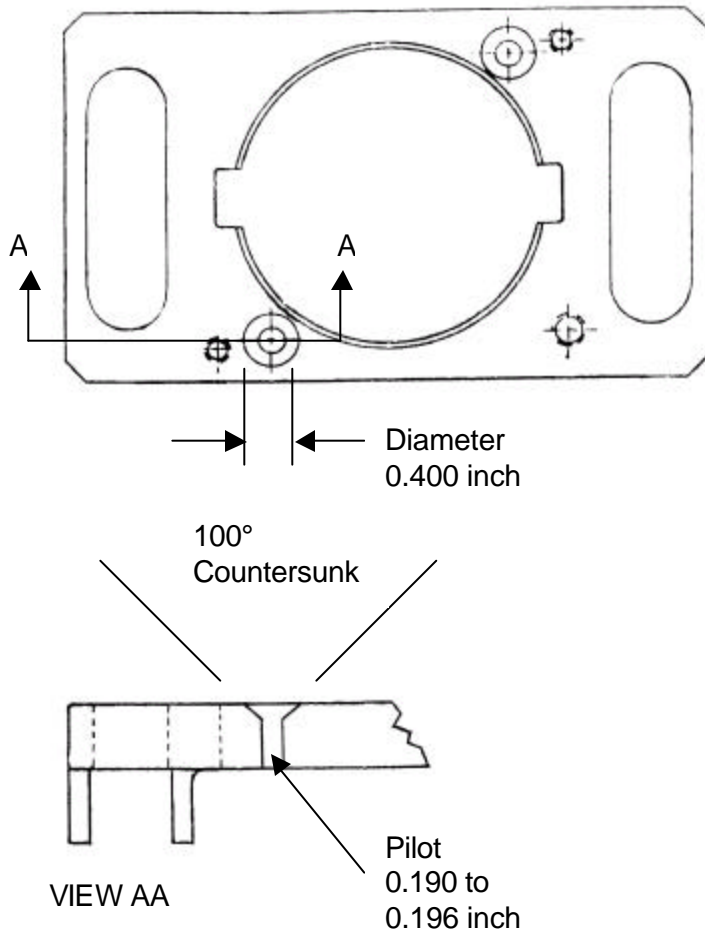
Figure 1 Support 206-010-191

One of two conditions may contribute to this potential interference. Some 206-010-191 supports may have been manufactured with the countersinks for the attaching screws not deep enough. Primer or paint may have been applied to the plate, reducing the dimension of the attachment screws countersink.

Either of the above conditions may cause the screw head to protrude above the surface and foul the mast nut when the mast nut is tightened. This condition is not a safety issue but the protruding screws head may damage the mast nut and in extreme conditions affect the mast nut torque.

Use a straight edge placed on the screws head to ensure the screw heads do not protrude above the support. If the screws head protrude, check the support countersinks for presence of primer or paint. Remove any primer or paint from the countersinks, and repeat the straight edge check. If a screw head is found to protrude after the paint removal, rework the support as follows:

1. Using a press drill and a 100° countersink bit with a 0.190 to 0.196 inch diameter pilot, machine the countersink as shown in figure 1.
2. After rework brush cad plate the countersink. Do not apply primer or paint to the countersink surfaces.
