INFORMATION LETTER 206-05-91
206L-05-77

SUBJECT: 206-033-426-001 AND -003, INSPECTION OF TAIL ROTOR GEARBOX SUPPORT ASSEMBLY

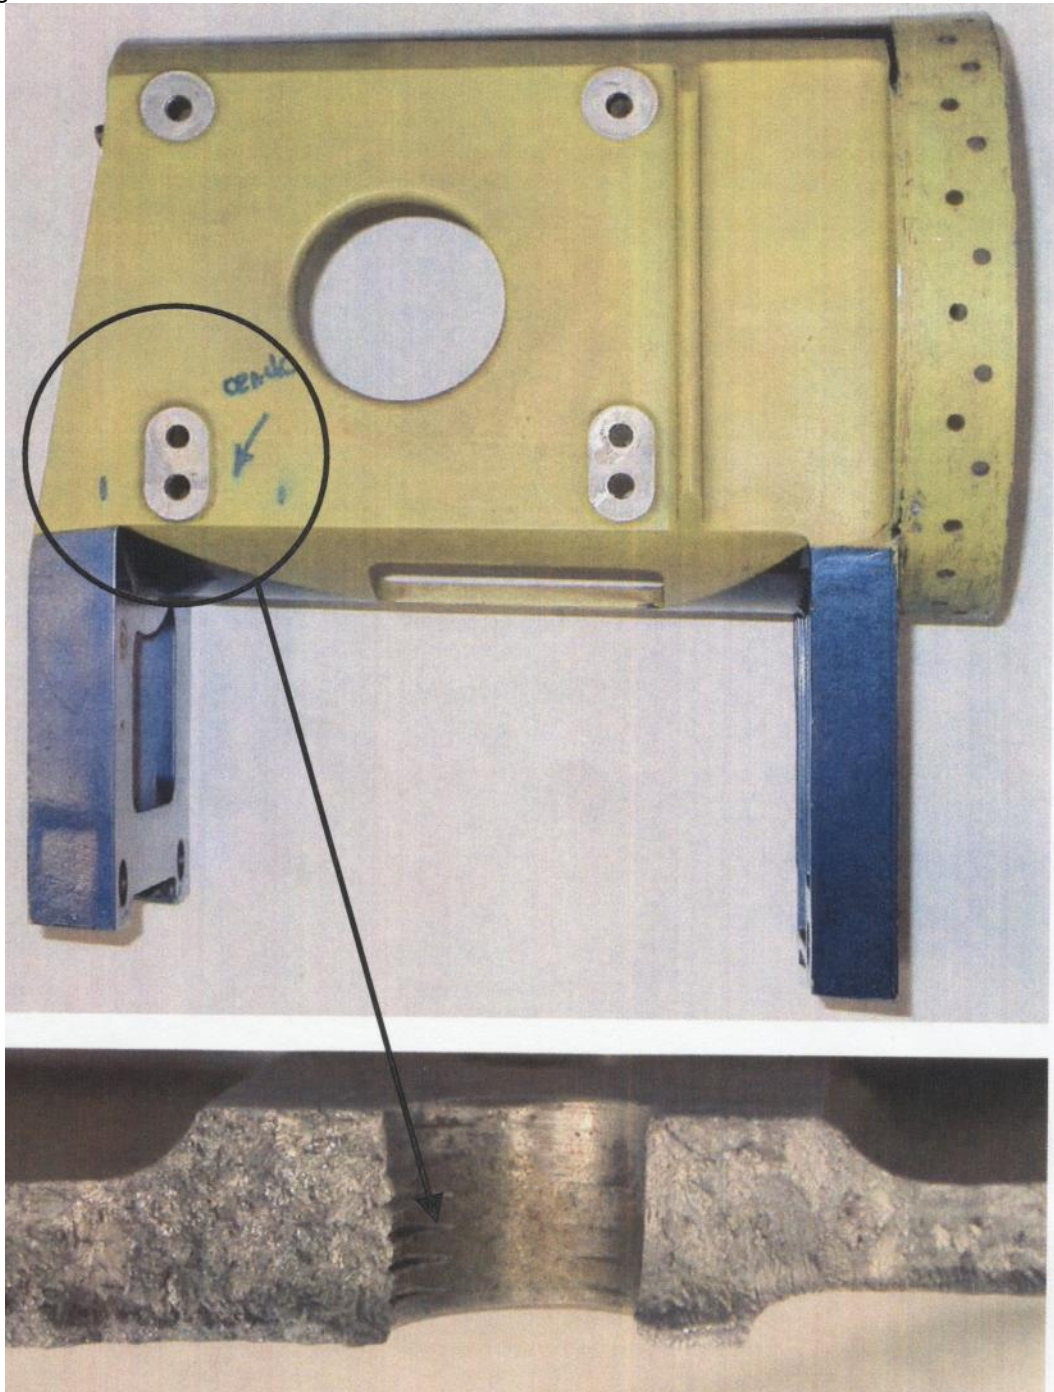
As an example, Bell Helicopter has received report of a cracked 206-033-426-001 tail rotor gearbox support assembly. The subject crack was located at the aft outboard right hand stud hole. Thread marks worn into the bore of the stud hole were observed, see Figure 1. After evaluation, it has been determined that the crack originated at the thread marks in the stud hole.

Figure 1: View of wear inside the bore at the cracked bolt hole.

In this situation, it is prudent to verify the condition of the bore of the gearbox at the tail rotor gearbox install or replacement. Check the perpendicularity of the tail rotor gearbox case studs using a square between the case studs and mounting pad. Damage is frequently reported during handling or removal of the gearbox. A bent stud will score the casing and shall result in the replacement of the stud or casing.

In result of the above statement, it is recommended to visually inspect the components for signs of damage and distortion at removal or installation.
