INFORMATION LETTER 206L-00-70

TO: All Owners/Operators of Bell 206L, L-1 and L-3 Helicopters.

SUBJECT: LOW CLEARANCE BETWEEN HYDRAULIC RETURN TUBE ASSEMBLY 206-076-649-101 AND CYCLIC CONTROL TUBE ASSEMBLY 206-001-193-001.

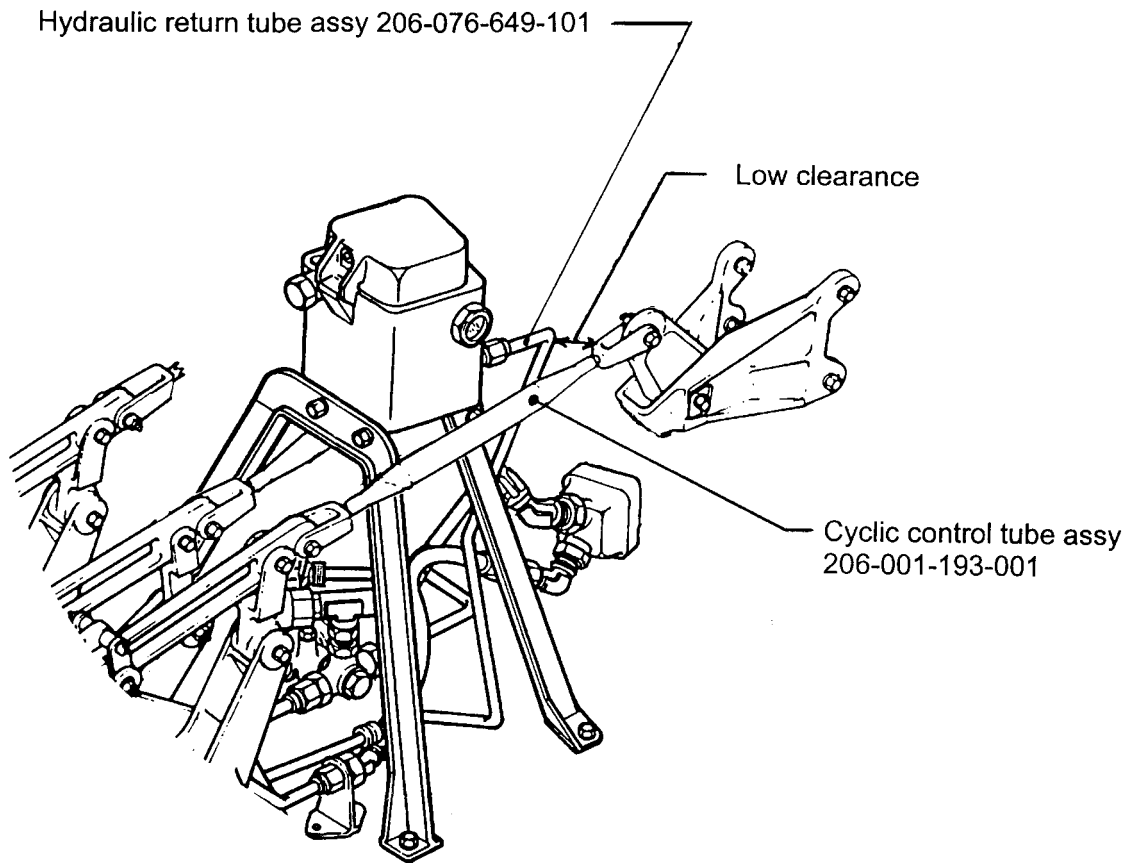
FIGURE 1.

This Information Letter is issued to inform of a condition of low clearance that may exist on some helicopters. Interference in certain flight conditions may result when the left hand cyclic servo actuator is fully retracted as is the case when full right or full aft cyclic input is applied.

In low clearance conditions, the aft clevis of the left hand cyclic control tube assembly 206-001-193-001 may contact the hydraulic return tube assembly in the area of the uppermost bend, see figure 1. The contact will be evidenced by chafing marks on the hydraulic tube assembly 206-076-649-101.

A tube assembly 206-076-665-101 has been developed with increased clearance, and introduced on the model 206L4. In order to correct or prevent a low clearance condition, tube assembly 206-076-649-101 may be replaced with tube assembly 206-076-665-101 which provides more clearance in that location. Tube assembly 206-076-665-101 supersedes tube assembly 206-076-649-101.
