## **INFORMATION LETTER 206L-02-73**

**SUBJECT: MAIN ROTOR FLAP RESTRAINT KIT 206-706-013 CHANGE IN INSTALLATION PROCEDURE**

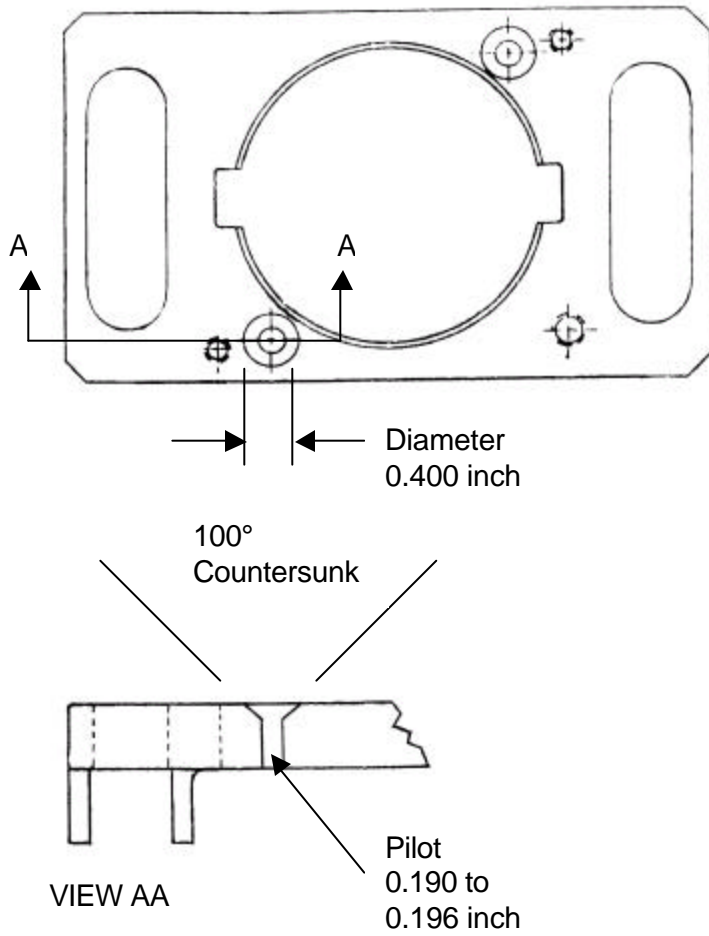
Figure 1 Support 206-010-191

One of two conditions may contribute to this potential interference. Some 206-010-191 supports may have been manufactured with the countersinks for the attaching screws not deep enough. Primer or paint may have been applied to the plate, reducing the dimension of the attachment screws countersink.

Either of the above conditions may cause the screw head to protrude above the surface and foul the mast nut when the mast nut is tightened. This condition is not a safety issue but the protruding screws head may damage the mast nut and in extreme conditions affect the mast nut torque.

Use a straight edge placed on the screws head to ensure the screw heads do not protrude above the support. If the screws head protrude, check the support countersinks for presence of primer or paint. Remove any primer or paint from the countersinks, and repeat the straight edge check. If a screw head is found to protrude after the paint removal, rework the support as follows:

1. Using a press drill and a 100° countersink bit with a 0.190 to 0.196 inch diameter pilot, machine the countersink as shown in figure 1.
2. After rework brush cad plate the countersink. Do not apply primer or paint to the countersink surfaces.
