Bell Helicopter **TEXTRON**

INFORMATION LETTER 206L-99-62

SUBJECT: Alternate Means of Compliance to FAA AD 99-02-01

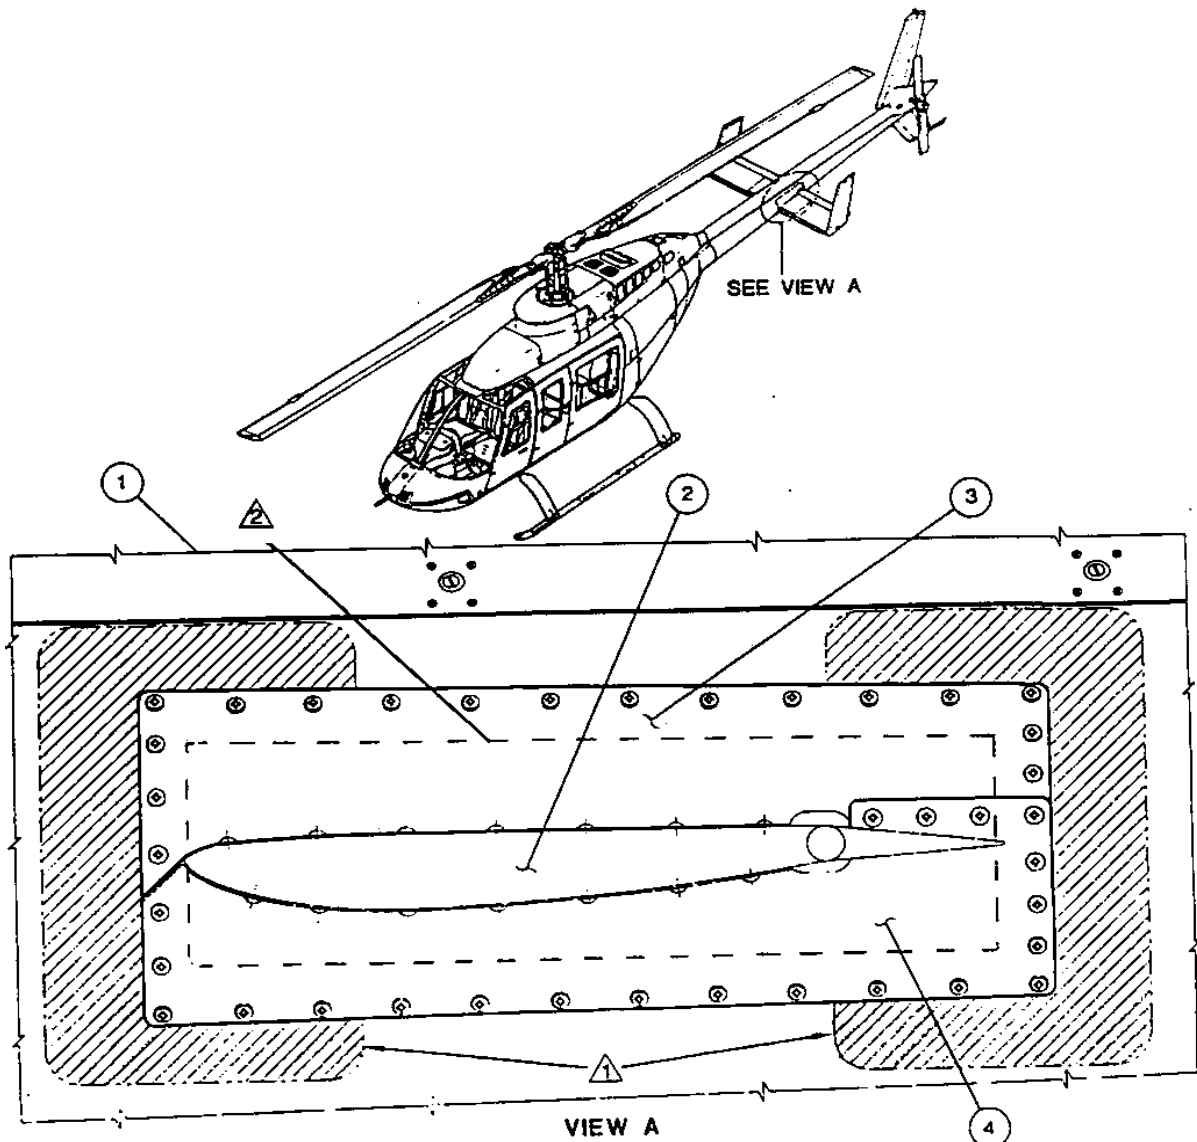
Figure 1
PL AD 99-02-01

- ⚠ Visually inspect/check for a crack in the shaded areas on both sides of the tailboom.
- ⚠ Fluorescent-penetrant inspect the entire edge of the horizontal stabilizer opening on both sides of the tailboom.

- (a) Before further flight and thereafter, at intervals not to exceed 10 hours time-in-service (TIS), visually inspect for any cracks in the shaded areas shown in figure 1. Use a 10-power or higher magnifying glass. If a crack is found, replace the tailboom with an airworthy tailboom

- (b) At intervals not to exceed 5 hours TIS, visually conduct a preflight check of the shaded areas shown in figure 1 for any cracks. If a crack is found, replace the tailboom with an airworthy tailboom. The visual check may be performed by the owner/operator (pilot) holding at least a private pilot certificate, and must enter into the aircraft records showing compliance with this inspection.

- (c) Within 50 hours TIS:
 - (1) Remove all 4 horizontal stabilizer supports, P/N 206-023-100-all dash numbers, from the tailboom and the horizontal stabilizer.
 - (2) Perform a one-time fluorescent-penetrant inspection of the edges of the tailboom skins for any cracks around the left and right horizontal stabilizer openings (Figure 1). Remove paint and primer to inspect the edges and exterior skin surface in the skin area at least 3/4 inch around the edges of the horizontal stabilizer openings.
 - (3) If crack is found, replace the tailboom with an airworthy tailboom.
 - (4) After completion of the one-time FPI, the inspection with the use of a 10-power or higher magnifying glass, as referenced by (a) above, is not required. However (b) above is still required.

- (d) After completion of (c) above, at intervals not to exceed 100 hours TIS conduct the following:
 - (1) Remove all 4 horizontal stabilizer supports, P/N 206-023-100-all dash numbers, from the tailboom and horizontal stabilizer.
 - (2) Visually inspect with a 10-power or higher magnifying glass for any cracks on the entire edge of the horizontal stabilizer opening on both sides of the tailboom.
 - (3) If a crack is found, replace the tailboom with an airworthy tailboom.
