# **Bell Helicopter** **TEXTRON**

**INFORMATION LETTER** 212-05-57  
412-05-57  
412CF-05-18

**SUBJECT: CREW SEATS P/N 412-070-810-ALL: NOTIFICATION OF POSSIBLE DAMAGE TO SEAT ATTENUATOR GUIDE PIN P/N 222-620-821-101**

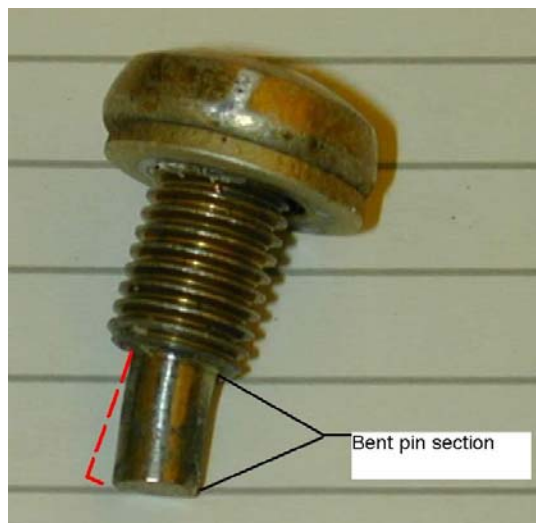
It has been brought to the attention of Bell Helicopter Textron that during an unscheduled inspection of a Bell 412 crew seat, the attenuator guide pin was found bent (see Figure 2).

The damage seen in Figure 2 was determined to have no effect on the attenuating capability of the seat. However, if heavy contact is suspected, pin should be removed, inspected and replaced as required.

FIGURE 2: Observed damage to pin

This Information Letter is issued to remind all 412 operators that the adjustment of the crew seats vertical height without personnel controlling the upward motion (no weight on seat) will result in guide pin damage. The seat attenuator internal spring assists personnel when the seat vertical position is adjusted. The external guide pin P/N 222-620-821-101 will limit upward movement of the seat but damage will result if upward velocity is not controlled. The 412 maintenance manual warns operators to this effect.
