Bell Helicopter **TEXTRON**

INFORMATION LETTER 206-03-88 206L-03-74 407-03-72

SUBJECT: THE CORRECT ORIENTATION OF THRUST BEARING 206-040-038-ALL AND 406-040-038-ALL

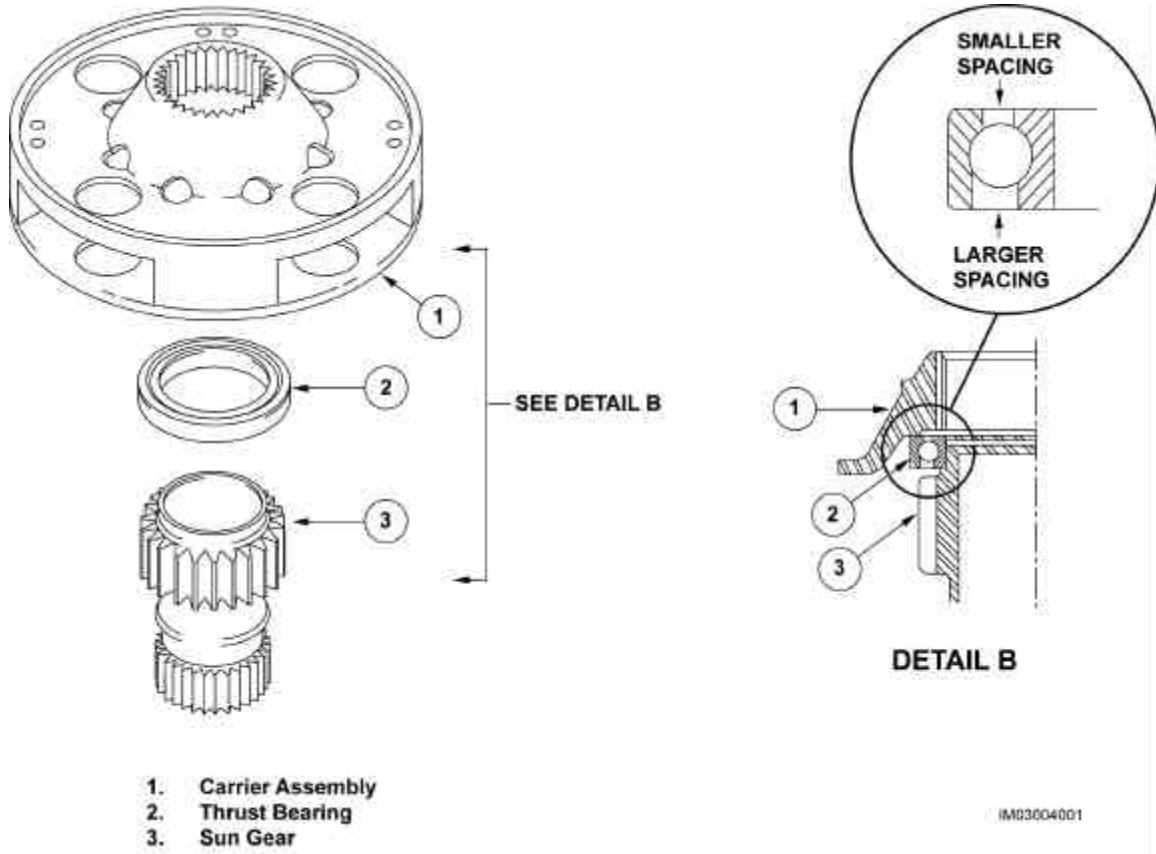
Bell Helicopter has received reports of planetary carrier thrust bearing 206-040-038-ALL or 406-040-038-ALL oriented incorrectly. In most cases the transmission started to generate metal that did not cause further damage to the component. This Information Letter is issued to help visualize the correct way to install the bearing.

The faces of the planetary carrier thrust bearing are not symmetrical. The difference in the spacing between the bearing inner and outer rings is visually apparent. The spacing between the rings of one of the faces is smaller than the other. Therefore, prior to inserting the thrust bearing into the center of the carrier assembly, orient the bearing with the smaller spacing towards the top of the carrier assembly (figure 1).

Figure 1. Thrust bearing orientation
