INFORMATION LETTER 206-05-92

TO: All Owners/Operators of Bell 206 series Helicopters

SUBJECT: FILTER 50-075-1, INSPECTION AND RECALL OF

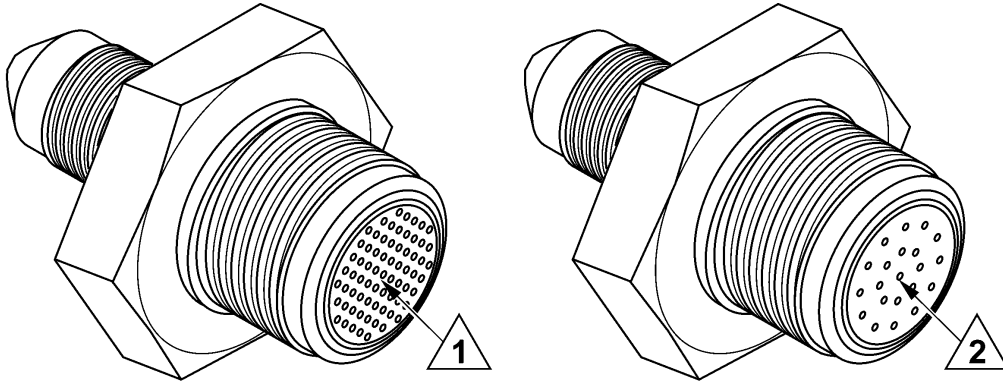
Figure 1. Filter 50-075-1 Physical Difference

This information letter is issued to report that in some filter units 50-075-1, the screen portion of the filter was not manufactured with the correct number of holes. Testing has confirmed this condition is not detrimental to the normal operation of the transmission and freewheel oil system. However, Bell Helicopter recommends that filter units with an incorrect hole pattern be identified and replaced.

- 1** Acceptable hole pattern. A minimum of 65 holes are required.
- 2** Unacceptable hole pattern to be removed from service.

To identify the configuration to be removed from service, examine the screen hole pattern (refer to Figure 1). Replace any unacceptable filter unit at your earliest convenience.
