INFORMATION LETTER 206-09-98

TO: All Owners/Operators of Bell 206A/B Series Helicopters

SUBJECT: SUSPECT FLAP RESTRAINT SUPPORT 206-010-191-001

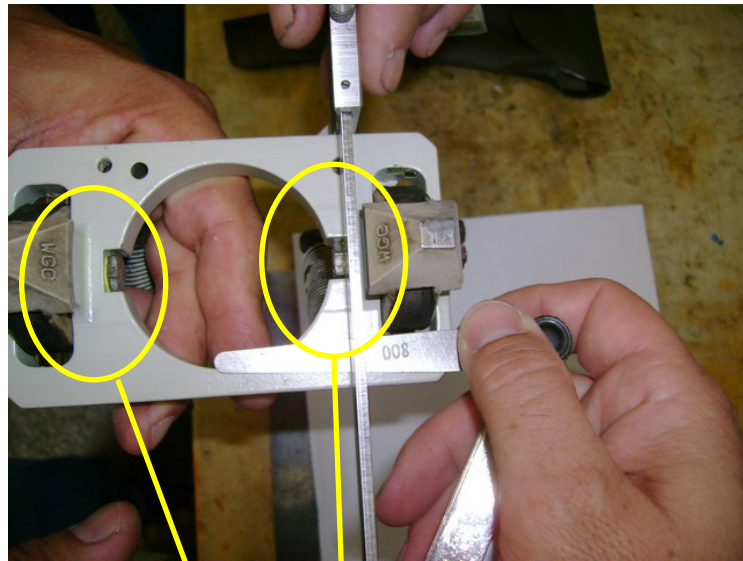
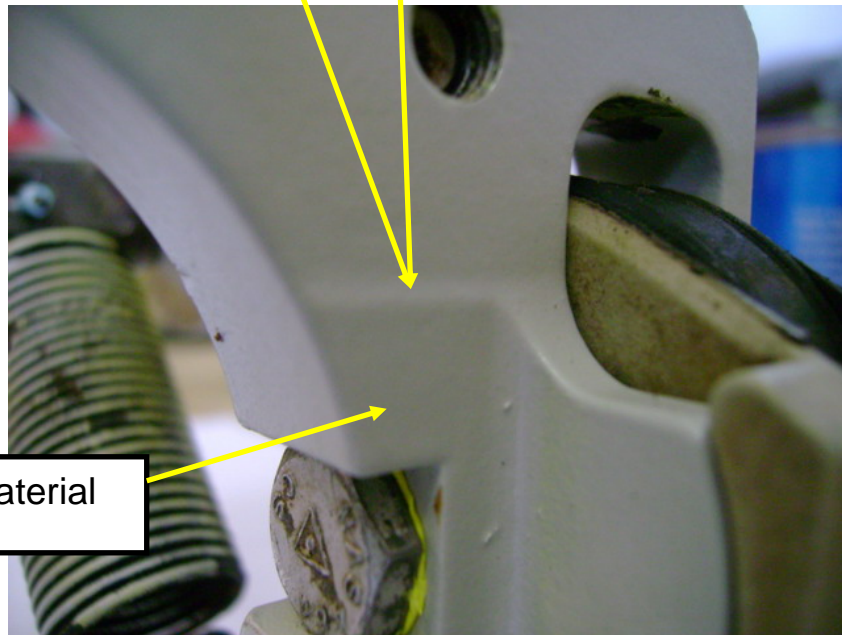
Figure 1. Discrepant Flap Restraint Support 206-010-191-001.

Bell Helicopter has received two reports of flap restraint supports 206-010-191-001 that were not manufactured to Bell Helicopter specifications. These supports have two raised areas on the lower surface that contacts the main rotor trunnion as shown on page two. This condition is not considered detrimental to the normal operation of the helicopter however if discrepant parts are found, contact Product Support Engineering for further instructions.

Raised material
