INFORMATION LETTER 206L-05-78

TO: All Owners/Operators of Bell 206L series Helicopters

SUBJECT: FILTER 50-075-1, INSPECTION AND RECALL OF

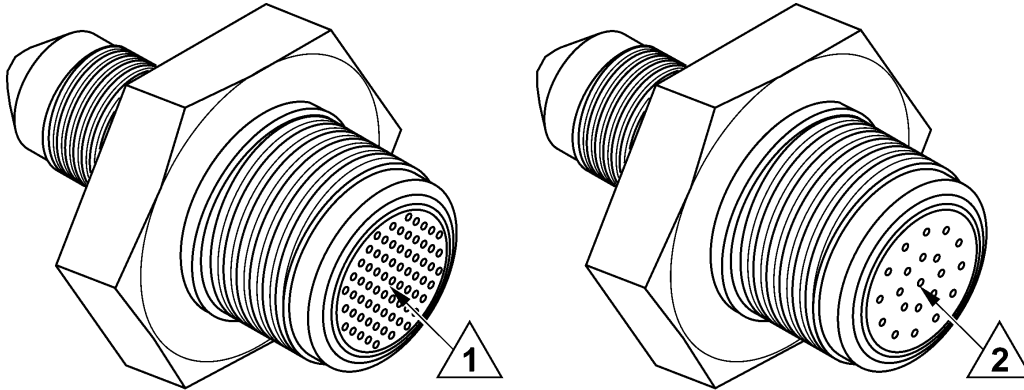
Figure 1. Filter 50-075-1 Physical Difference

This information letter is issued to report that in some filter units 50-075-1, the screen portion of the filter was not manufactured with the correct number of holes. Testing has confirmed this condition is not detrimental to the normal operation of the transmission and freewheel oil system. However, Bell Helicopter recommends that filter units with an incorrect hole pattern be identified and replaced.

- 1** Acceptable hole pattern. A minimum of 65 holes are required.
- 2** Unacceptable hole pattern to be removed from service.

To identify the configuration to be removed from service, examine the screen hole pattern (refer to Figure 1). Replace any unacceptable filter unit at your earliest convenience.
