INFORMATION LETTER 206L-08-84

TO: All Owners/Operators of Bell 206L Series Helicopters

SUBJECT: MAST NUT 206-040-078-103, INSPECTION AND RECALL OF

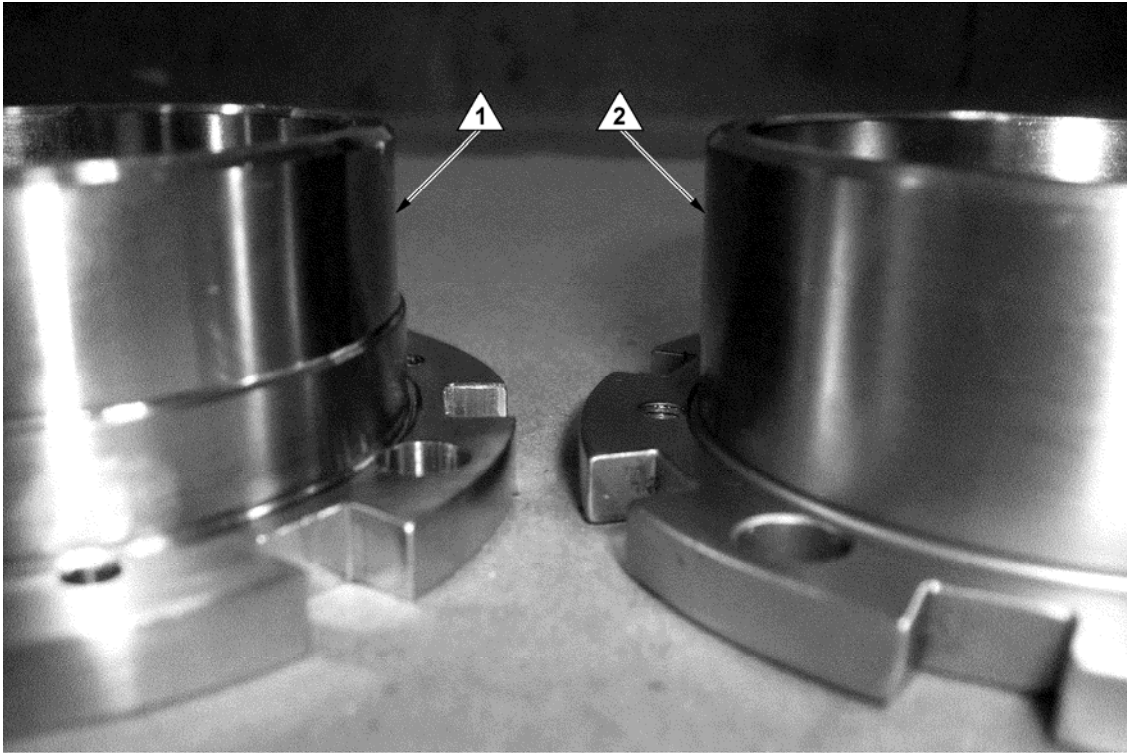
Figure 1. Mast Nut 206-040-078-103, physical difference

This information letter is issued to report that some mast nuts 206-040-078-103 were delivered with a step adjacent to the mast nut flange (refer to Figure 1). This condition is not considered detrimental to the normal operation of the helicopter. However, Bell Helicopter recommends that affected installed or in spare stock mast nuts that are identified, be replaced whenever practical. Installed mast nut can only be identified at mast disassembly.

- 1** Unacceptable mast nut to be removed from service.
- 2** Acceptable mast nut with no step.

Bell Helicopter will supply replacement nut at no charge: To receive this credit, purchase the replacement nut from an approved BHTI supply source. Submit a completed MMIR to BHTI Warranty Department no later than 90 day after the replacement nut is installed in your aircraft or replaced in your stock.
