INFORMATION LETTER 206L-09-86

TO: All Owners/Operators of Bell 206L Series Helicopters

SUBJECT: SUSPECT FLAP RESTRAINT SUPPORT 206-010-191-001

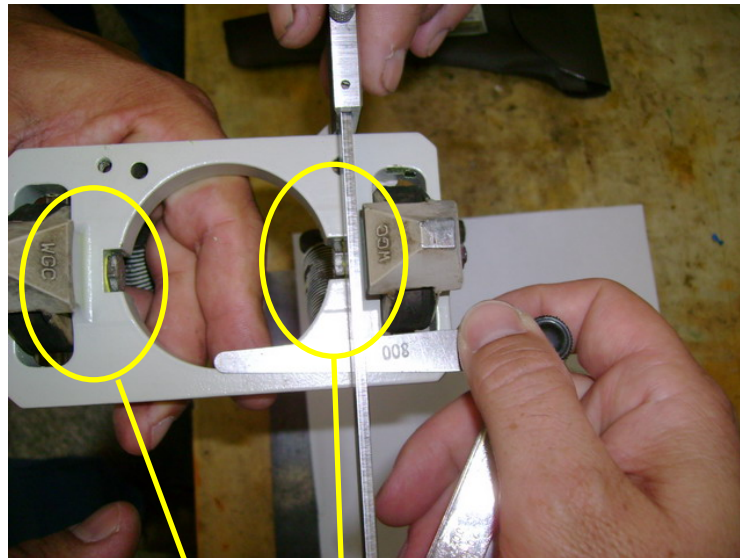
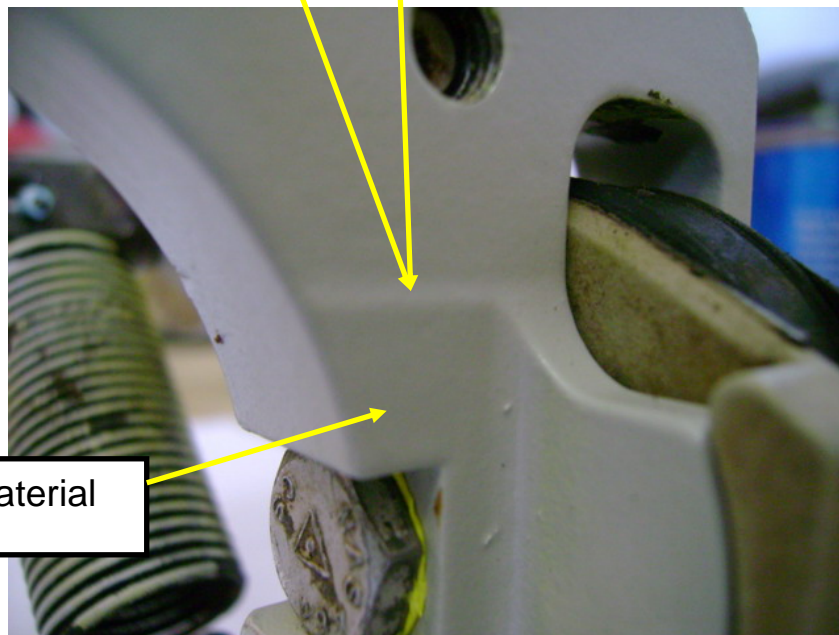
Bell Helicopter has received two reports of flap restraint supports 206-010-191-001 that were not manufactured to Bell Helicopter specifications. These supports have two raised areas on the lower surface that contacts the main rotor trunnion as shown on page two. This condition is not considered detrimental to the normal operation of the helicopter however if discrepant parts are found, contact Product Support Engineering for further instructions.

Raised material

Figure 1. Discrepant Flap Restraint Support 206-010-191-001.
