## **INFORMATION LETTER 407-06-91**

**SUBJECT: AIRCOMM CORP S.T.C. #SR00222DE AIR CONDITIONING KIT**

**Service Bulletin:** SB407-3526; Bell 407 Air Conditioner Drive Pulley Bevel Washer Replacement.

**Subject:** Tail Rotor Driveshaft Bevel Washer Replacement.

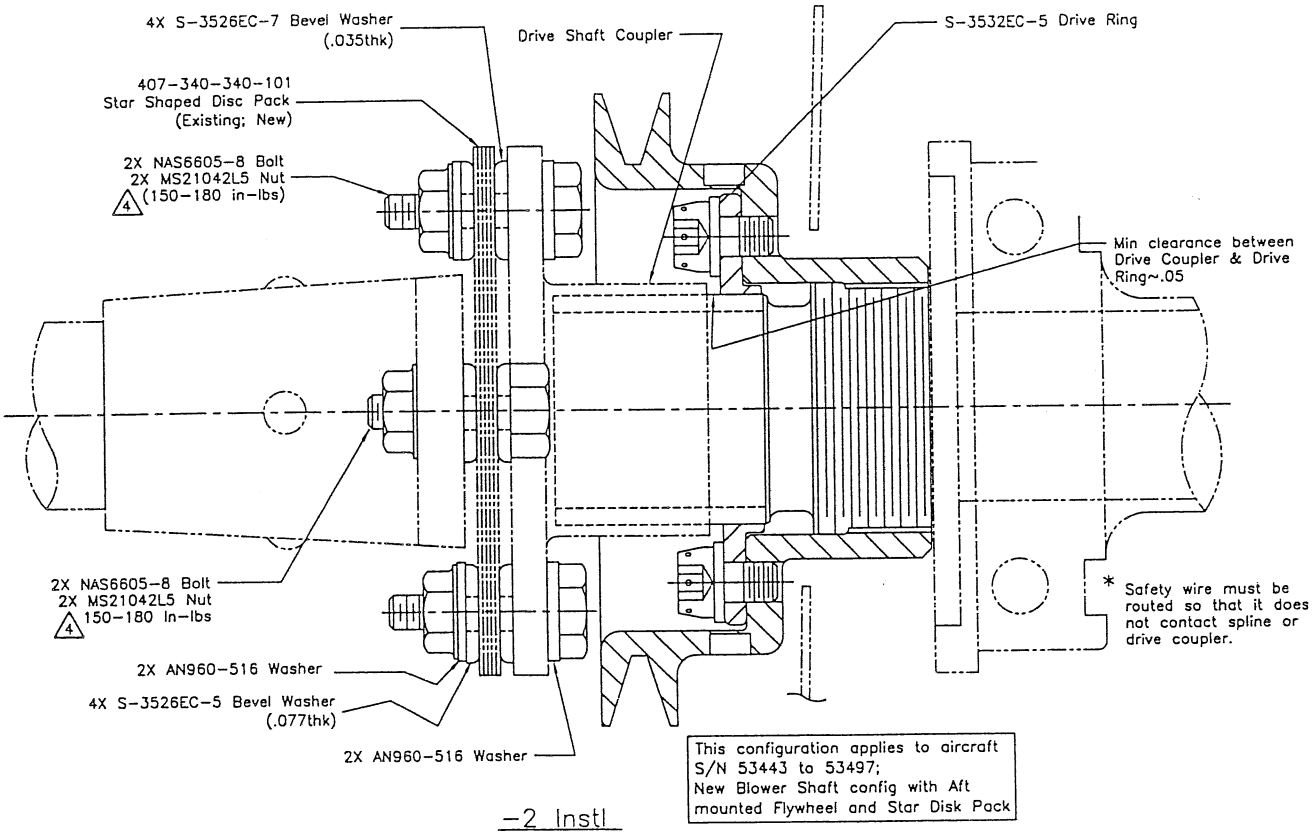
Field inspections have indicated that some wear maybe occurring between the inside shoulder of the S-3526EC-4 Bevel Washer and the base of the NAS6605 Bolt head on Bell 407 Helicopters equipped with an Air Comm air conditioner system.

Installation Configuration -2 (Installation of S-3526EC-7 Bevel Washers)

Configuration	Part Number	Description	Quantity
<b>-2</b>	S-3526EC-7	Bevel Washer	4
	NAS6605-8	Bolt	2
	MS21042L5	Nut	4
*	*	*	*
<b>-3</b>	S-3526EC-7	Bevel Washer	4
	NAS6605-10	Bolt	2
	MS21042L5	Nut	4

4. Torque all fasteners in accordance with the specific Applied torques shown on the face of the illustrations for the appropriate configuration ( -2, or -3).

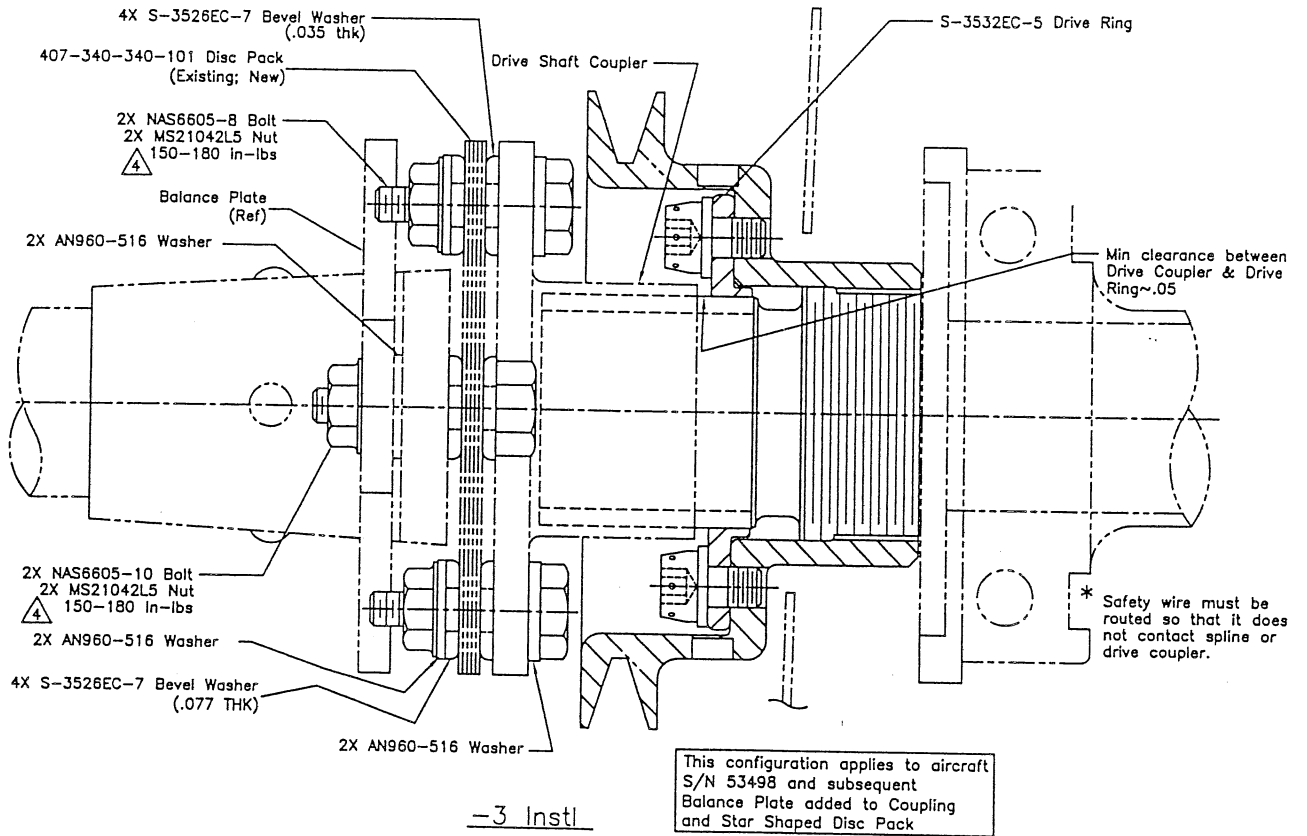
Installation Configuration -3 (Installation of S-3526EC-7 Bevel Washers)
