INFORMATION LETTER 407-07-93

TO: All Owners/Operators of Bell 407 Helicopters.

SUBJECT: SHEAR BEARING P/N 407-310-101-ALL

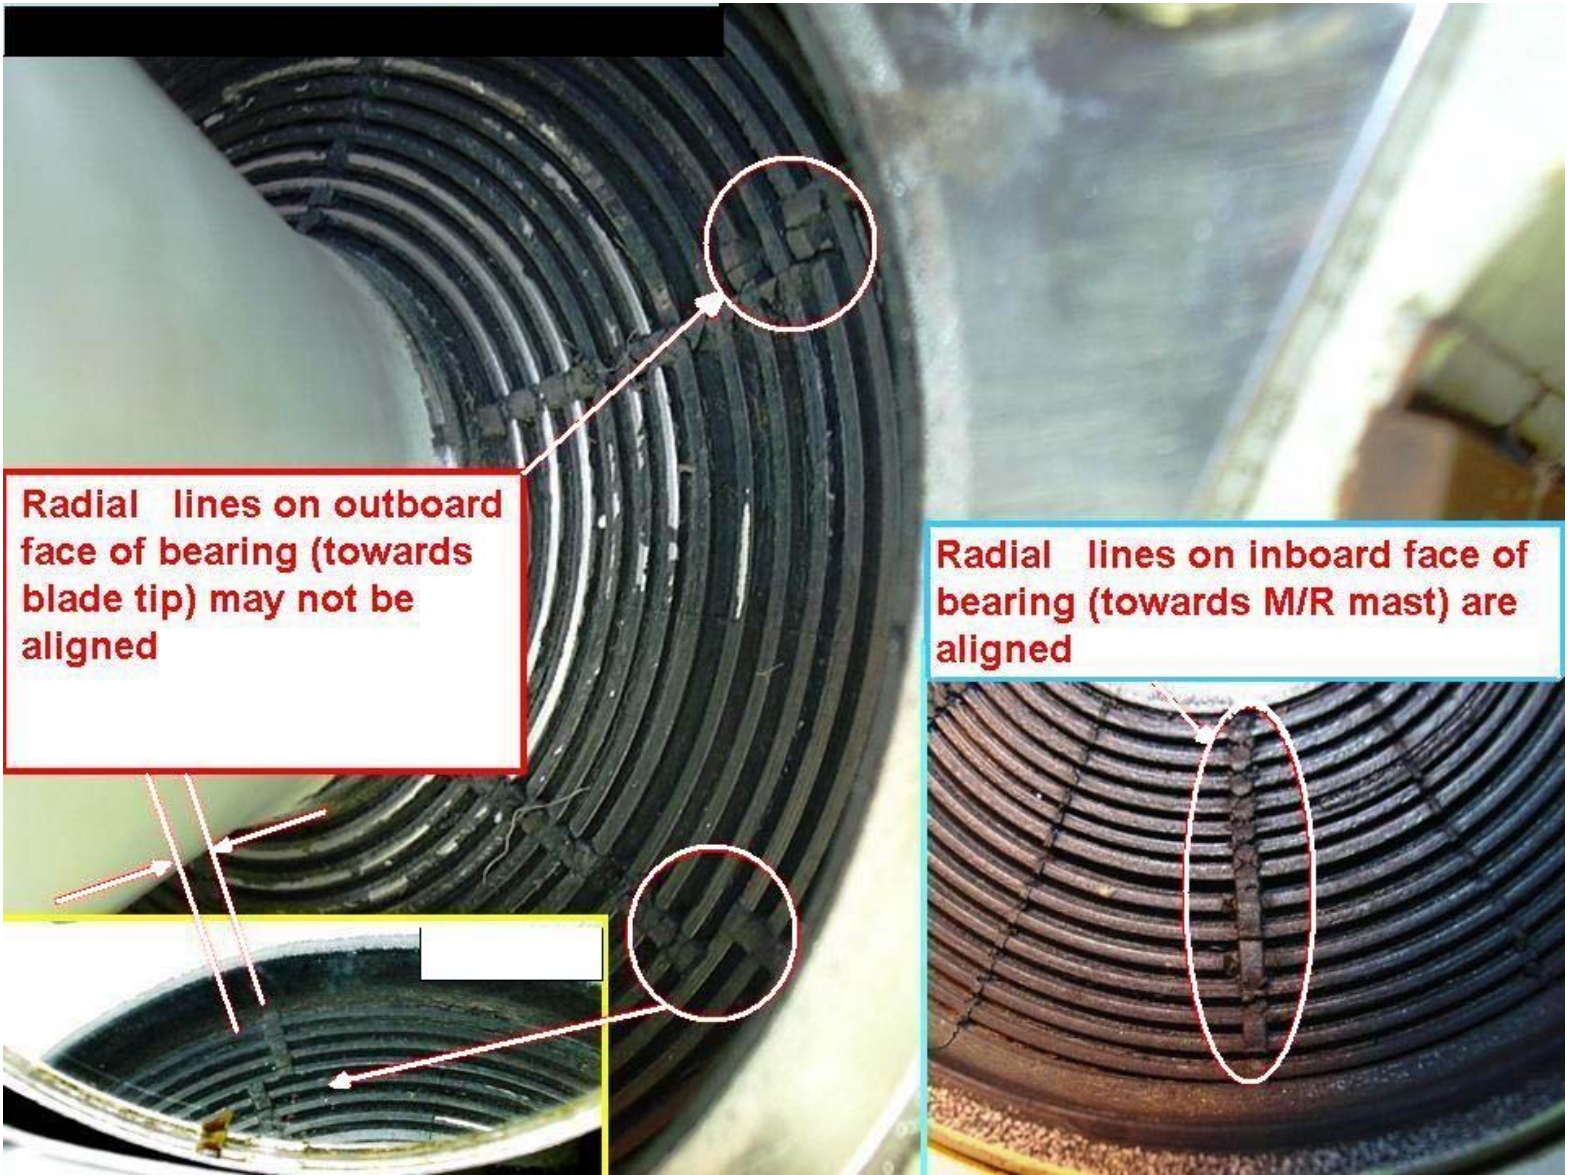
Figure 1

Some operators report misalignment of the radial injection lines on shear bearings outboard surface while the same injection lines on bearing inboard surface are aligned.

This information letter is issued to inform owners and operators that misalignment of the radial injection lines on the shear bearing outboard surface alone is not a cause for rejection.

The outboard side of the shear bearing is manufactured with multiple sets of mold inserts which do not need to be aligned. On the contrary, the opposite side of the bearing (inboard side) uses one set of inserts and the "lines" should be aligned. Refer to figure 1 for additional details.

Shear bearings with misaligned radial injection lines on outboard surface may remain in service provided they meet the criteria listed in applicable maintenance and overhaul manuals.
