**OPERATIONS SAFETY NOTICE**

OSN 205A-1-00-36
OSN 212-00-37
OSN 412-00-23

SUBJECT: MAIN SERVO ACTUATOR 212-076-005-ALL, LOWER ROD-END BEARING

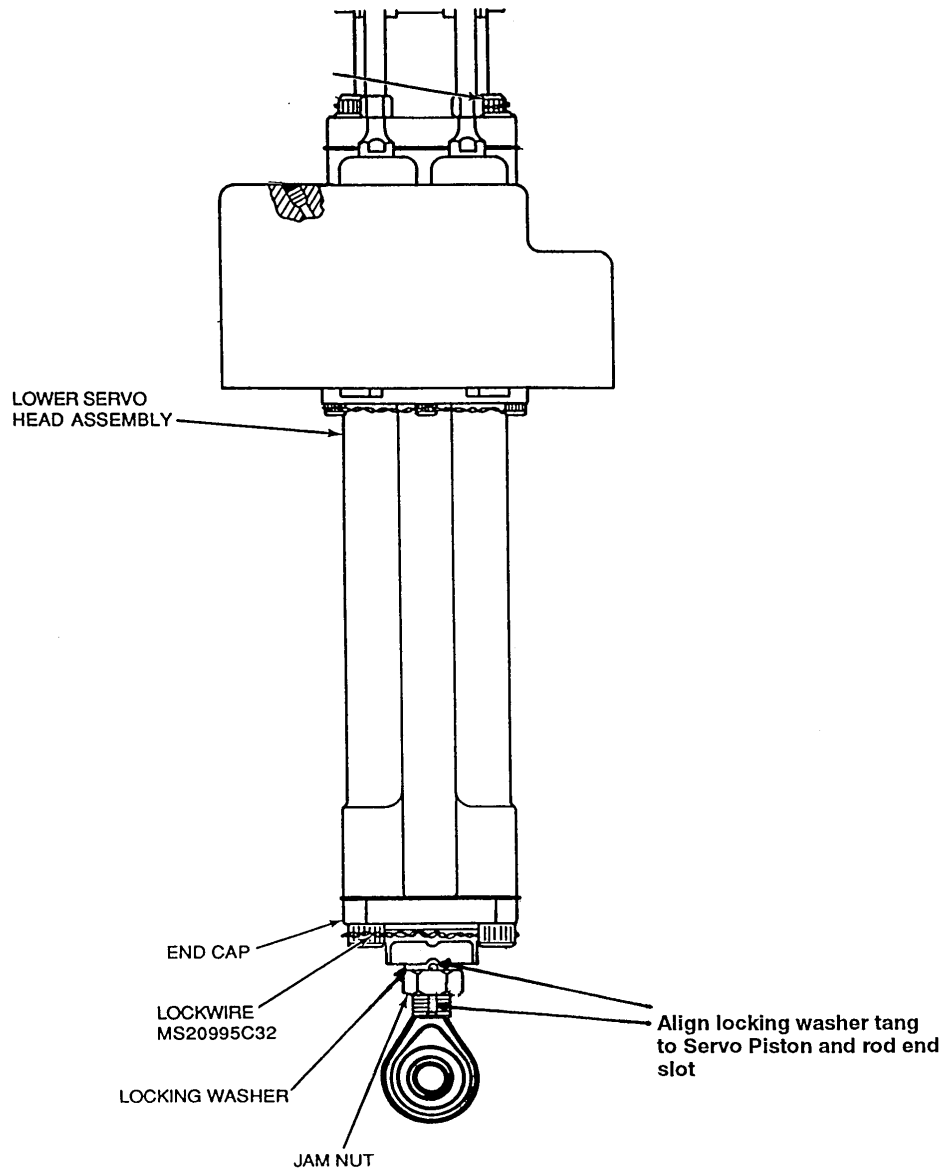
FIGURE 1

Bell Helicopter Textron has learned of an incident in which a model 212 experienced collective control restriction while attempting to lift off from a platform. Preliminary investigation revealed that the lower rod end bearing jam nut on the collective servo was found loose. It appears that the locking washer may have been damaged while securing the jam nut, causing a false torque indication. The servo actuator piston was then able to rotate, allowing the rod end to migrate out of the piston.

**Main Servo Actuator
212-076-005-ALL**

The minimum torque for the jam nut is 200 in/lbs. The locking washer should be properly seated into the servo piston slot and aligned to the rod end slot prior to tightening the jam nut. The jam nut should be tightened while holding the rod end. If the locking washer rotates while applying torque to the jam nut, the jam nut should be loosened and the locking washer replaced. Replacement locking washers (NAS513-6) should have a green dye finish on them to indicate that the part has been magnetic particle inspected at manufacture.
