**OPERATIONS SAFETY NOTICE**

November 24, 2004

OSN 206L-04-45**TO: All Owners/Operators of Bell 206L Series Helicopters****SUBJECT: TAILBOOM ATTACHMENT FITTINGS P/N 206-032-409-001 and P/N 206-031-403-005, PERIODIC INSPECTION OF**

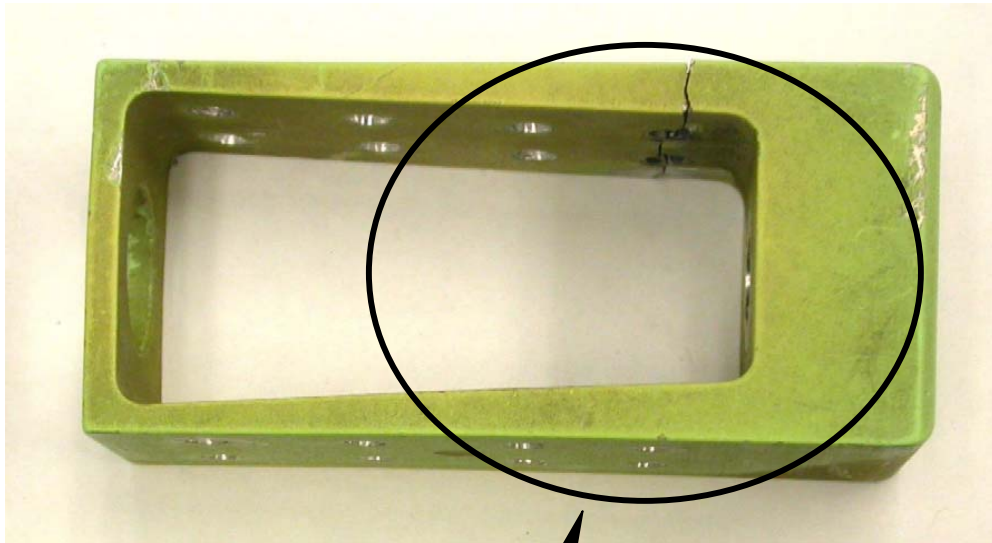
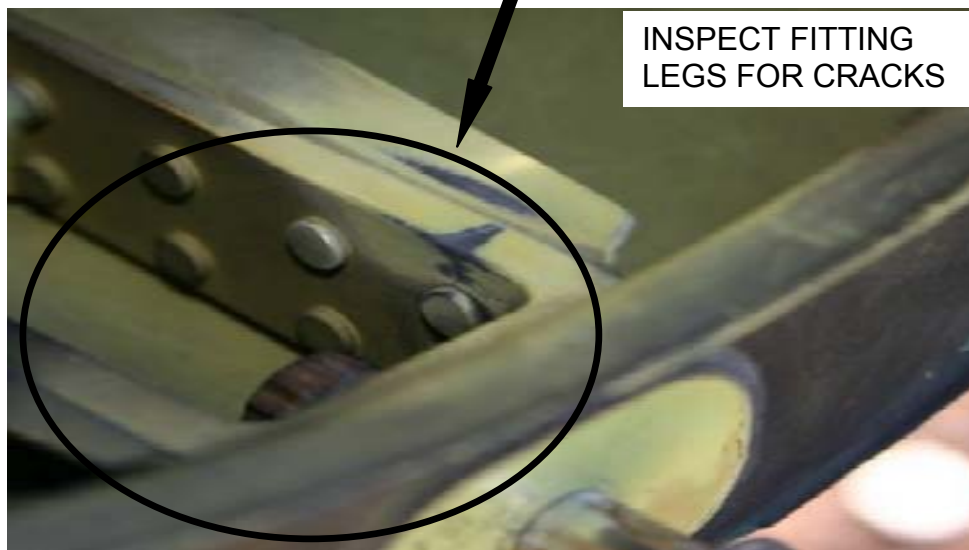
Bell Helicopter has received two reports of 206L-4 tailboom attachment fittings found cracked. In both cases the cracks were found during the scheduled 100-hour inspection (Maintenance Manual, Chapter 5). Preliminary evaluation indicates that cracks originated from a rivet hole.

Particular attention is assigned to the first rivet line adjacent to the tailboom/airframe attachment bolt for the upper L/H airframe side-fitting 206-031-329-101/-103, the upper L/H tailboom side-fitting 206-032-409-001 and lower L/H tailboom side-fitting 206-031-403-005.

The attached pictures give examples of recently found cracks, which could occur on either leg of the fitting. If a crack is found, the fitting shall be replaced prior to next flight and Bell Helicopter Textron Product Support Engineering should be notified at the contacts below.
