**OPERATIONS SAFETY NOTICE**

**OSN 212-01-38  
OSN 412-01-24  
OSN 412CF-01-04**

**TO: All Owners/Operators of Bell 212/412/412CF Helicopters**  
**SUBJECT: ENGINE INTAKE FAIRING P/N 212-061-207-023 / -025, Inspection Of**

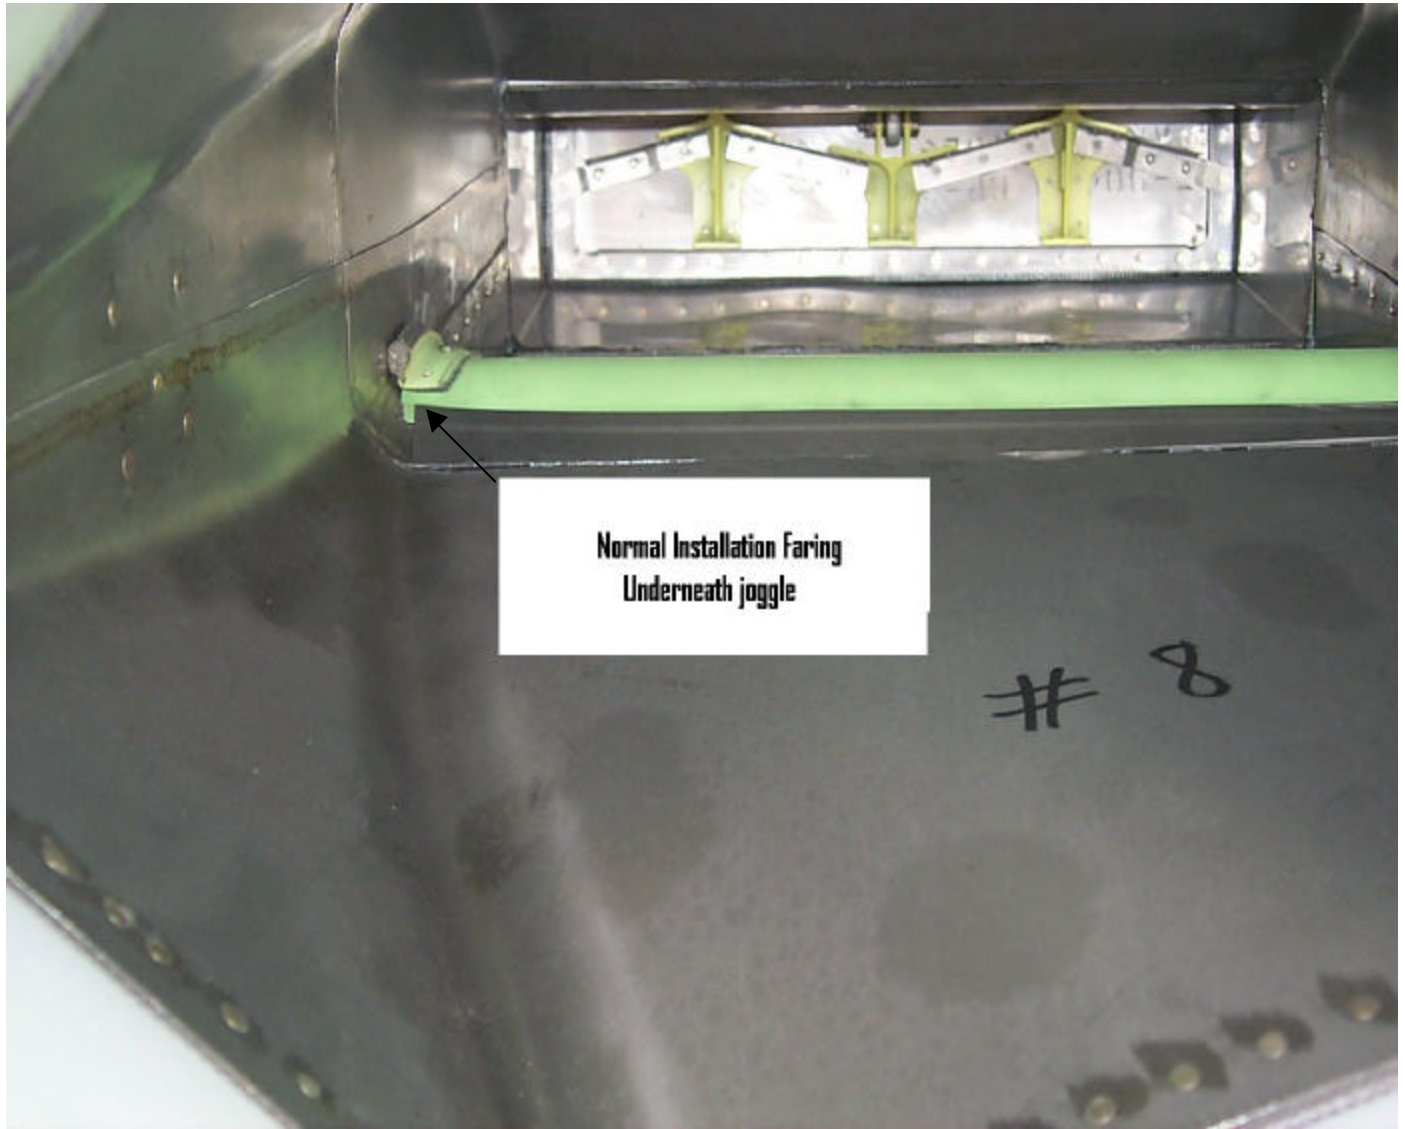
**Figure 1**

Normal installation fairing underneath joggle

The P/N 212-061-207-023 / -025 fairing should be inspected to ensure the ramp (yellow portion) is positioned underneath the joggle at the forward end.

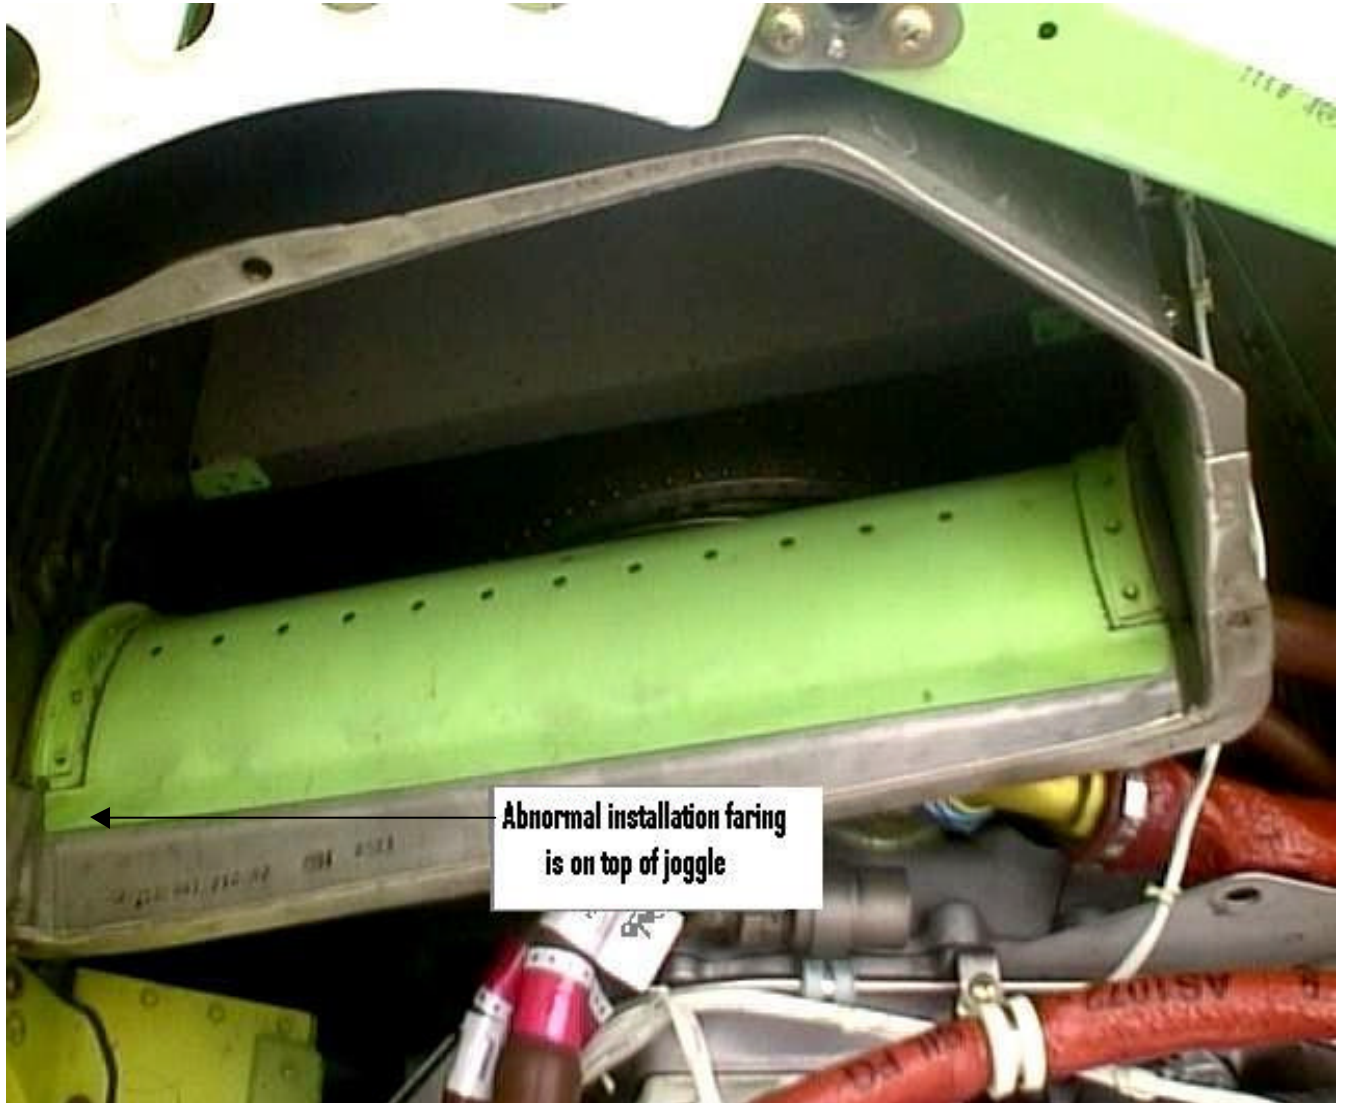
**Figure 2**

Bell Helicopter Textron has received reports of the P/N 212-061-207-023 / -025 fairing assembly not being installed properly.

Abnormal installation fairing on top of joggle

Replace detail parts as required if any cracks or deformations are observed on the ramp portion.
