TECHNICAL BULLETIN
Bell Helicopter **TEXTRON**

No. 205-04-116

MODEL AFFECTED: 205

SUBJECT: CHIP DETECTOR INDICATOR, REPLACEMENT FOR SPARES

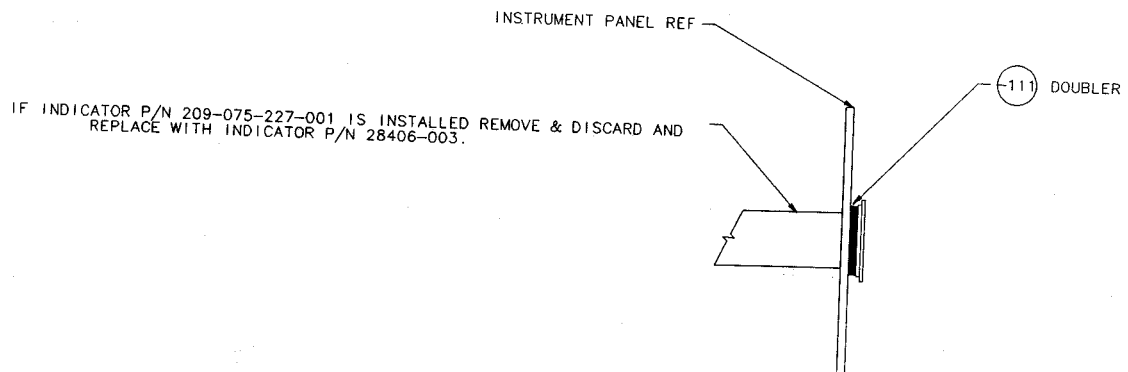
Fig 3

Indicator Installation

1. Disconnect battery.
2. Gain access to the back of chip detector indicator located on the instrument panel.
3. Disconnect wires from chip detector indicator.
4. Using fig 2, delete wires as mentioned.
5. Remove and discard chip detector indicator from instrument panel.
6. Install new chip detector indicator in conjunction with doubler –111 as shown in fig 3.
7. Using fig 1, 4 and BHT-ELEC-SPM section 4-4 relocate and connect wires on previously installed indicator.
