TECHNICAL BULLETIN

No. 212-00-182

MODEL AFFECTED: 212

SUBJECT: CYCLIC AND COLLECTIVE JACKSHAFTS,
INSPECTION AND MODIFICATION OF.

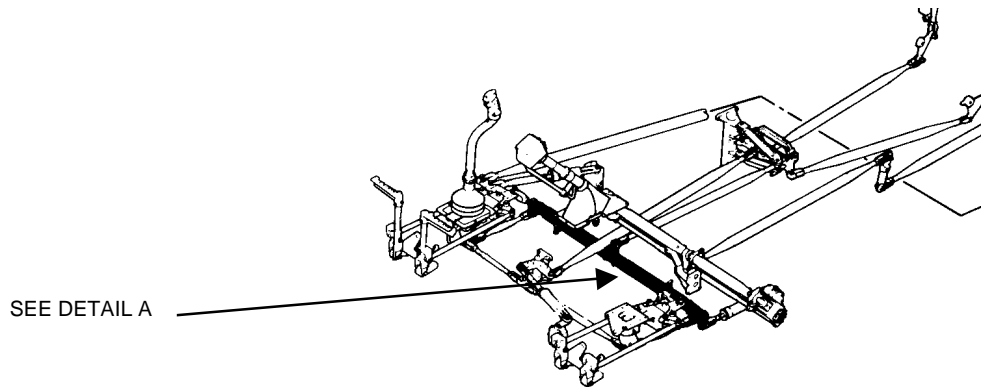
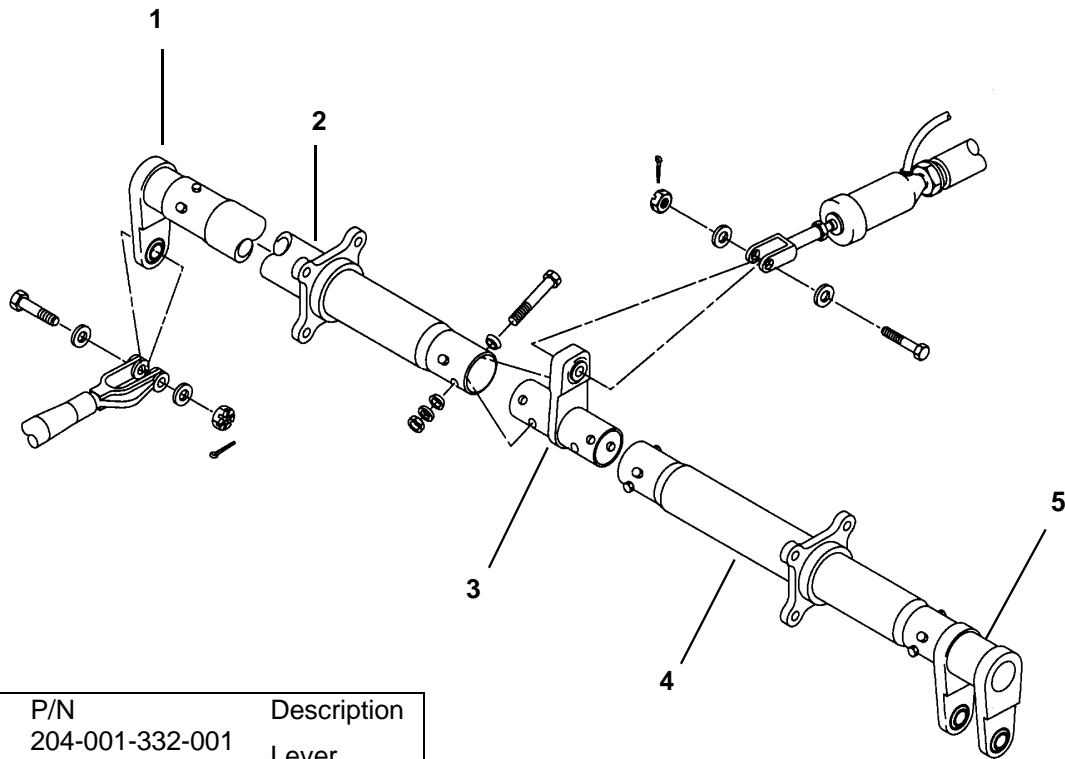
FIGURE 1
Cyclic Jackshaft

4. Separate levers (1) & (5) from tubes (2) & (4). Tag and identify hardware for reinstallation.

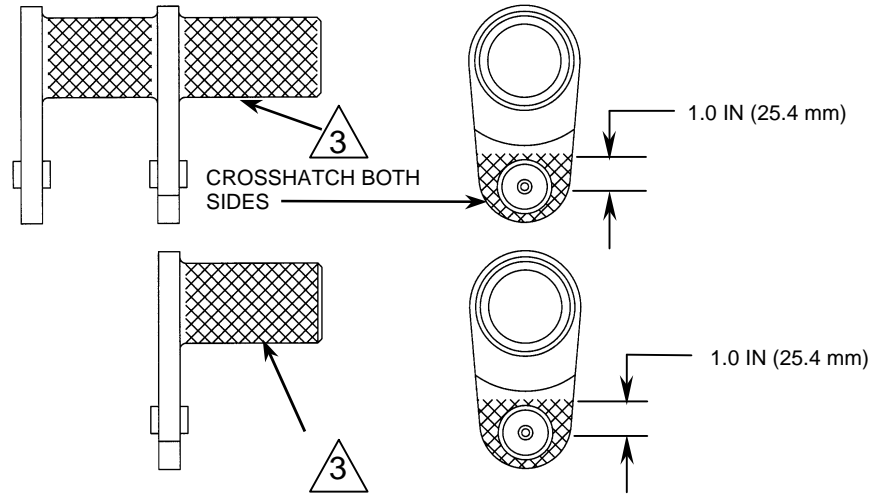
FIGURE 2

ARM ASSEMBLY
204-001-356 AND 204-001-332
DAMAGE LIMITS

1. **Bearing bore damage not to exceed 0.001 inch (0.025 mm) for ¼ circumference. Limit one repair per bore.**
2. **Tapered hole damage shall not exceed 0.002 inch (0.0508 mm) for ¼ circumference. Limit one repair per bore.**
3. **Tapered holes (ref) these surfaces (4 places).**

5. Inspect levers P/N 204-001-332-001/-005 (1) and 204-001-356-001 (5) as per figure 2. Repair or replace parts that are found damaged or corroded beyond limits. Refer to C R & O Manual.

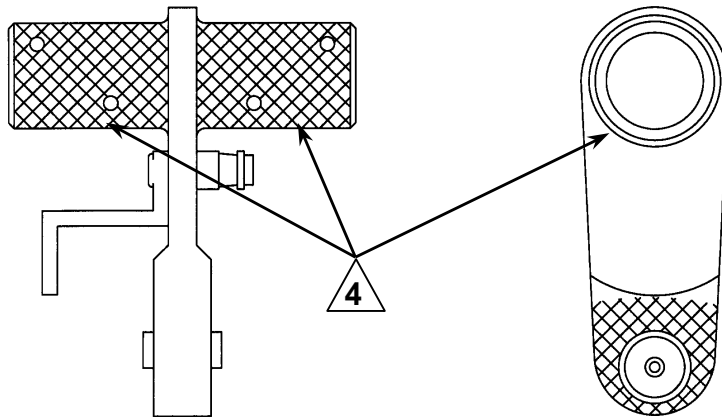
FIGURE 5

LEVER AND SUPPORT ASSEMBLY
212-001-248

1. No cracks allowed.
2. Bearing bore damage not to exceed 0.001 inch (0.0254 mm) for ¼ circumference.
3. Tapered hole

damage shall not exceed 0.002 inch (0.0508 mm) for ¼ circumference. Limit one repair per hole.

Tapered holes (ref) these surfaces (8 places).

12. Inspect collective jackshaft levers P/N 212-001-105-001 (1) & 212-001-124-001 (5) as per Component Repair and Overhaul, chapter 67. Repair or replace parts that are found damaged or corroded beyond limits.
13. **(S/N 30502 through 31311, 32101 through 32152 & 35001 through 35048)** Inspect collective jackshaft lever P/N 204-001-185-005 (3) as per Component Repair and Overhaul, chapter 67. Repair or replace parts that are found damaged or corroded beyond limits.
14. **(S/N 35049 through 35103)** Inspect collective jackshaft lever P/N 212-001-248-001 (3) as per figure 5. Repair or replace parts that are found damaged or corroded beyond limits.
