TECHNICAL BULLETIN
Bell Helicopter **TEXTRON**

No. 212-02-188

MODEL AFFECTED: 212

SUBJECT: TRANSMISSION OIL COOLER LINES P/N 412-040-243-101 & 412-040-244-101, INTRODUCTION OF

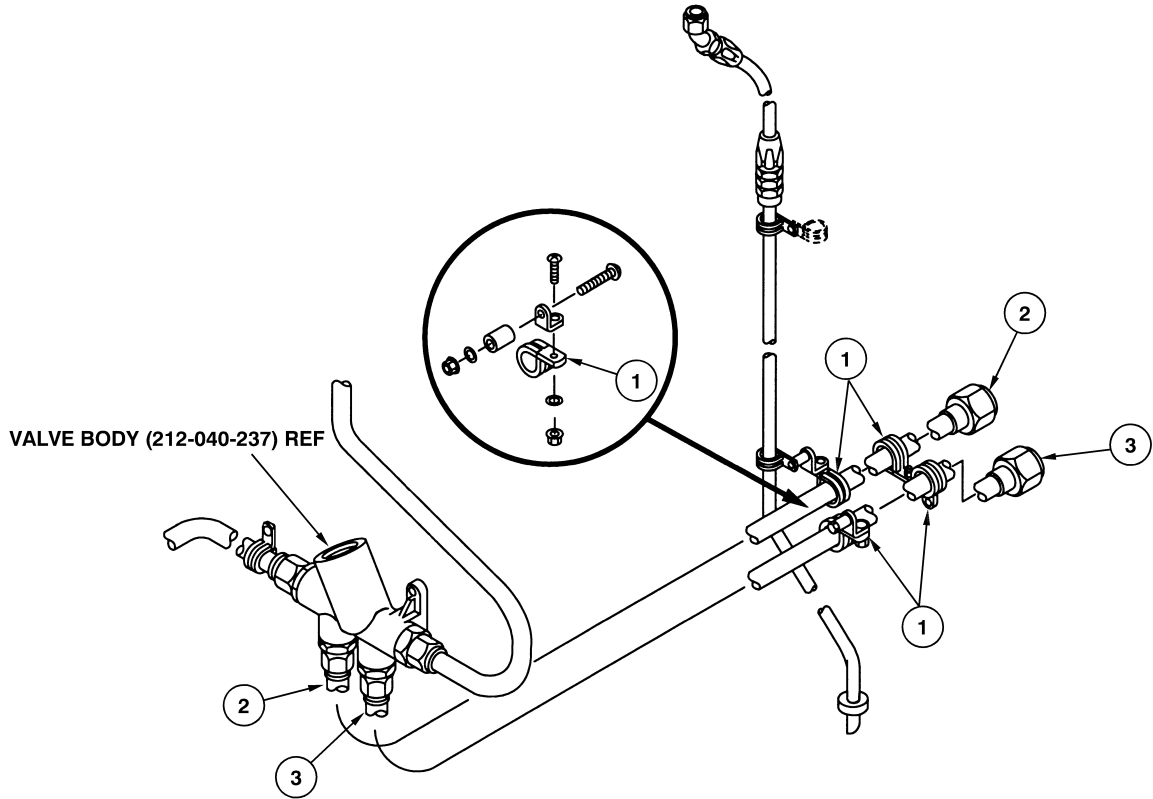
Figure 1. Transmission Oil Cooler Lines

Bell Helicopters is introducing CRES oil cooler lines to reduce corrosion and fatigue related damage. Concurrently, the retention clamps are to be replaced.

1. Drain oil from cooling system.
2. Remove clamps P/N MS21919WDG (Figure 1, Items 1). Retain attaching hardware for reuse or replace with similar type as required.
3. Remove tubes P/N 212-040-234-001 (Item 2) and P/N 212-040-233-001 (Item 3).

4. Install the replacement CRES oil tubes P/N 412-040-244-101 (Item 2) and P/N 412-040-243-101 (Item 3) leaving the attaching tube nuts loose at this time.

5. Tighten tube nuts on the replacement tubes (Items 2 & 3). If you suspect a load has occurred, loosen the tube nuts and reapply the torque, ensuring a twisting or bending load has not been induced in the tubes.

6. Install the replacements clamps P/N MS21919WCG10 (Items 1) as indicated in Figure 1. Oil lines (Items 2 & 3) retained by the clamps (Items 1) must be installed without applying a bending load.
7. Replenish previously drained oil, accomplish ground run and leak check procedures.
8. Make entry in helicopter historical records indicating compliance with this Technical Bulletin.
