SUBJECT: REVISION "A" TO TECHNICAL BULLETIN 212-03-189:

**REPLACEMENT OF LANDING LIGHT MECHANICAL RELAY
ASSEMBLY WITH A SOLID-STATE SWITCH MOUNTED ON A
PRINTED WIRING BOARD.**

No. 212-03-189

NO. G5400-97-001

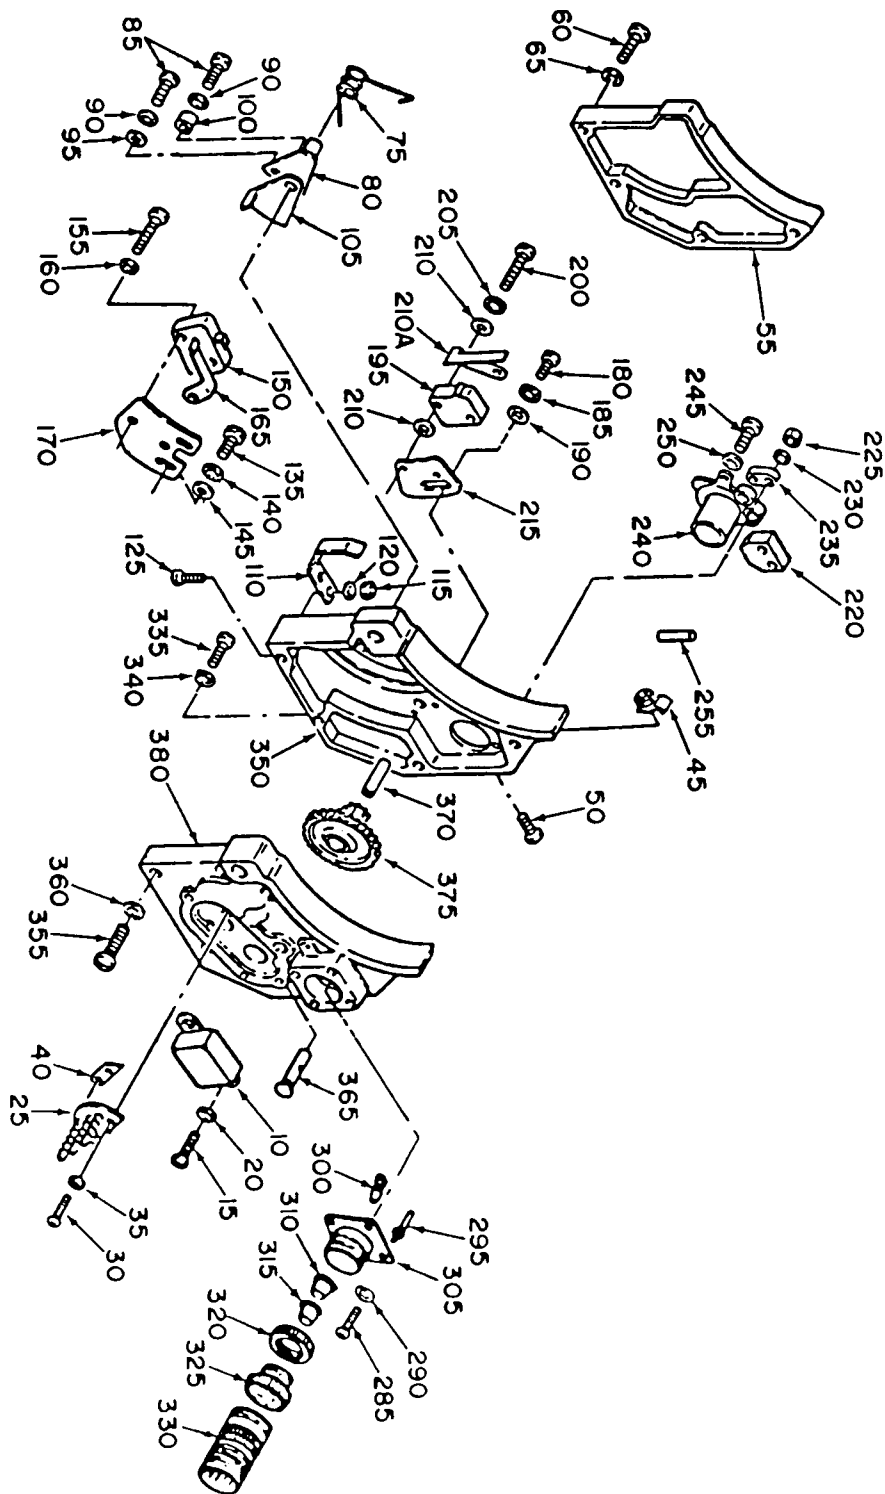
Landing Light (old configuration)
Figure 1

Bell Helicopter has become aware of the mechanical relay contact's "welding" themselves closed in the landing light assembly. This situation will cause the landing light to stay in the "on" position even when landing light switch was turned "off". The intent of this bulletin is to provide instructions to replace the mechanical relay with a new solid-state switch mounted on a printed wiring board.

1. **See Figure 1,** Remove five screws (60), lock washers (65) and side cover (55) from the drive housing assembly (350). Keep the side cover and attaching parts.
2. Remove the mechanical relay assembly (240) as follows:
 - (a) Remove two screws (245) and lock washers (250) to loosen relay (240). Discard screws (245) and lock washers (250).
 - (b) Cut relay control wire close to relay (240) and discard relay.
3. Remove two nuts (225), lock washers (230) and contact block assembly (220) from the drive housing assembly (350). Discard the contact block assembly (220) and the attaching parts.
4. Leave the two threaded studs (295) in place.
5. Strip approximately 0.25 inch (6,35 mm) from the end of the relay control wire.
6. Use a soldering iron to tin the end of the relay control wire.

9. **See Figure 1**, Position the side cover (55) on the drive housing assembly (350) and secure with original five lock washers (65) and screws (60).
10. Test the landing light in accordance with referenced CMM or applicable aircraft operating procedures.
