**TECHNICAL BULLETIN**  
**Bell Helicopter** **TEXTRON**

No. 212-04-199

**MODEL AFFECTED:** 212

**SUBJECT:** NEW CHIP DETECTOR INTERFACE PROBLEM  
WITH THE MASTER CAUTION PANEL

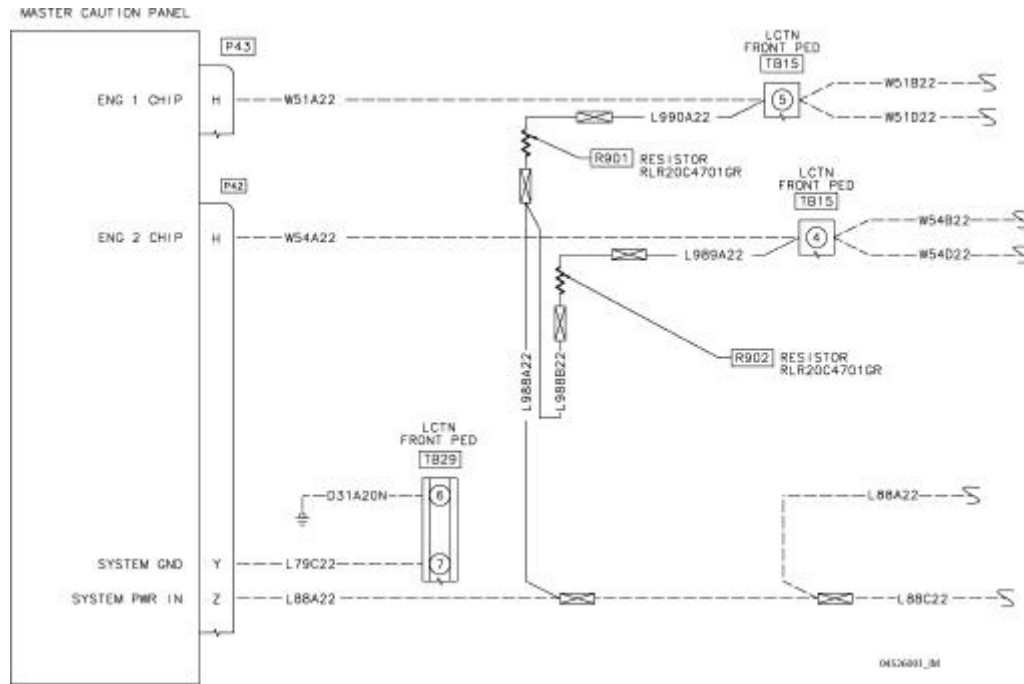
Figure 1

Operators have reported improper operation of the master caution panel after installing new engine chip detectors in accordance with Pratt & Whitney service bulletins 5411 and 5354. With the new chip detectors installed and the caution panel dimmed, the pilot and copilot Master Caution light may illuminate, although the ENG CHIP caution light does not illuminate.

This bulletin eliminates the problem by introducing 2 pull up resistors that ensure proper chip detector input to the Master Caution panel.

Refer to figure 1 and figure 2.
