TECHNICAL BULLETIN
Bell Helicopter **TEXTRON**

No. 214-02-93

MODEL AFFECTED: 214B/214B-1

SUBJECT: **MAIN ROTOR HUB ASSEMBLY SPINDLE ASSEMBLY, P/N 214-010-103, REVISION OF INSPECTION AND OVERHAUL REQUIREMENTS.**

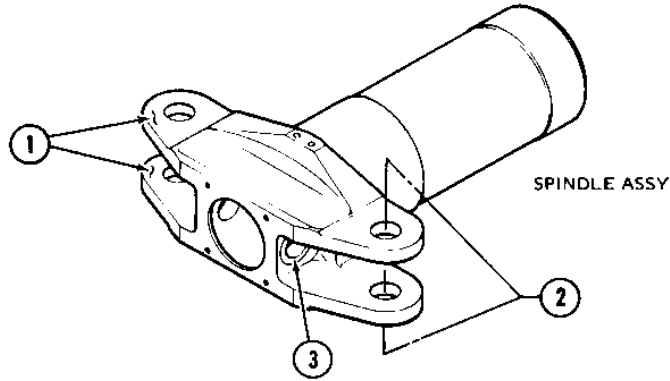
Figure 65-7. Main rotor hub conditional inspection (Sheet 4 of 6)

NO.	ITEM	REUSE SPINDLE	SCRAP SPINDLE-STRAPS-PINS	SCRAP HUB ASSY
	NOMENCLATURE			
1	Spindle lug faces, eight places	No visible deformation on lug face when checked with a straight edge	Any visible deformation on both sides of a lug when checked with a straight edge	
2	Spindle to yoke attachment bushings	Unworn 214-040-129 pin shall fit through the spindle tangs without interference. Hole round within 0.0005 inch.	Any significant bind or looseness. Out-of-round exceeds 0.0005 inch.	
3	Strap Pin Hole	Hole round within 0.0005 inch.	Out-of-round exceeds 0.0005 inch.	Out-of-round exceeds 0.0015 inch with larger dimension in a spanwise direction.

2. Figure 65-7 (sheet 4)

Revise as noted on page 5 of this bulletin.
