TECHNICAL BULLETIN

NO. 214-78-18

Bell Helicopter **TEXTRON**

SUBJECT: REINFORCEMENT/REPAIR OF TAIL BOOM
P/N 214-030-003-7

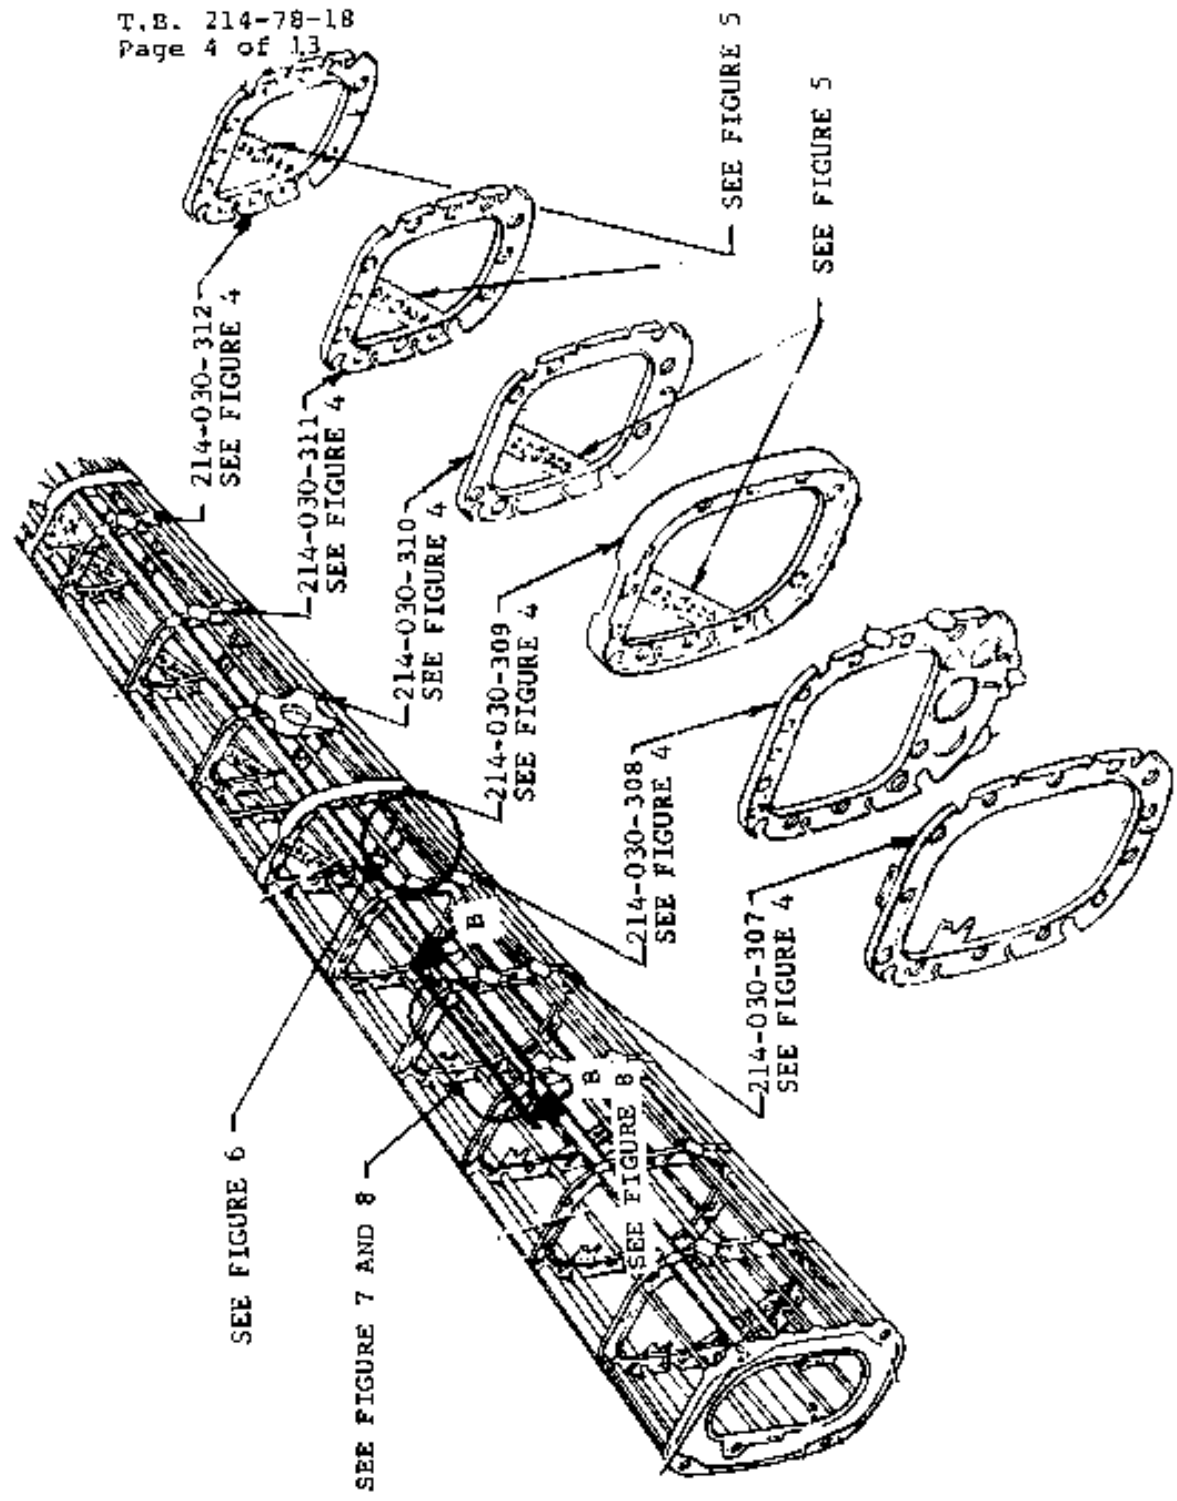
TAIL BOOM REINFORCEMENT
FIGURE 1

214B heavy lift operators report certain bulkheads in the tail boom are cracking. The addition of doublers and brackets will provide a repair for the bulkheads that have cracked

1. Refer to figure 1. Gain access to the interior of the tail boom by removing all the lower access panels.
2. Inspect each bulkhead in the area of the longerons and "J" stringer for cracks. If crack or cracks are found stop drill with a No. 40 drill.
