**TECHNICAL BULLETIN**  
**Bell Helicopter** **TEXTRON**

No. 214ST-02-169

Date 08-30-02

**SUBJECT:** **MAIN ROTOR HUB ASSEMBLY SPINDLE ASSEMBLY, P/N 214-010-103, REVISION OF INSPECTION AND OVERHAUL REQUIREMENTS.**

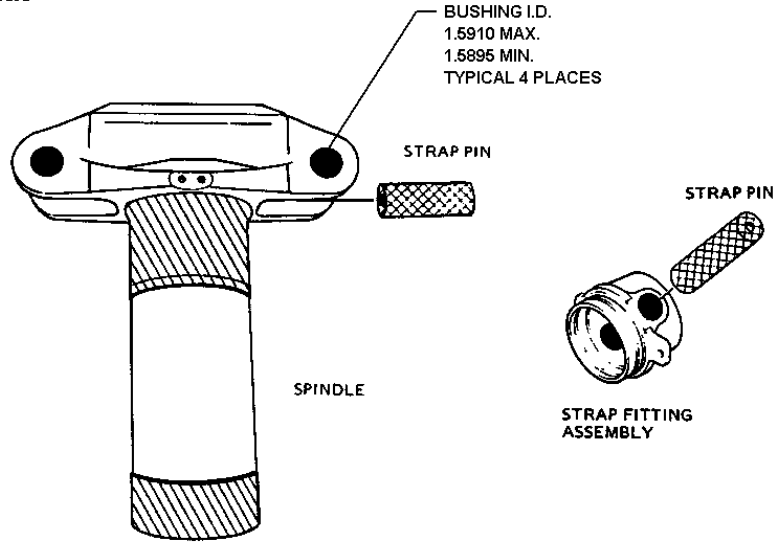
Figure 62-26. Main rotor hub mechanical and corrosion damage limits (sheet 2)

MAXIMUM DEPTHS AND REPAIR AREAS		
MECHANICAL DAMAGE	0.001 in. (0.0254 mm)	0.010 in. (0.254 mm)	0.004 in. (0.1016 mm)
CORROSION DAMAGE	0.001 in. (0.0254 mm)	0.010 in. (0.254 mm)	0.004 in. (0.1016 mm)
MAXIMUM AREA PER FULL DEPTH REPAIR	0.50 in. sq. (322.58 mm sq.)	Not Critical	0.50 in. sq. (322.58 mm sq.)
NUMBER OF REPAIRS	Two	Not Critical	Two Per Shaded Area
EDGE CHAMFER	0.010 in. (0.254 mm)	0.040 in. (1.016 mm)	0.010 in. (0.254 mm)
MOUNT BOLT BORE ● DAMAGE:	0.001 in. (0.0254 mm) for 1/4 circumference, size limits apply.		
CRACKS:	No cracks allowed.

Revise as noted on page 8 of this bulletin.

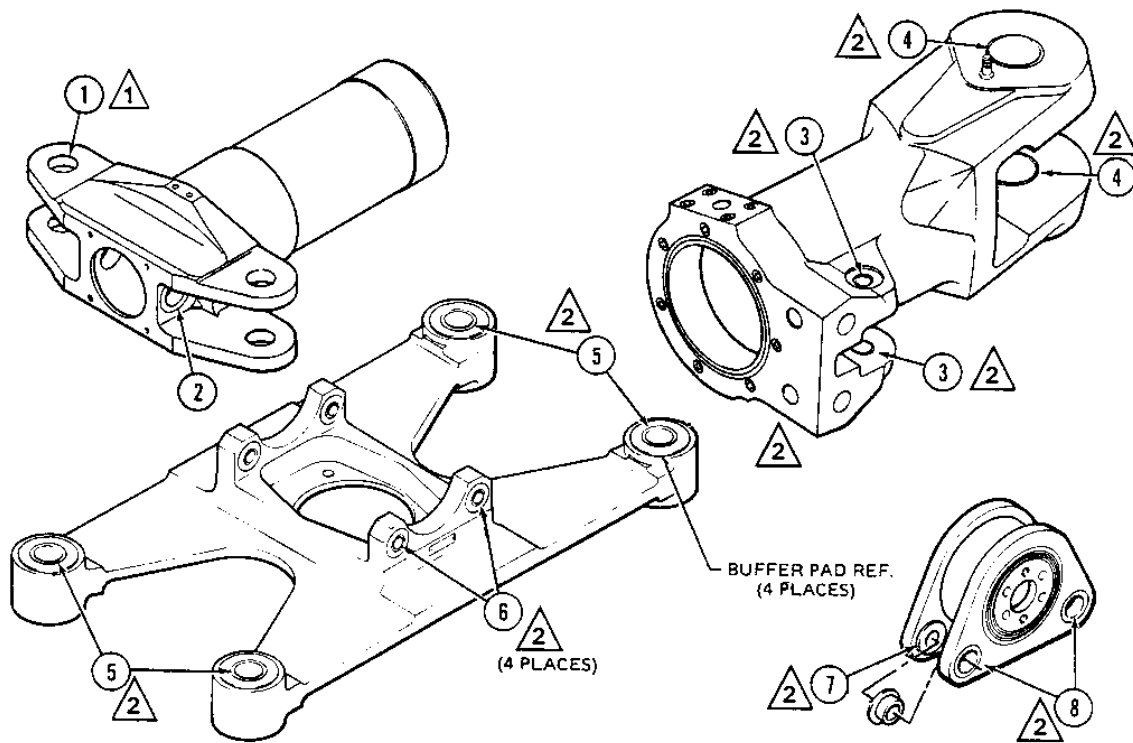
Figure 62-29. Hub components hole wear limits (Sheet 1 of 3)

HOLE NO.	NOMENCLATURE	HOLE DIAMETER	
		MIN	MAX
		INCHES	
1	Bushings, Spindle to Yoke	1.5895 (40.3733 mm)	1.5910 (40.4114 mm)
2	Hole, Strap Pin	1.625 (41.275 mm)	1.6265 (41.3131 mm)
3	Bushings, Drag Brace Installation	1.000 (25.400 mm)	1.002 (25.4508 mm)
4	Bushings, Main Blade Bolt	2.875 (73.025 mm)	2.877 (73.0758 mm)
5	Bushings, Spindle Installation	1.5895 (40.3733 mm)	1.5905 (40.3987 mm)
6	Bushing, Bearing Installation	0.7495 (19.0373 mm)	0.7505 (19.0627 mm)
7	Bushing, Bearing to Yoke	0.7495 (19.0373 mm)	0.7510 (19.0754 mm)
8	Bushing, Slip Bushing Installation	1.0000 (25.400 mm)	1.0015 (25.4381 mm)

- NOTE:
- 1 Any wear or damage to bushing exceeding these limits requires component be shipped to Bell Helicopter for repairs. 214ST-R-62-29-1
  - 2 Any wear or damage to bushing exceeding these limits requires component be shipped to authorized repair station for repairs.
