TECHNICAL BULLETIN
Bell Helicopter **TEXTRON**

No. 222-02-169

MODEL AFFECTED: 222 and 222B

SUBJECT: TRANSMISSION TOP CASE BUSHINGS P/N 222-040-326-101, REPLACEMENT OF

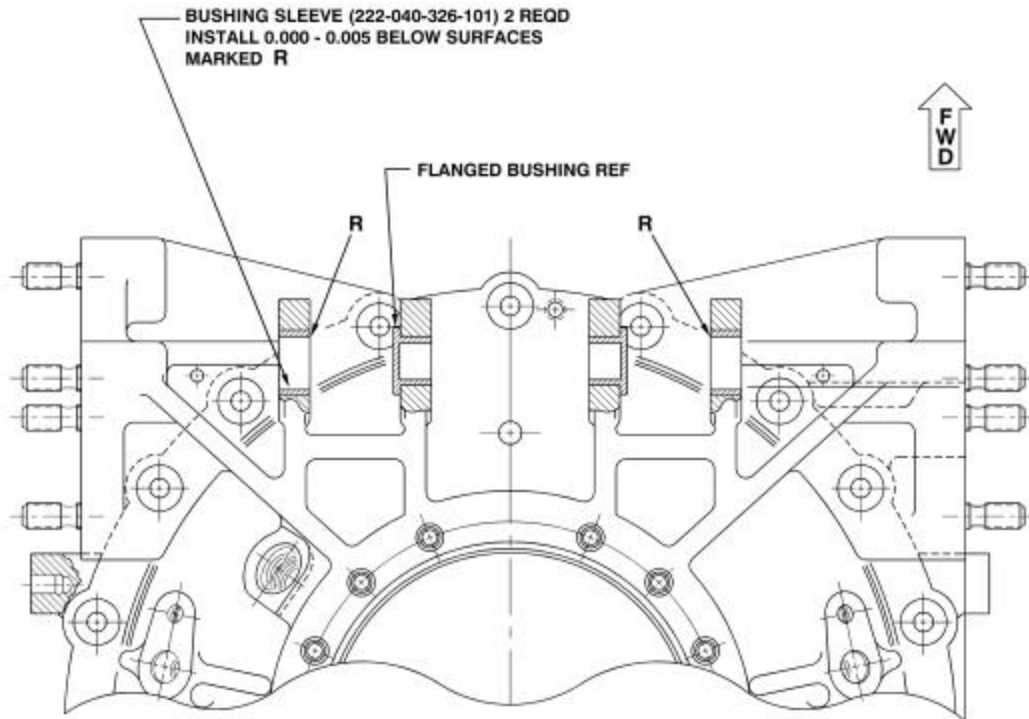
FIGURE 1
TRANSMISSION TOP CASE

Every 600 hours of operation, transmission top case bushings P/N 222-040-326-101 must be inspected for wear. These bushings are installed in the forward lug of the transmission top case P/N 222-040-061-105. When the bushings are worn beyond damage limits they must be replaced.

This procedure details the replacement of the P/N 222-040-326-101 sleeve bushings (Figure 1) installed in the top case assembly, P/N 222-040-061-101 and -105.

- a. Thermo fit new bushing P/N 222-040-326-101 into the lug per BHT-ALL-SPM using P/N T103416-103 replacement set as shown in Figure 2, Detail B.
- b. Install the bushing .000 - .005 inches below the inboard surface face of the lug as noted in Figure 1. Allow primer to dry.
