TECHNICAL BULLETIN
Bell Helicopter **TEXTRON**

No. 222U-02-94

MODEL AFFECTED: 222U

SUBJECT: TRANSMISSION TOP CASE BUSHINGS P/N 222-040-326-101, REPLACEMENT OF

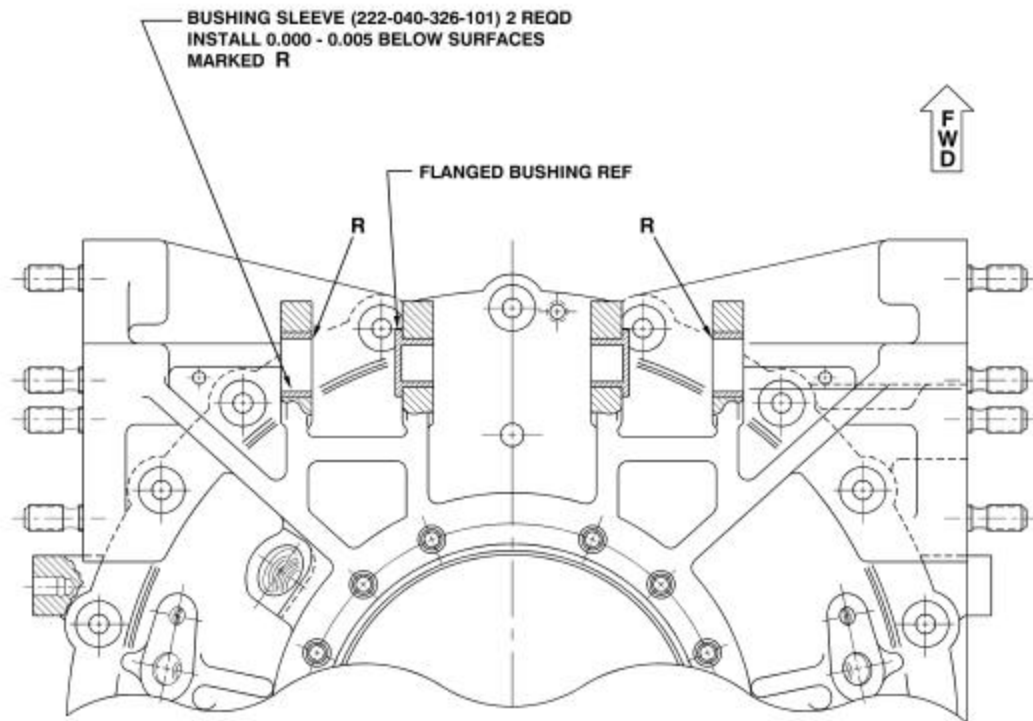
FIGURE 1
TRANSMISSION TOP CASE

Every 600 hours of operation, transmission top case bushings P/N 222-040-326-101 must be inspected for wear. These bushings are installed in the forward lug of the transmission top case P/N 222-040-061-105. When the bushings are worn beyond damage limits they must be replaced.

This procedure details the replacement of the P/N 222-040-326-101 sleeve bushings (Figure 1) installed in the top case assembly, P/N 222-040-061-105.

- a. Thermo fit new bushing P/N 222-040-326-101 into the lug per BHT-ALL-SPM using P/N T103416-103 replacement set as shown in Figure 2, Detail B.
- b. Install the bushing .000 - .005 inches below the inboard surface face of the lug as noted in Figure 1. Allow primer to dry.

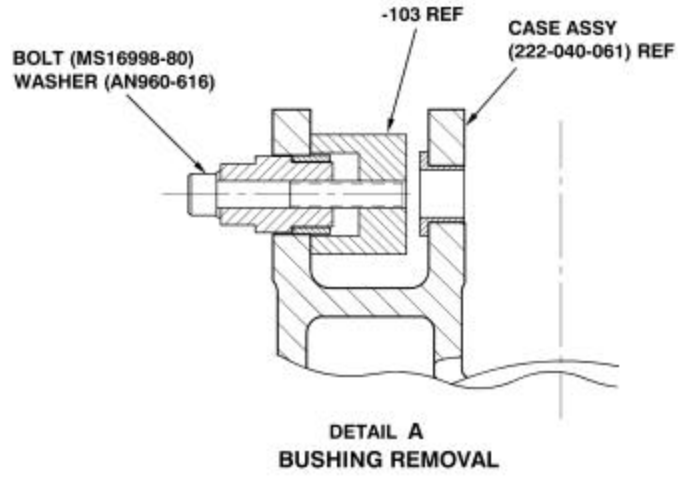
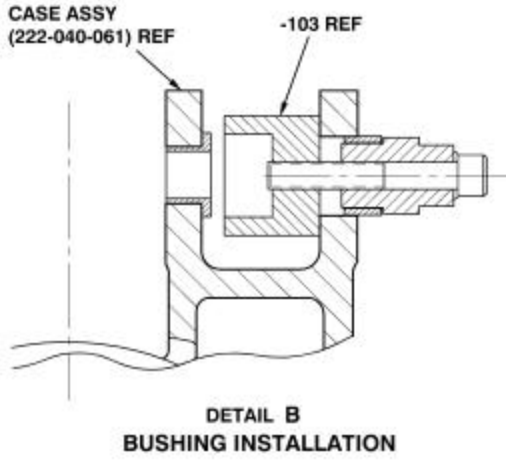
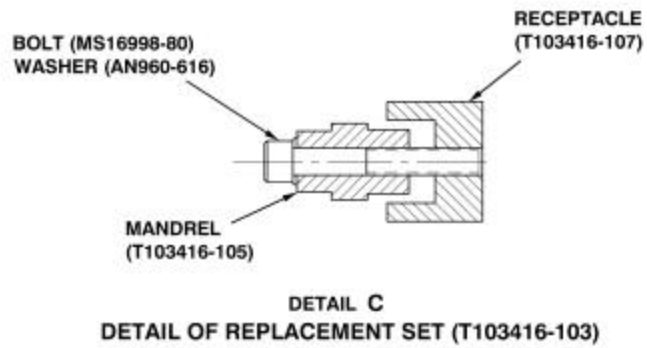
FIGURE 2
BUSHING REMOVAL / INSTALLATION

2. Remove the existing sleeve bushing using the P/N T103416-103 replacement set as shown in Figure 2, Detail A.
3. Visually inspect the lug for obvious damage. Bushing hole should measure 1.063 inches maximum. Do a Liquid penetrant Inspection of the hole per BHT-ALL-SPM.
4. Install new sleeve bushing as follows:
