TECHNICAL BULLETIN
Bell Helicopter **TEXTRON**

No. 230-02-33

MODEL AFFECTED: 230

SUBJECT: TRANSMISSION TOP CASE BUSHINGS P/N 222-040-326-101, REPLACEMENT OF

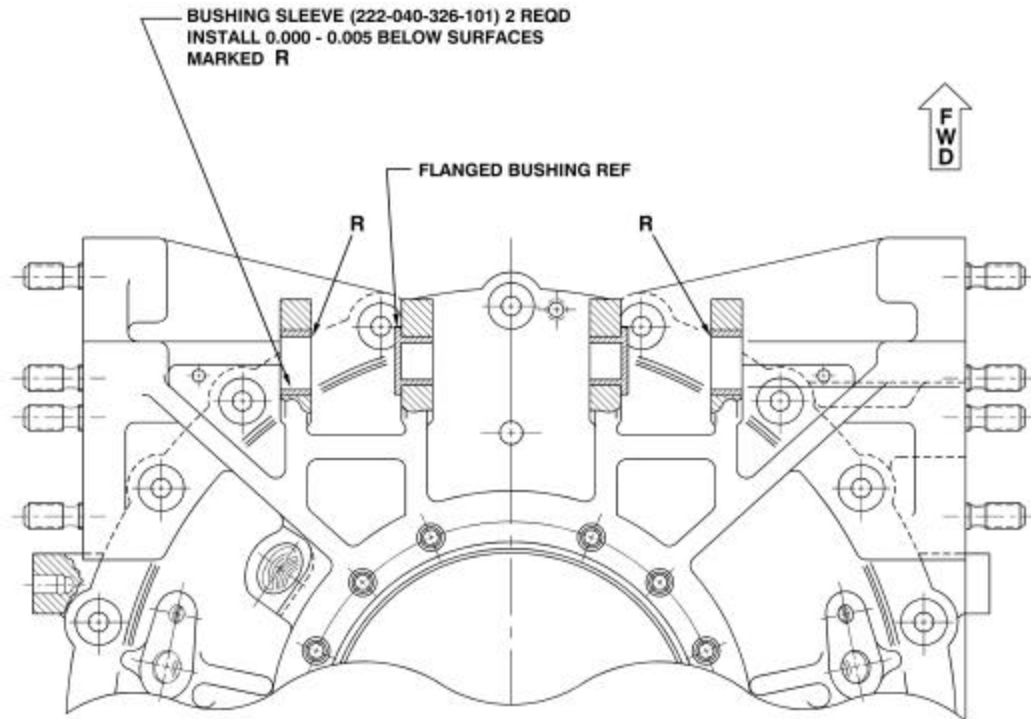
FIGURE 1
TRANSMISSION TOP CASE

Every 600 hours of operation, transmission top case bushings P/N 222-040-326-101 must be inspected for wear. These bushings are installed in the forward lug of the transmission top case P/N 222-040-061-105. When the bushings are worn beyond damage limits they must be replaced.

This procedure details the replacement of the P/N 222-040-326-101 sleeve bushings (Figure 1) installed in the top case assembly, P/N 222-040-061-105.

- a. Thermo fit new bushing P/N 222-040-326-101 into the lug per BHT-ALL-SPM using P/N T103416-103 replacement set as shown in Figure 2, Detail B.
- b. Install the bushing .000 - .005 inches below the inboard surface face of the lug as noted in Figure 1. Allow primer to dry.
