TECHNICAL BULLETIN
Bell Helicopter **TEXTRON**
A Subsidiary of Textron Inc.

NO 407-00-21

MODELS AFFECTED: 407

SUBJECT: **TAIL ROTOR GEARBOX CASE ASSEMBLY,
P/N 406-040-406-101, MODIFICATION OF.**

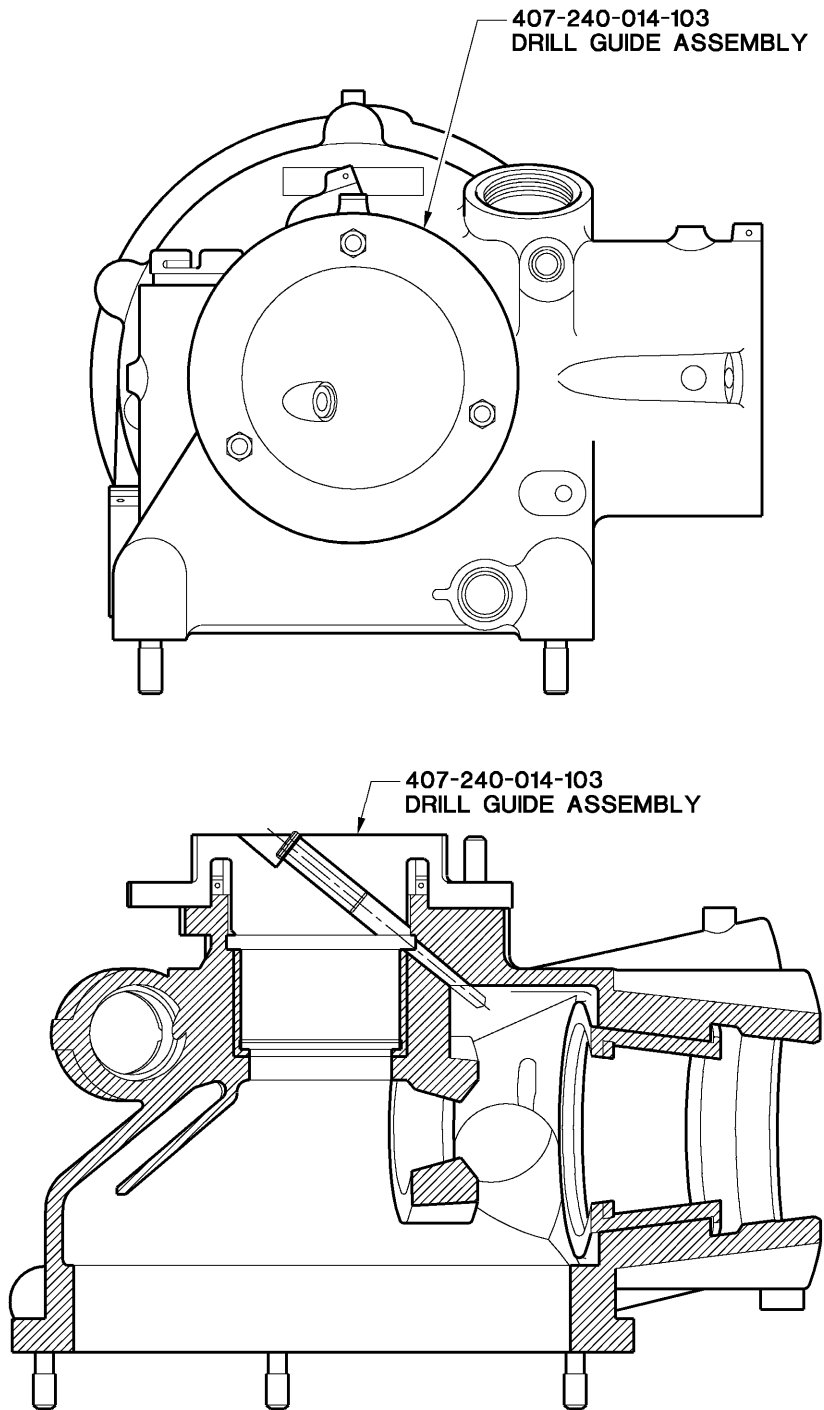
Figure 1. Drill Guide Tool 407-240-014-103

It has been determined that oil can collect in the case gallery behind the 406-040-432-103 output shaft duplex bearing of the tail rotor (T/R) gearbox during aircraft operation. Oil that collects in this gallery can go into the inner diameter of the T/R output gear shaft, then leak from the area of the T/R control crosshead. Oil can also get trapped in the bottom of the case breather threaded boss, blocking the inlet to the breather. This causes venting to be done through the output shaft, again causing oil leakage at the crosshead.

1. Drain hole for bearing gallery :
 - a. Remove the tail rotor gearbox (Refer to Maintenance Manual BHT-407-MM-7, Chapter 65).
 - b. Disassemble the tail rotor gearbox assembly (Refer to BHT-407-CR&O, Chapter 65, for instruction).
 - c. Clean the gearbox case. Make sure that paint or sealant is fully removed from the gearbox surface that connects with the drill guide.
 - d. Install the drill guide tool 407-240-014-103 on the gearbox case assembly and attach with the existing hardware (Figure 1).
 - e. Use a short fluted twist drill bit 5/32 inch or equivalent drill 0.156 inch (3.962 mm) diameter. Lubricate the drill with cutting oil to drill the hole through the case.
 - f. Remove the drill guide tool 407-240-014-103.
 - g. Use a Swiss file or equivalent to de-burr the sharp edges of the holes.

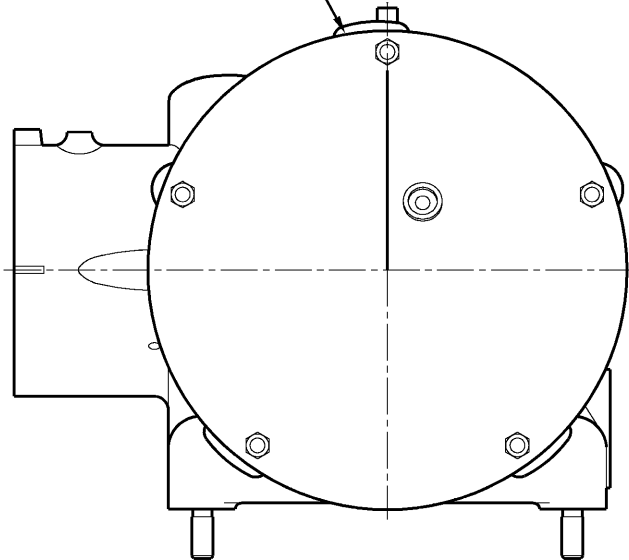
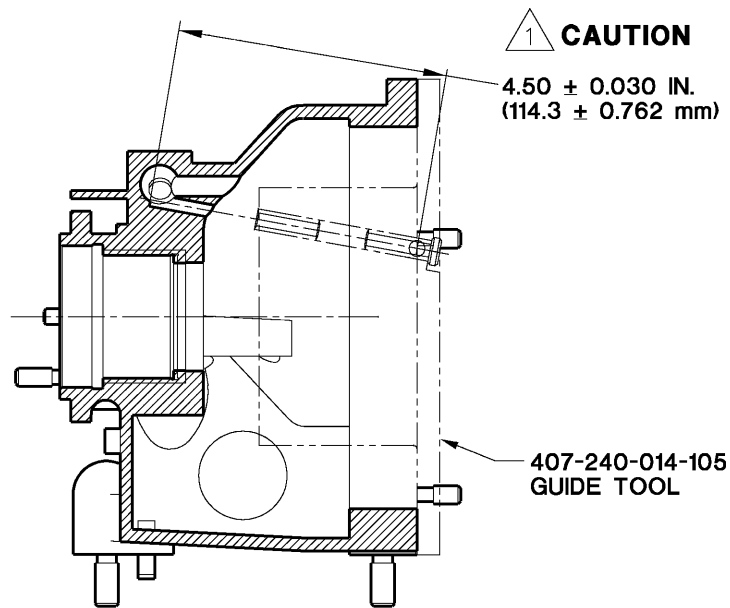
Figure 2. Drill Guide Tool 407-240-014-105

The distance between drill plate guide assembly 407-240-014-105 and bottom of vent cavity is 4.50 ± 0.030 inches (114.30 ± 0.762 mm). Ensure hole does not exceed this depth.

2. Drain hole for vent hole bore:
 - a. Make sure that the paint or sealant is fully removed from the gearbox surface that connects with the drill guide.
 - b. Install the drill guide tool 407-240-014-105 on the gearbox case assembly and attach with the existing hardware (Figure 2).

- c. Install a drill stop or equivalent at 4.50 ± 0.030 inch (114.300 ± 0.762 mm) from the point of a short fluted twist drill bit $3/16$ inch or equivalent drill 0.187 inch (4.749 mm) diameter. Lubricate drill with cutting oil and drill a hole to the bottom of the vent cavity. (Figure 2).
