**TECHNICAL BULLETIN**  
**Bell Helicopter** **TEXTRON**

No. 407-01-34

**SUBJECT:** **PYLON SIDE BEAMS 407-010-201-105 AND 407-010-203-105, INSTRUCTION FOR RETURNING TO SERVICE.**

**HELICOPTERS AFFECTED:** All Model 407 Helicopters.

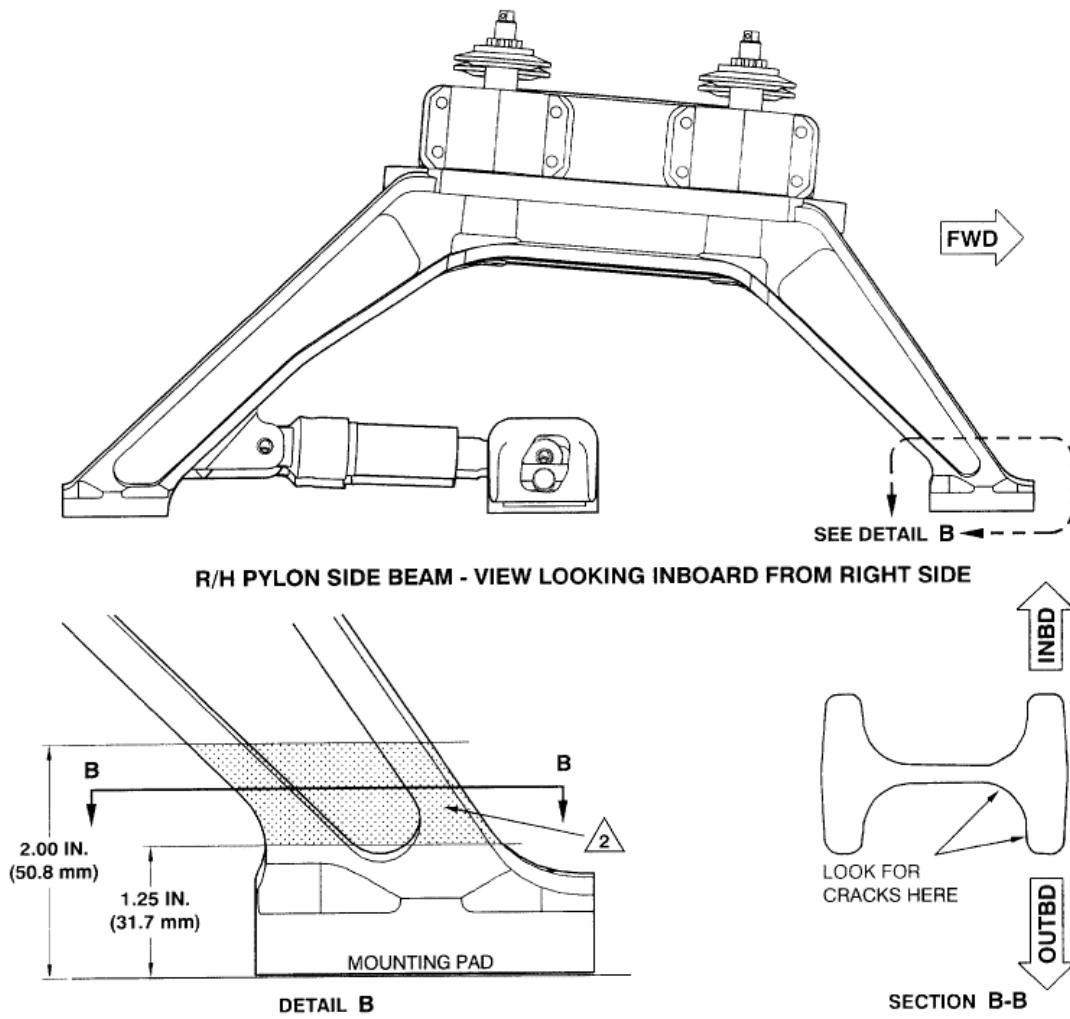
Figure 1. Pylon Side Beams (P/N 407-010-201-105/407-010-203-105) Inspection (Sheet 2)

1 2 Inspect the upper outboard flange and flange/web area for cracks. Inspect the area between 1.25 inches (31.7 mm) and 2.0 inches (50.8 mm) above the mounting pad.

- 3. If a crack is found in a pylon side beam, replace before the next flight and contact Product Support Engineering at the following numbers:
