TECHNICAL BULLETIN
Bell Helicopter **TEXTRON**

No. 407-03-48

SUBJECT: MAIN ROTOR CONE SET 407-010-114-101
SHIMMING PROCEDURE INTRODUCTION OF.

HELICOPTERS AFFECTED: Model 407 helicopters serial number 53000 through 53579.

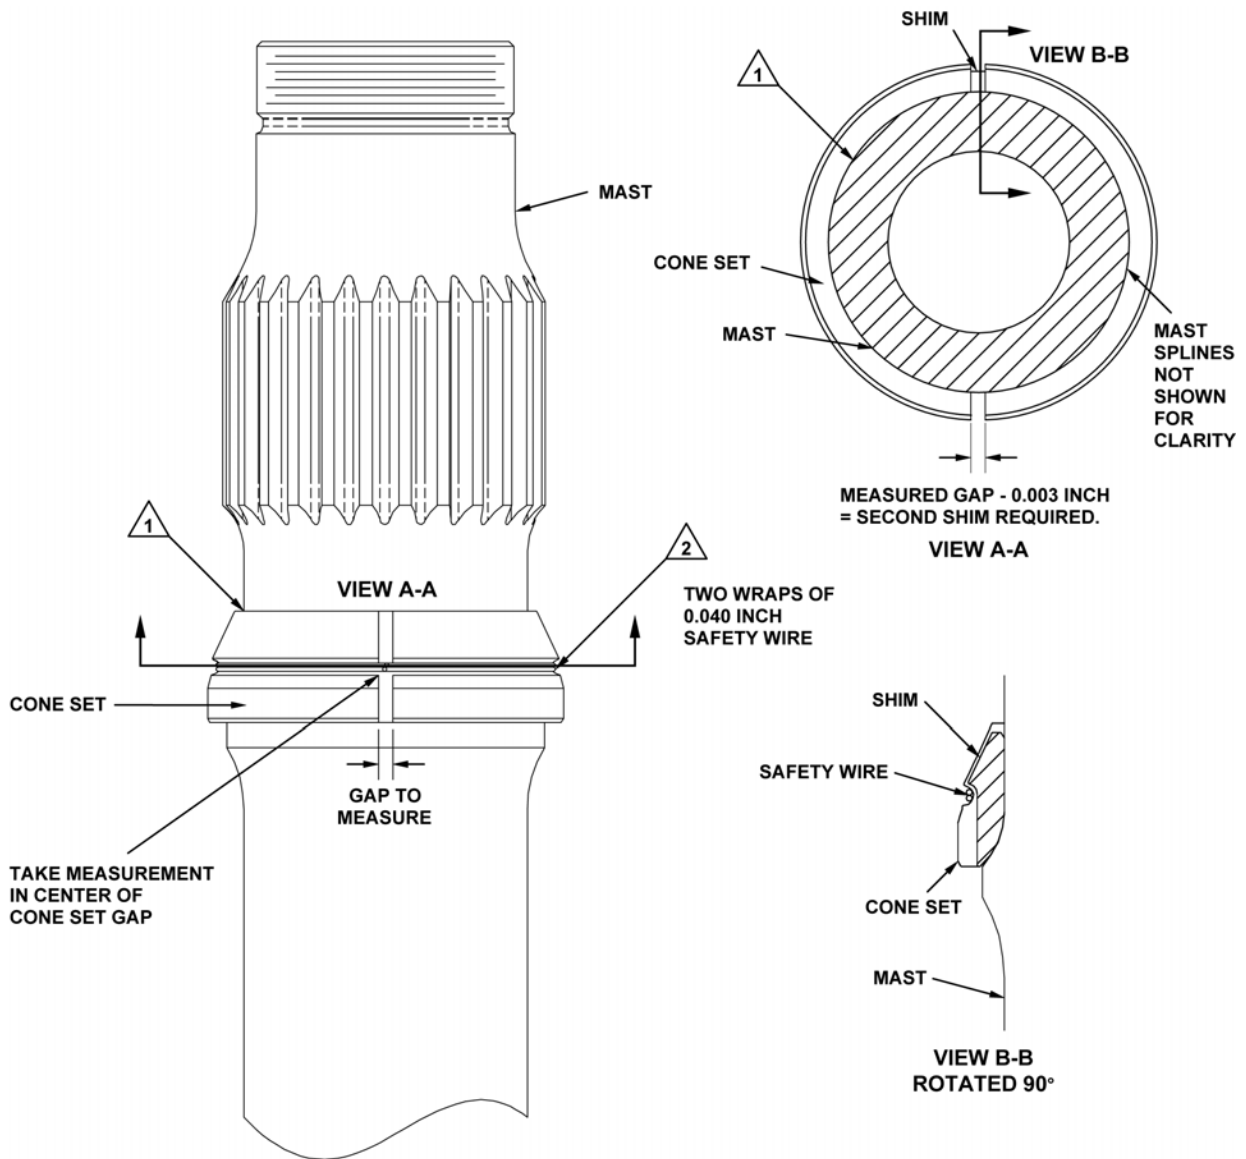
Figure 3. Second shim required

- 1 Make sure no gap exists between the Cone Set halves and the Mast.
- 2 Two wraps of 0.040 inch Safety Wire are used in this temporary installation to ensure a firm contact of the Cone Set on the Mast. In addition to the safety wire a "C" clamp may also be used to make sure that no gap exists as directed in note 1.

- a. Temporary install the cone set on the mast with two wraps of 0.040 inch safety wire (C-447). Refer to Figure 3. The 0.040 inch safety wire is used in this step only to ensure that the 407-010-114 cone set is firmly in contact with the mast and that no gap exist all around. It might also be required to use a "C" clamp to ensure that no gap exist between the mast and the cone set as shown on the Figure 3.

- b. Install the first shim in one split as shown on the Figure 3. Make sure the two cone set halves are well in contact with the first installed shim and that they are still in firm contact with the mast.

- c. Use a caliper and measure the gap between the two cone set halves in the center of the gap.
- d. Record the dimension obtained in step c. and subtracts this number by 0.003 inch. This number is the maximum amount of shims to be installed. The intent is to have a minimum loose fit of the second shim of 0.003 inch. As an example if the dimension measured in step c. is 0.128 inch the required shim thickness will be 0.125 inch. Since the shim has 0.003 inch laminates the required shim will be peeled to approximately 0.123 inch. If the dimension measured is 0.120 inch the required shim dimension is 0.117 inch. In this case the shim would need to be peeled to approximately 0.117 inch.

- e. Temporary install the second shim in the remaining gap to verify the fit. The shim should be slightly loose (0.003 inch) in the gap and the cone set should be in firm contact with the mast. Make sure that no gap exists between the cone set and the mast as indicated on the Figure 3 Note 1.

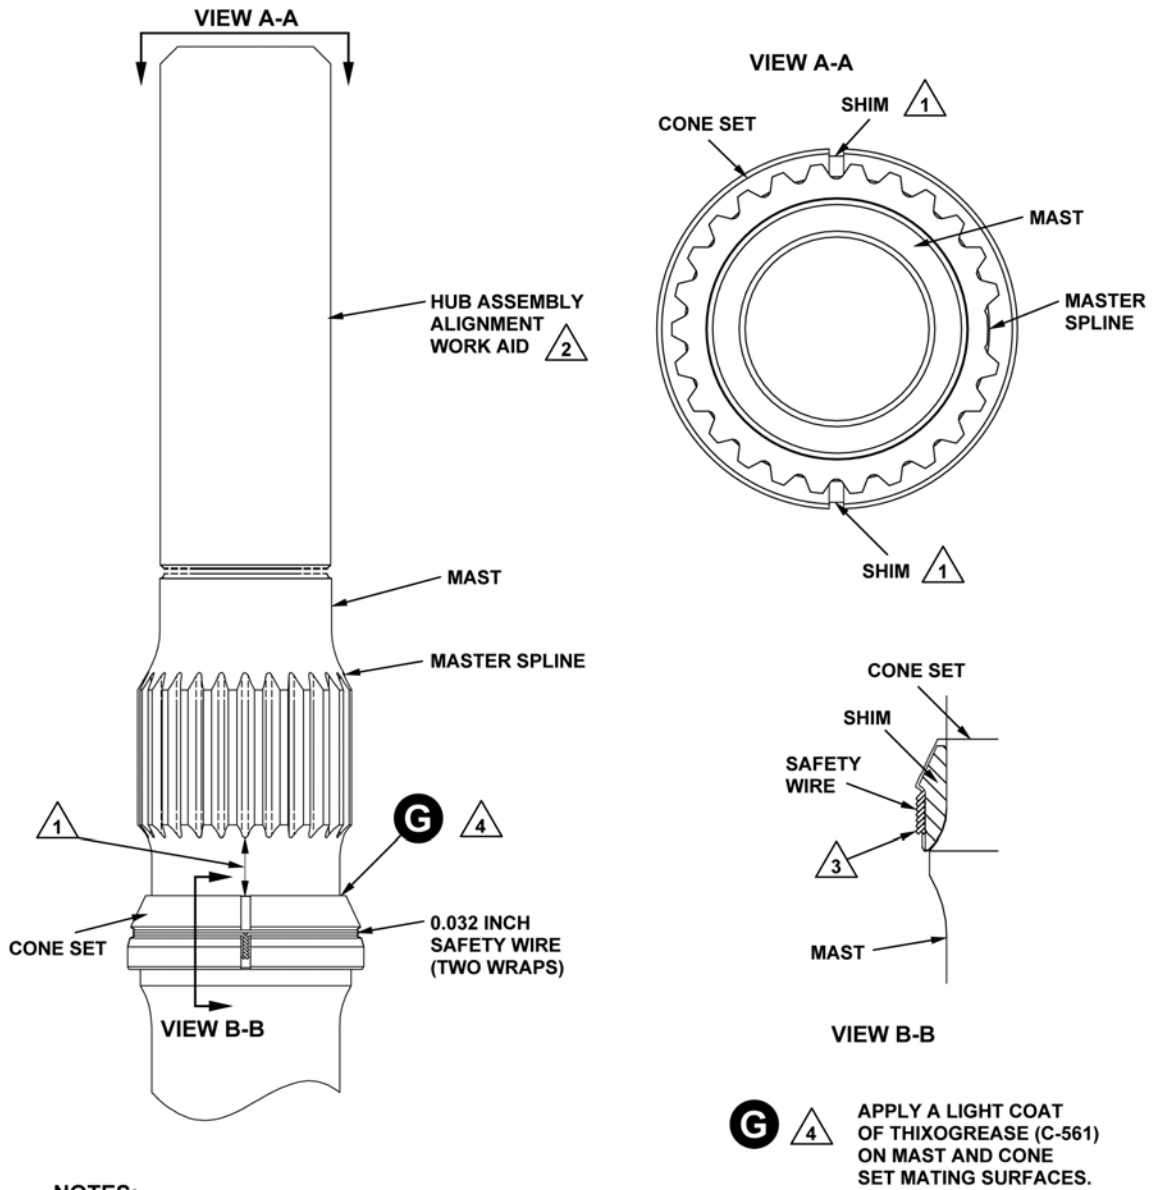
Figure 4. Shims installation

- (1) Shims are to be installed at 90° to the Master Spline and inline between two splines.
- (2) Hub Alignment Work Aid can be locally manufactured or procured from Paravion Technology under part number T0001
Paravion Technology Inc.
2001 Airway avenue
Fort Collins, CO. 80524
USA.
Phone: (970) 224-3898
Fax.: (970) 224-3899
E Mail: paravion@paravion.com
- (3) Make sure the Safety Wires pigtail is properly tucked in the cavity.
- (4) Thixogrease NLGI No. 2 replaces the corrosion preventive compound MIL-C-16173 Gr 2. at all locations indicated in the Maintenance Manual, Chapter 62 and the TB 407-99-16 for the main rotor hub assembly installation.

- g. Apply a light film of THIXOGREASE (C-561) to the inside diameter of the cone set and install on the mast with the two shims. The two shims or the cone set split line axis should be at 90 degrees with the master spline. Refer to the Figure 4 Note 1.
- h. Make sure that the cone set and the shims are firmly attached to the mast with two single wraps of 0.032 inch safety wire (C-405) and that no gap exists between the cone set and the mast as indicated on the Figure 3 Note 1.

Make sure the safety wires “pigtail” do not protrude from the gaps. If the safety wires “pigtail” protrude from the gaps damage to the 407-010-107 lower cone seat may occur at the next main rotor hub assembly removal.

- i. Bend the safety wires twisted ends as shown on the Figure 4 and tuck the “pigtails” as shown in detail A.
- j. After final cone set installation ensure that the cone set with the shims are firmly attached to the mast and that it is not allowed to move in any direction with light hand pressure only. If the cone set is loose on the mast redo the shimming.
- k. Install the work aid on the mast nut threads and proceed with normal main rotor hub assembly installation. Refer to the BHT-407-MM Chapter 62 or to the TB 407-99-16.
