**TECHNICAL BULLETIN**  
**Bell Helicopter** **TEXTRON**

No. 407-03-53

**MODEL AFFECTED:** 407

**SUBJECT:** AFT FIREWALL REINFORCEMENT

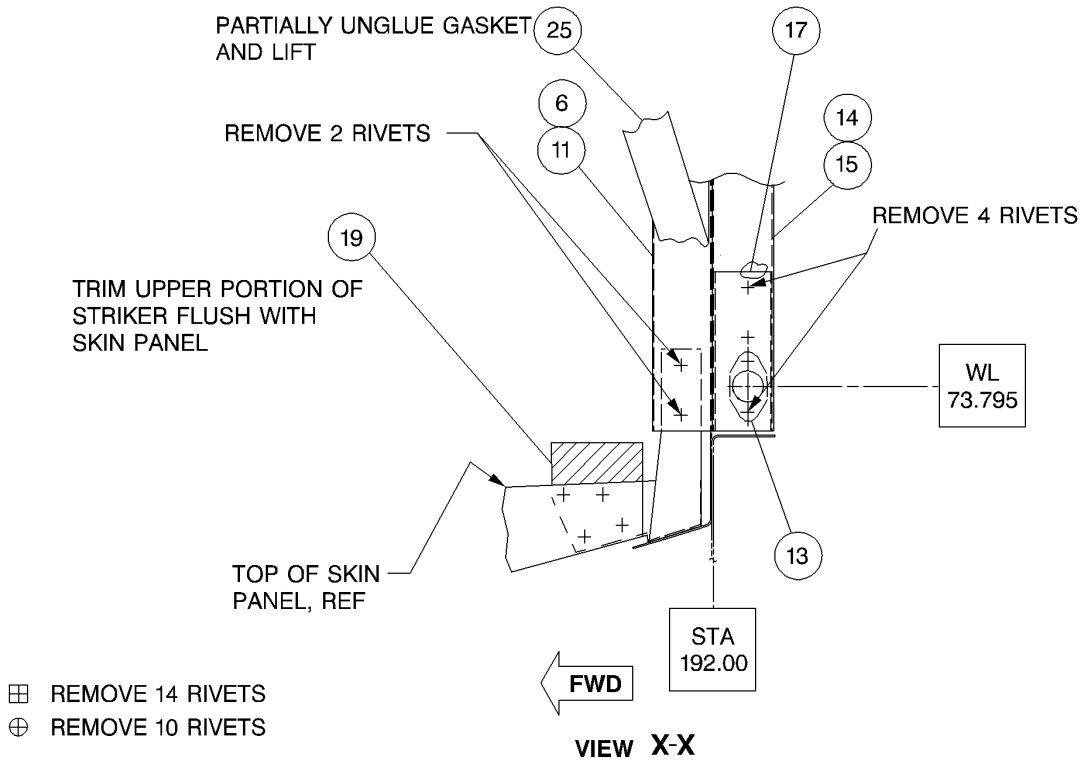
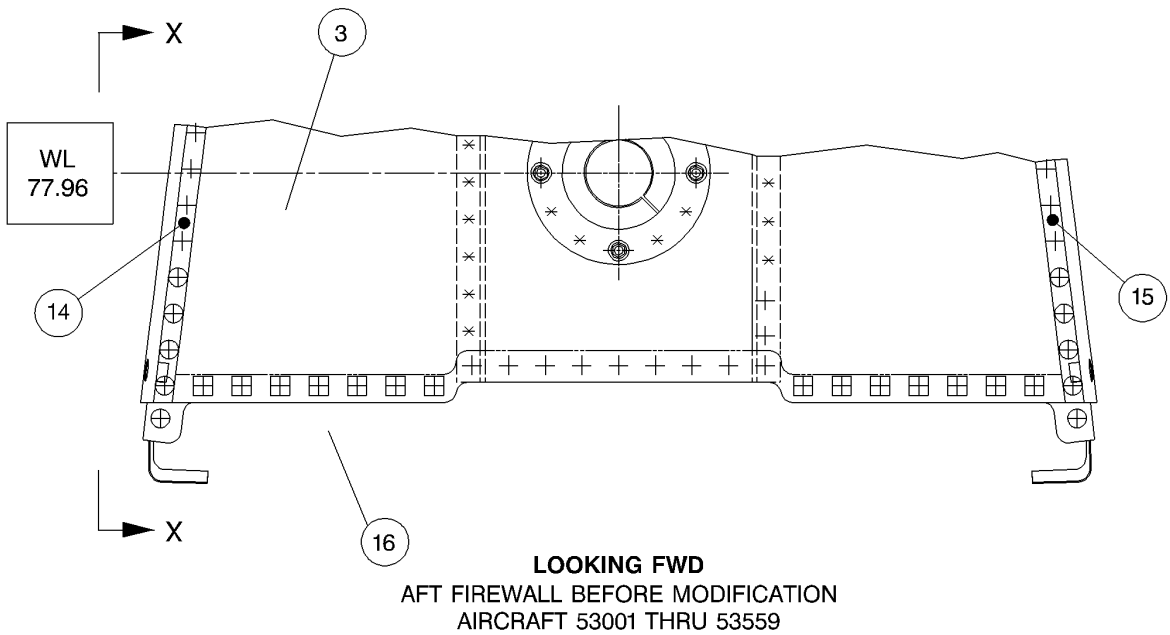
Figure 1. Aft firewall modification (sheet 1 of 5)

This bulletin provides instructions to modify and reinforce the aft firewall and channels. It changes the inlet duct assembly and engine door attachment by means of adding supports in front of the aft firewall, reinforcement and doubler aft of the firewall, and relocation of fasteners. By complying with this bulletin you will prevent further cracking of the firewall web and /or the attached channels

1. Removing rivets and trimming.
  - a. Refer to figure 1 sheet 1. Use a #40 drill and remove qty 14 rivets horizontally attaching web (3) to support (16).

- b. Remove qty 5 rivets on each side vertically attaching web (3) to channels (6,11,14, and15).
  - c. Refer to view X-X. Remove rivets securing receptacles (13) to channel (14 and 15). Keep receptacles (13) for reuse. Remove qty (2) remaining rivets attaching existing doubler (17) to channel (14 and 15). Discard both doublers (17).

- d. Partially unglue gasket and remove 2 rivets at bottom of channel (6 and 11).
  - e. From forward side of firewall, lift web (3) and trim each lower corner to eliminate the joggle area as shown in Detail A.

- f. Trim top portion of existing striker (19) flush with top of side skin as shown in View X-X.
2. Refer to figure 1, sheet 1. Replacement of channel 206-064-902-035 / -036 (14 and 15). If existing channels (14 and 15) are damaged or cracked, proceed as follows. If channels are serviceable, proceed to step 3.
