**TECHNICAL BULLETIN**  
**Bell Helicopter** **TEXTRON**

No. 407-04-57

**SUBJECT:** MAST ASSEMBLY 407-040-011-ALL, BUILT UP  
PROCEDURE CHANGE OF

**HELICOPTERS AFFECTED:** Model 407 Helicopters

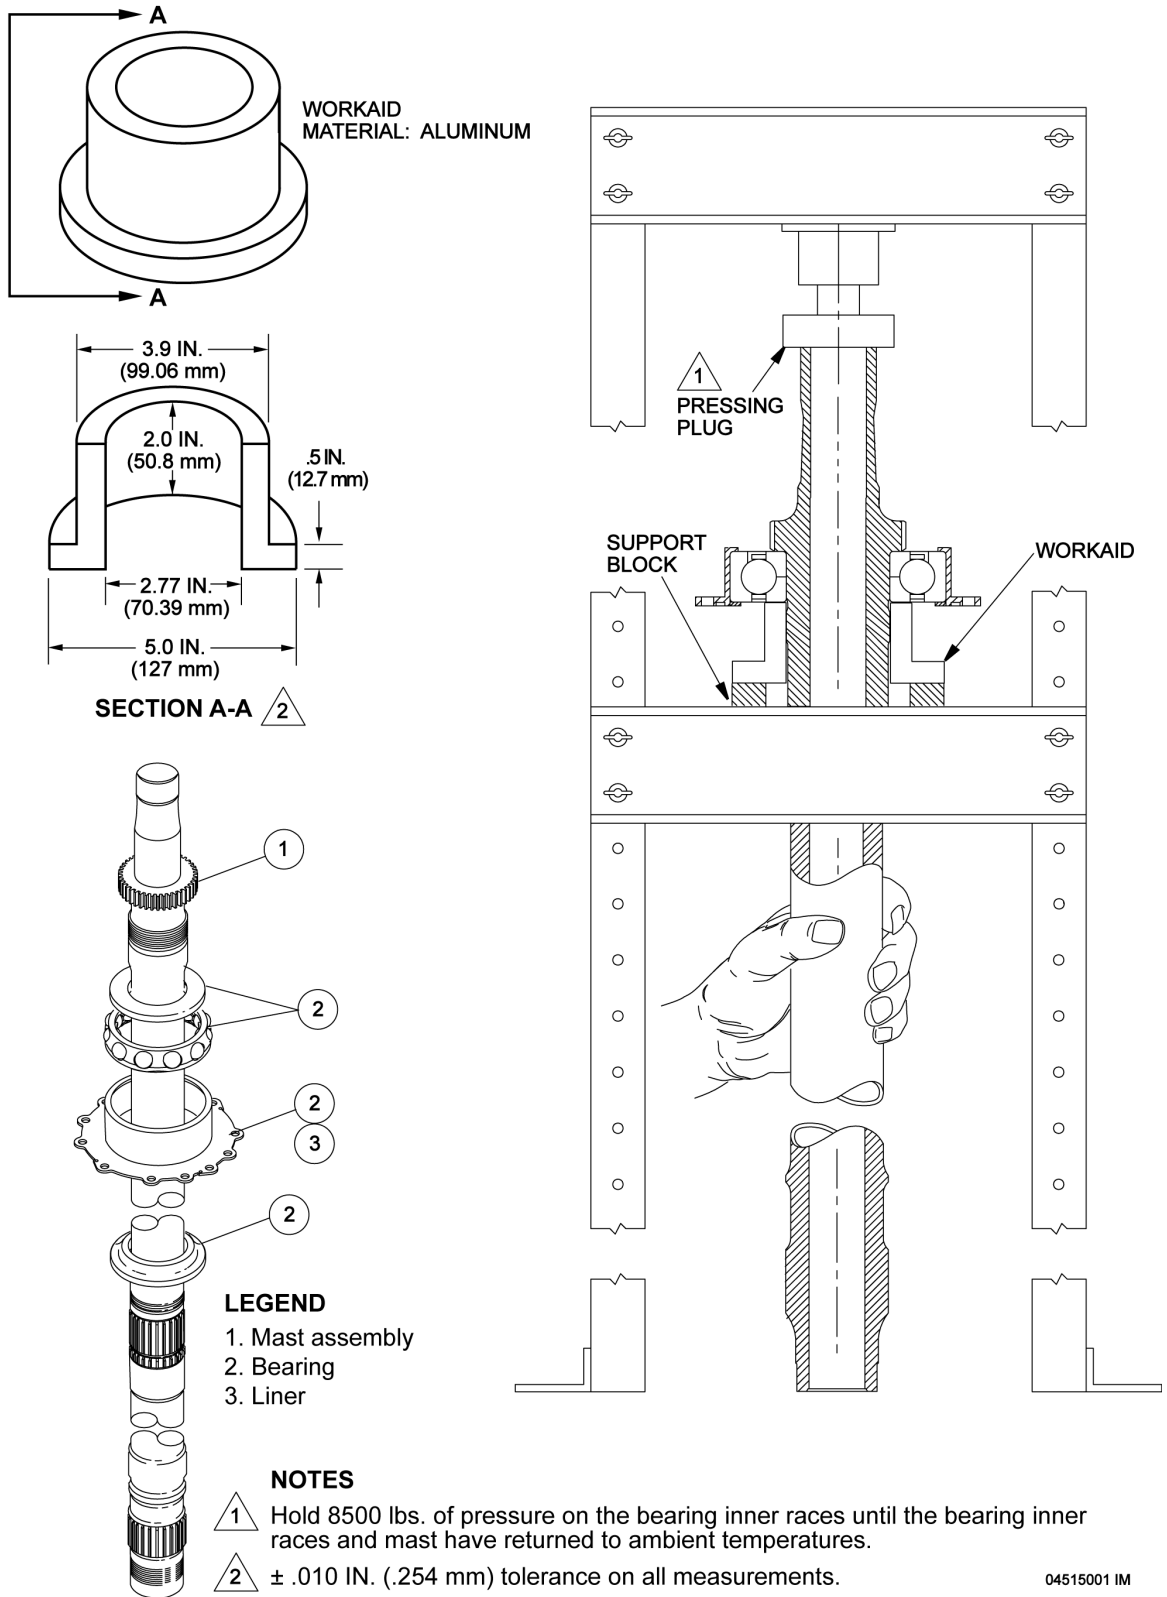
Bell helicopter has received report that bearing mast nuts p/n 406-040-090-103 were found loose during the overhaul inspection. Investigation has revealed that increasing the torque value would result in a tighter joint ensure that correct torque would be maintained.

**Figure 1. Bearing inner races installation**

1. During the build up of the mast assembly, follow the procedures in the BHT-407-CR&O, Chapter 63-10, with the following changes:
  - a. Immediately after the installation of the mast bearing and the liner on the mast assembly, apply pressure on the bearing inner races as shown on Figure 1.
  - b. At the installation of the mast nut apply a torque of 600 to 660 FT-LBS.
2. Make an entry in the Mast assembly Historical Service Record to show that this Technical Bulletin has been completed.
