**TECHNICAL BULLETIN**  
**Bell Helicopter** **TEXTRON**

No. 407-04-59

**MODEL AFFECTED:** 407

**SUBJECT:** MAIN ROTOR FLIGHT CONTROLS ANTI-FRETTING WASHERS 140-005-19-16-4 AND 140-055-1, INSTALLATION OF.

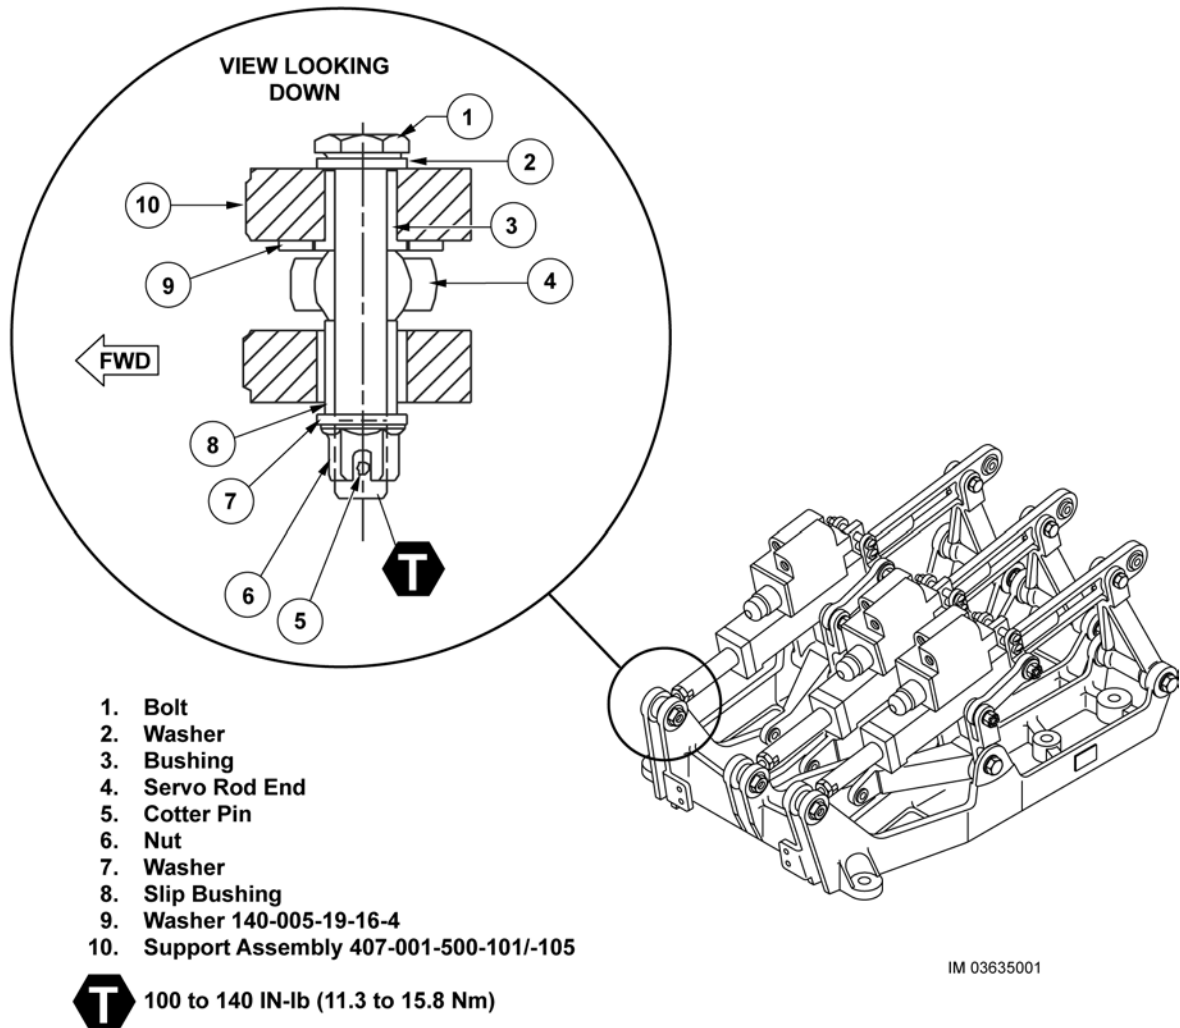
Figure 1. Washer installation on Support Assembly

It has been reported to Bell Helicopter that the forward servo actuator rod end can contact the actuator support 407-001-500-101/-105 forward attachment point. This condition could result in chafing damage to the actuator support assembly.

PART I of this Technical Bulletin provides installation instructions of washer 140-005-19-16-4 at three locations to prevent chafing damage on the hydraulic servo support assembly.

1. Disconnect the hydraulic servo actuators from the support assembly at the forward attachment point. Make sure the servo actuators are properly supported and protected to prevent damage. Refer to Figure 1.
2. Clean and inspect support assembly for damage in the actuators forward attachment point area.
3. Install one rubber washer (9, Figure 1) with no adhesive at each lug of the support assembly on the fixed bushing side.
4. Install hydraulic servo actuators to support assembly at the forward attachment point. Refer to BHT-407-MM-4, chapter 29.
5. Make an entry in the helicopter records to show that PART I of this Technical Bulletin has been completed.

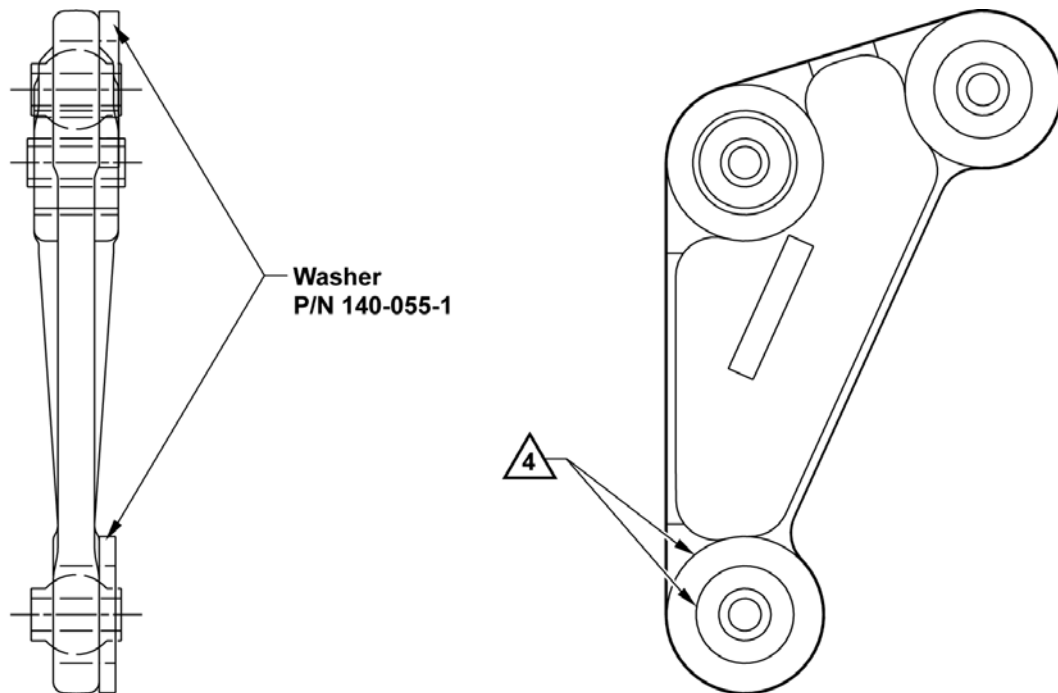
**Figure 2. Washer replacement on Bellcrank Assembly**

The same condition was also reported on the control tubes clevises inside surface. The chafing damage will occur when the control tube clevis come in contact with the stainless steel washers bonded on bellcranks 407-001-524-101/-105, 407-001-526-101/-105 and 407-001-527-101 or 407-001-528-101.

PART II of this Technical Bulletin provides instructions to replace the existing stainless steel and rubber washers with a nylon washer 140-055-1 to prevent chafing damage on main rotor control tubes clevis.

1. Disconnect main rotor control tubes from bellcrank. Protect disconnected control tubes from damage. Refer to BHT-407-MM-4, chapter 67.
2. Remove bellcrank from the helicopter.
3. Remove the stainless steel washers 140-009D60S96 and the rubber washers 140-005-30-24-8 from bellcrank using a sharp plastic scraper. Refer to figure 2.
4. Inspect bellcrank for damage.

7. Apply adhesive (C-301) to the prepared surface of washer 140-055-1. Bond washer to bellcrank. Apply between 5 and 20 psi pressure (34.5 and 138 KPa). Cure for two days at room temperature or 2 hours at 160°F (71°C). Refer to figure 2.

1. Washers P/N 140-009D60S96 and P/N 140-005-30-24-8 replaced with one washer P/N 140-055-1 at two locations.
2. Bond washer P/N 140-055-1 to bellcrank assembly with adhesive (C-301).
3. Do not allow adhesive and sealant to contact bearing.

- 4.** Apply a bead of sealant (C-251) around the inside and outside diameters of the washer 140-055-1 at mating surface with bellcrank.
