TECHNICAL BULLETIN

NO. 407-96-2

MODELS AFFECTED: 407

SUBJECT: **MODIFICATION FOR INCREASE IN V_{NE} ,
INTRODUCTION OF.**

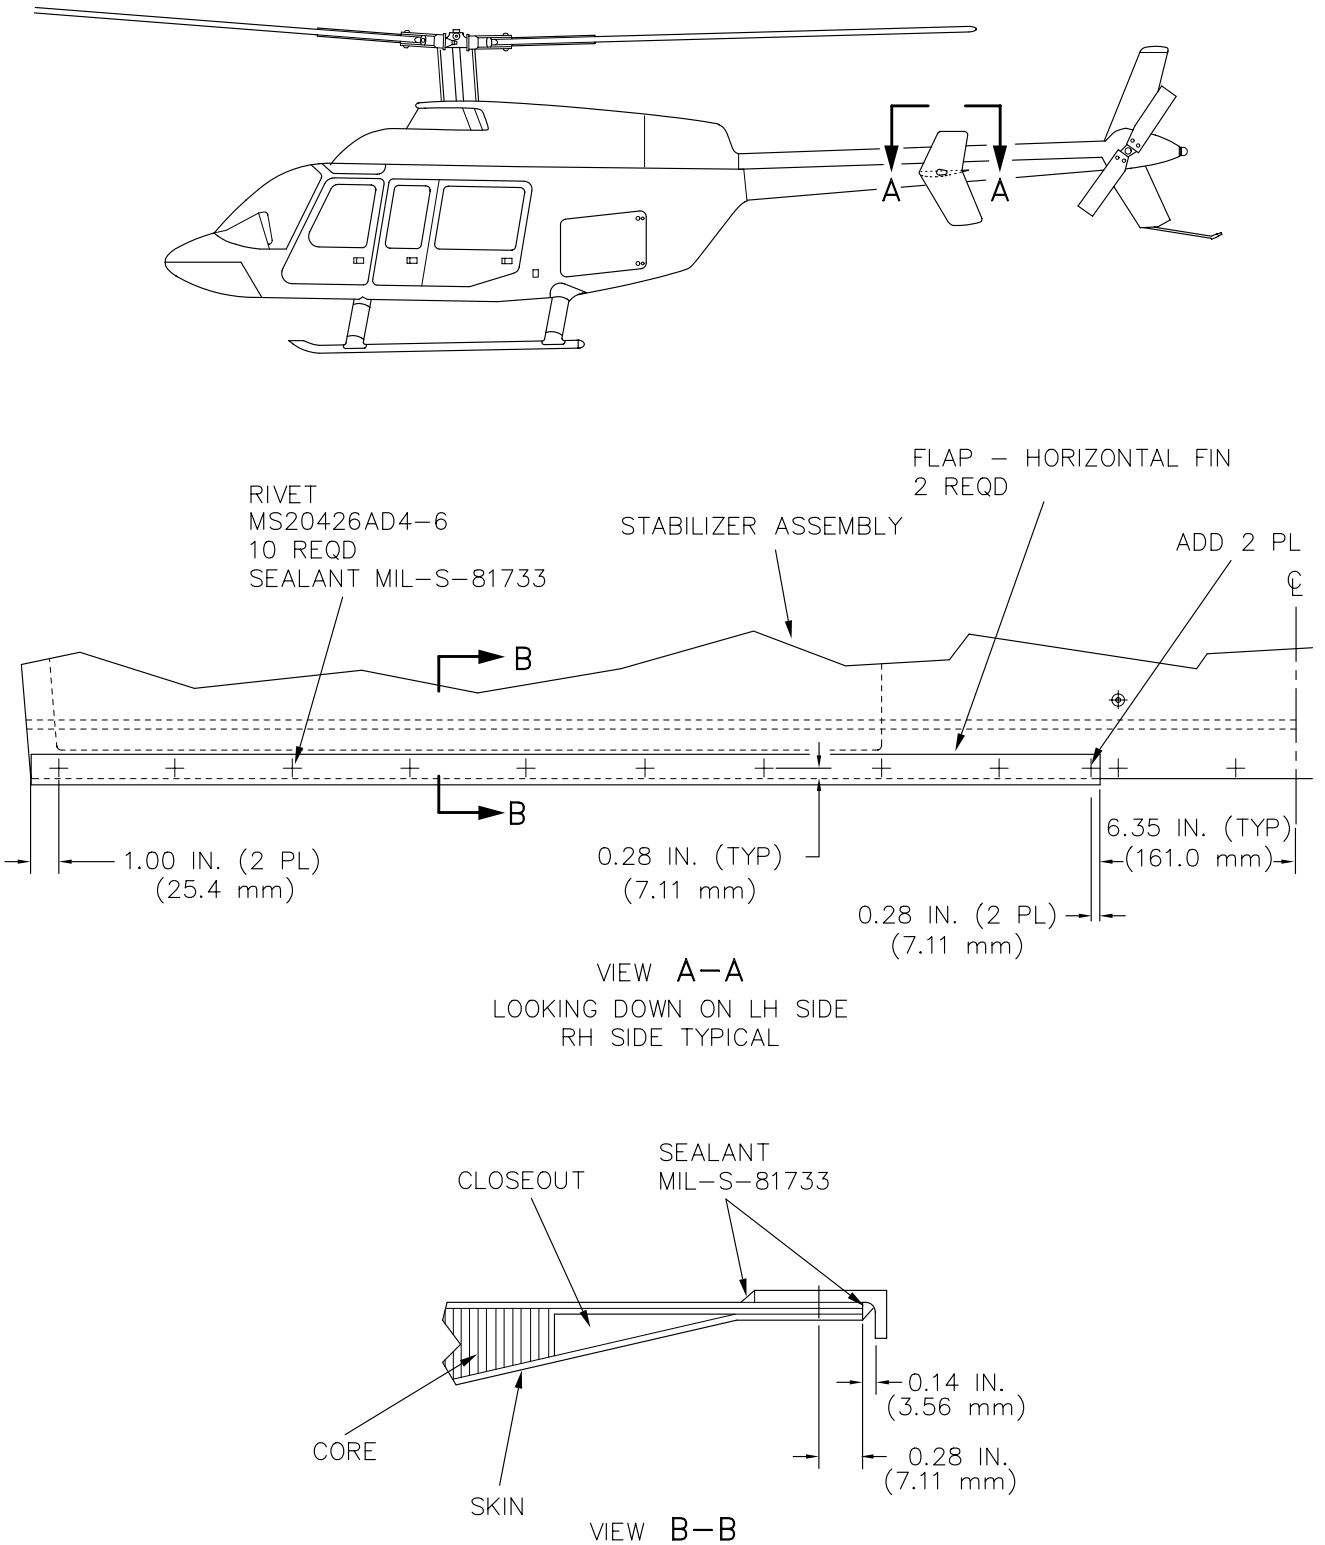
Figure 1. Stabilizer modification

Find the location of the flaps P/N 407-023-802-119 (qty.2). Refer to Figure 1. One flap is installed on the upper surface of each horizontal stabilizer along the trailing edge. The short leg of the flaps "L" extrusion points down. Remove and discard the rubber corner caps P/N 204-031-072-003 from the ends of the trailing edge.

6. Mark the rivet holes on each flap, refer to the applicable Figure. Measure and include the specified edge distances.
 - 6a. Put the flaps P/N 407-023-802-119 in position on the horizontal stabilizer. With the use of the horizontal stabilizer rivet holes backdrill the flaps. One more rivet hole is necessary on the inboard edge of the flap, refer to Figure 1.

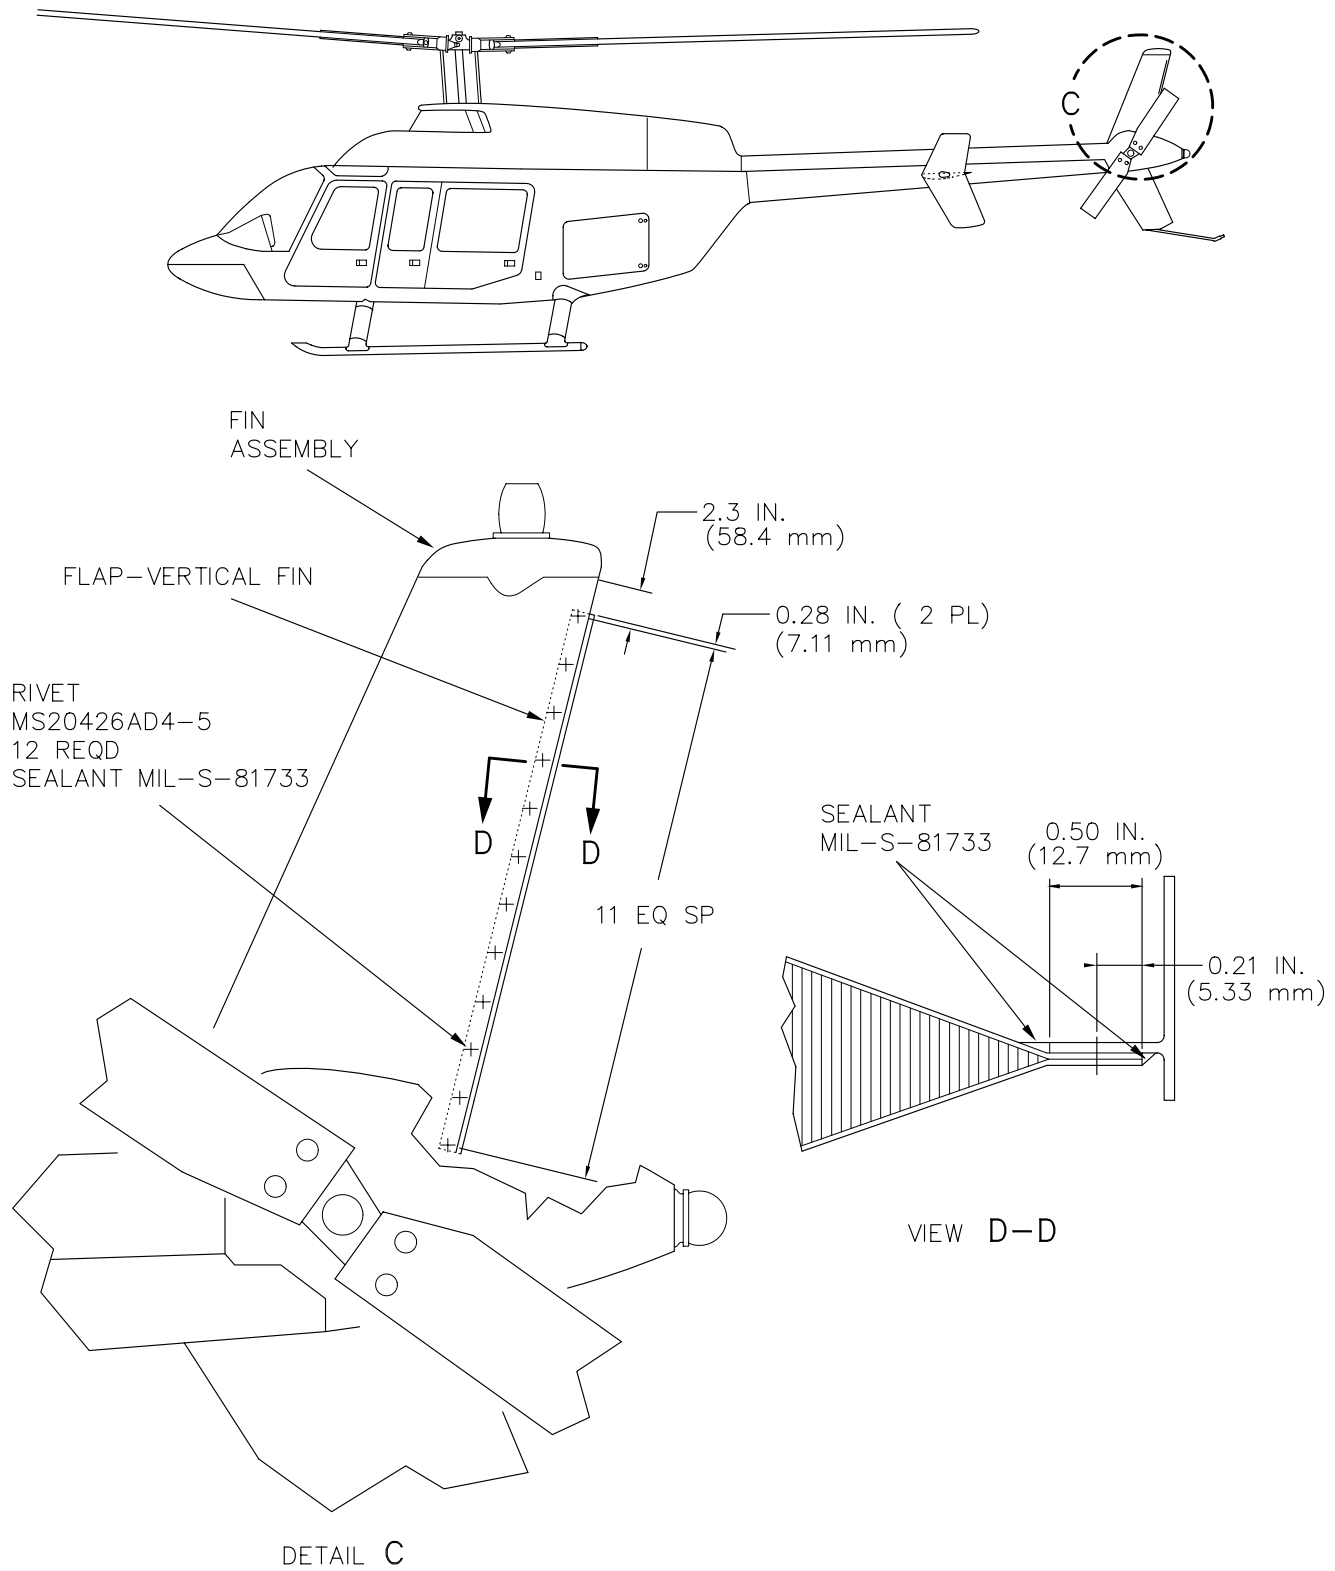
Figure 2. Vertical fin modification

Find the location of the flap P/N 407-023-802-117. Refer to Figure 2. The flap is installed on the right side along the upper trailing edge of the vertical fin. The long leg of the flap "T" extrusion points outboard.
