TECHNICAL BULLETIN

NO. 407-97-4

Bell Helicopter **TEXTRON**

SUBJECT: **AFT ENGINE FIREWALL COVER**
206-064-902-137, REPLACEMENT OF.

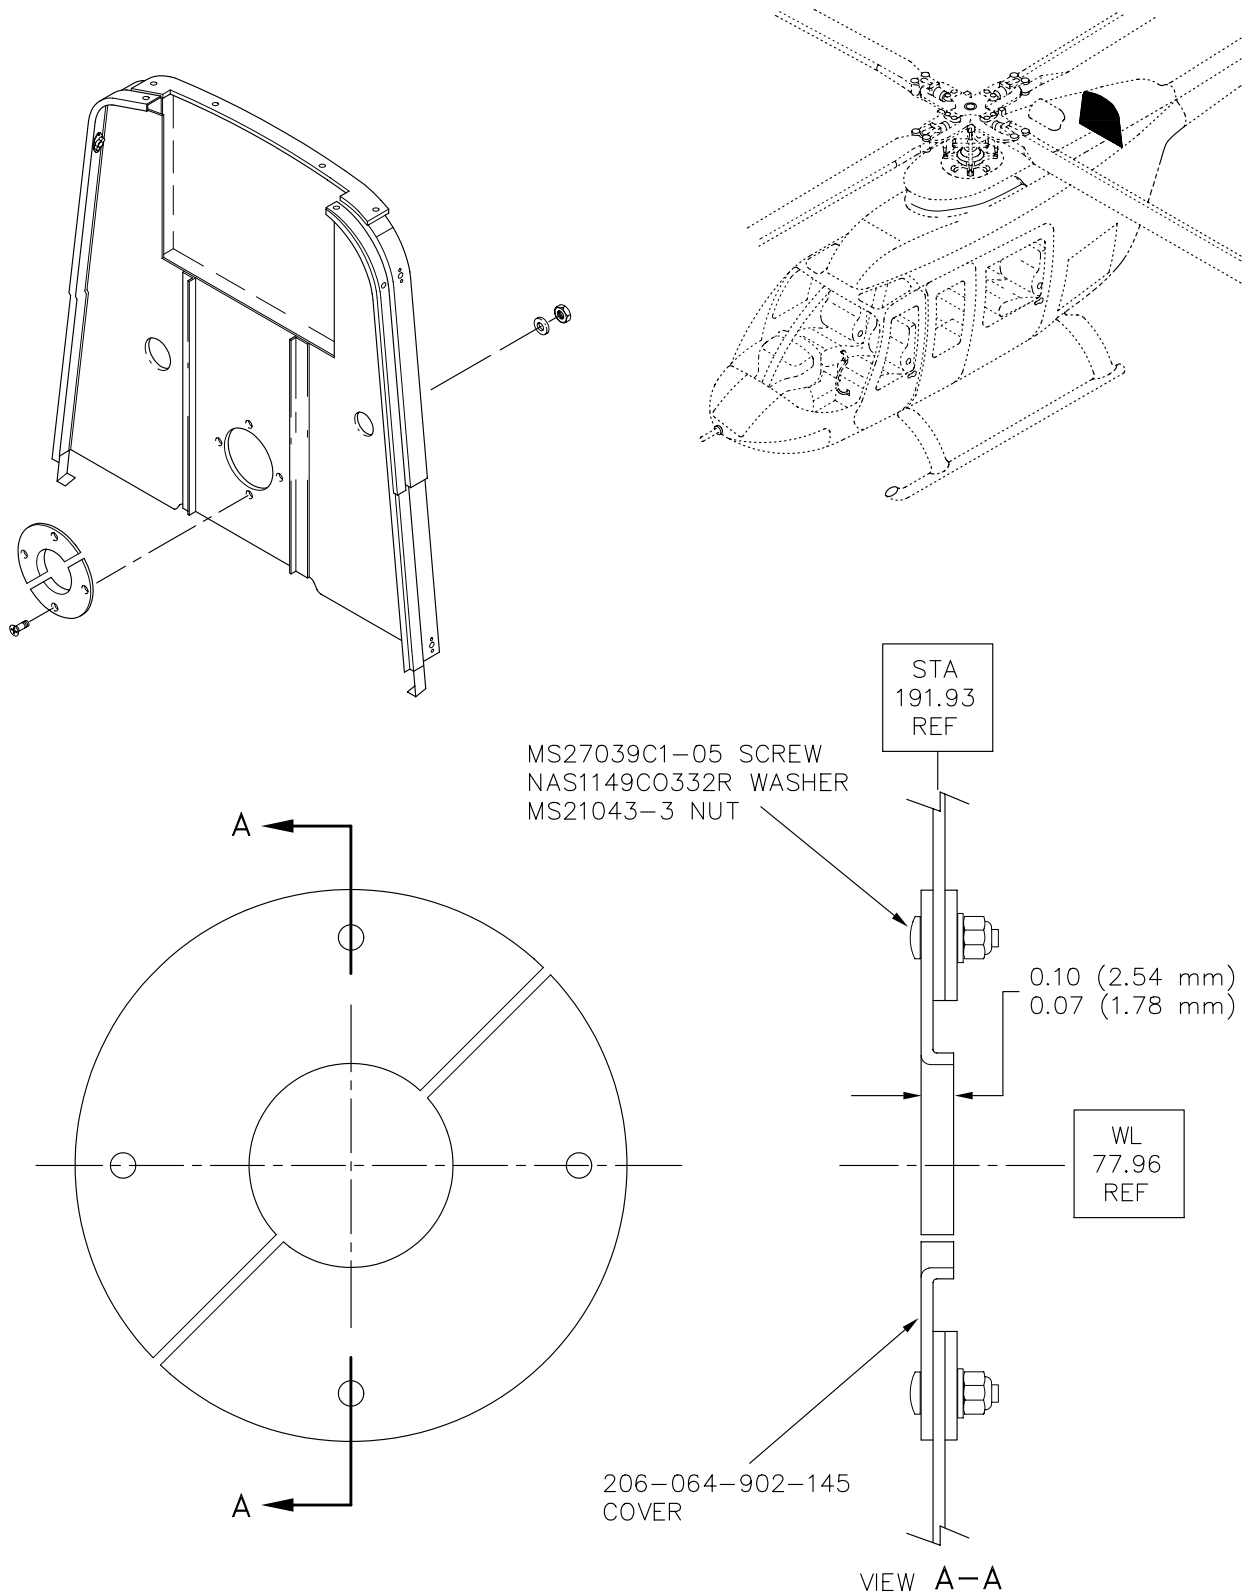
Figure 1. Replacement of cover.

DESCRIPTION: Bell Helicopter has found that the original configuration cover half P/N 206-064-902-137, installed on the aft firewall of the engine compartment, can permit contact between the cover flanges and the oil cooler blower shaft.

A new design cover half P/N 206-064-902-145, has been made and includes a lower profile flange which gives the necessary clearance (Figure 1).

1. Get access to the engine compartment. Remove the aft fairing assembly (Refer to BHT-407-MM-5, Chapter 53).
2. Remove the nuts, washers, and screws that attach the cover to the forward side of the aft firewall and remove the cover halves. Discard the screws and the cover halves (Refer to BHT-407-MM-5, Chapter 53).
3. Examine the oil cooler blower shaft for damage. Use a bright light and a mirror to examine the area indicated on Figure 2.
4. If the damage to the oil cooler blower shaft is more than the limits shown in BHT-407-MM-7, Chapter 65, Oil cooler blower shaft - Inspection, contact Product Support Engineering for instructions.
5. If the damage found on the shaft is less than the limits shown in BHT-407-MM-7, Chapter 65, Oil cooler blower shaft- Inspection, blend the damage. Treat the reworked area with Brush Cadmium Plating (Refer to Standard Practices Manual, Chapter 3).

6. Put the new cover P/N 206-064-902-145 in position on the aft firewall. Install the new screws P/N MS27039C1-05, washers, and nuts.
7. Install the aft fairing assembly and secure the engine compartment cowlings (Refer to BHT-407-MM-5, Chapter 53).
8. Make an entry in the helicopter historical record to show that this Technical Bulletin is completed.
9. Make an entry in the Record of Technical Bulletins in the Illustrated Parts Breakdown.

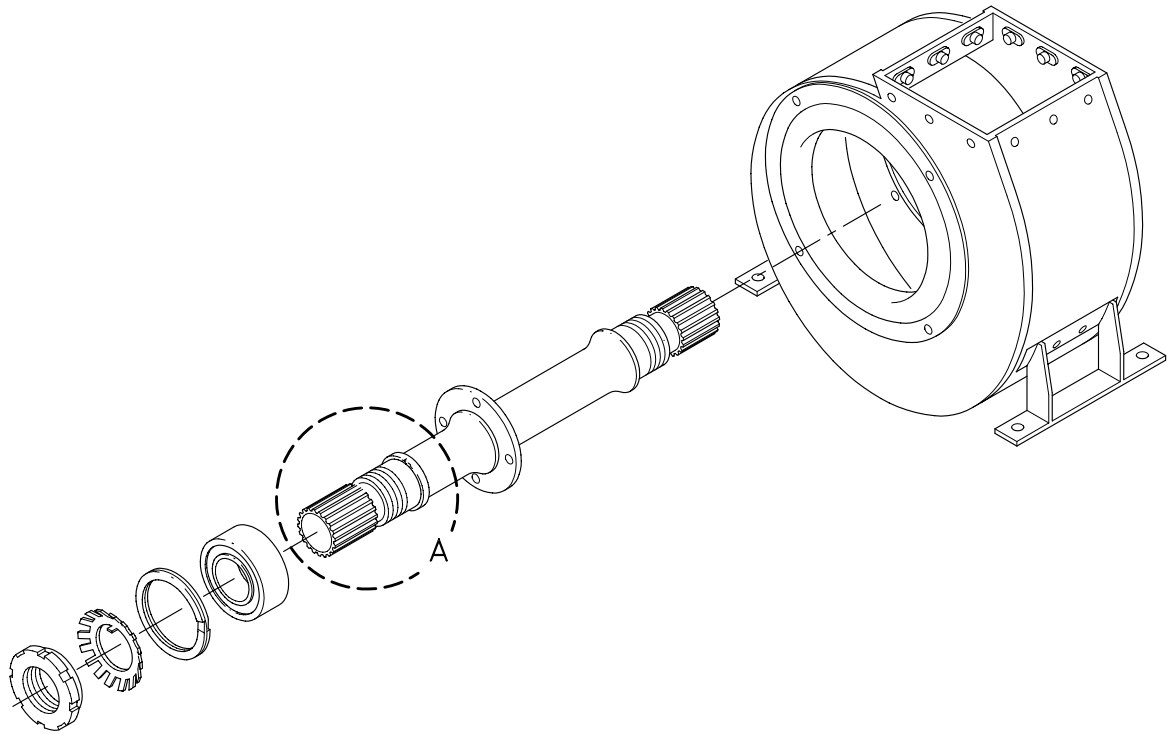
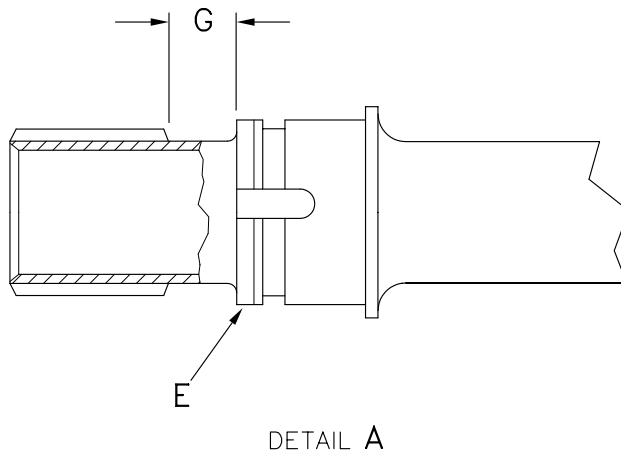
Figure 2. Oil cooler blower shaft - Inspection

Inspect shaft body outside diameter area G and E
(Refer to BHT-407-MM, Chapter 65, Oil cooler
blower shaft - inspection).
