TECHNICAL BULLETIN
Bell Helicopter **TEXTRON**
A Subsidiary of Textron Inc.

NO 407-99-20

MODELS AFFECTED: 407

SUBJECT: **FREEWHEEL RETURN LINES,
REPLACEMENT AND RELOCATION OF.**

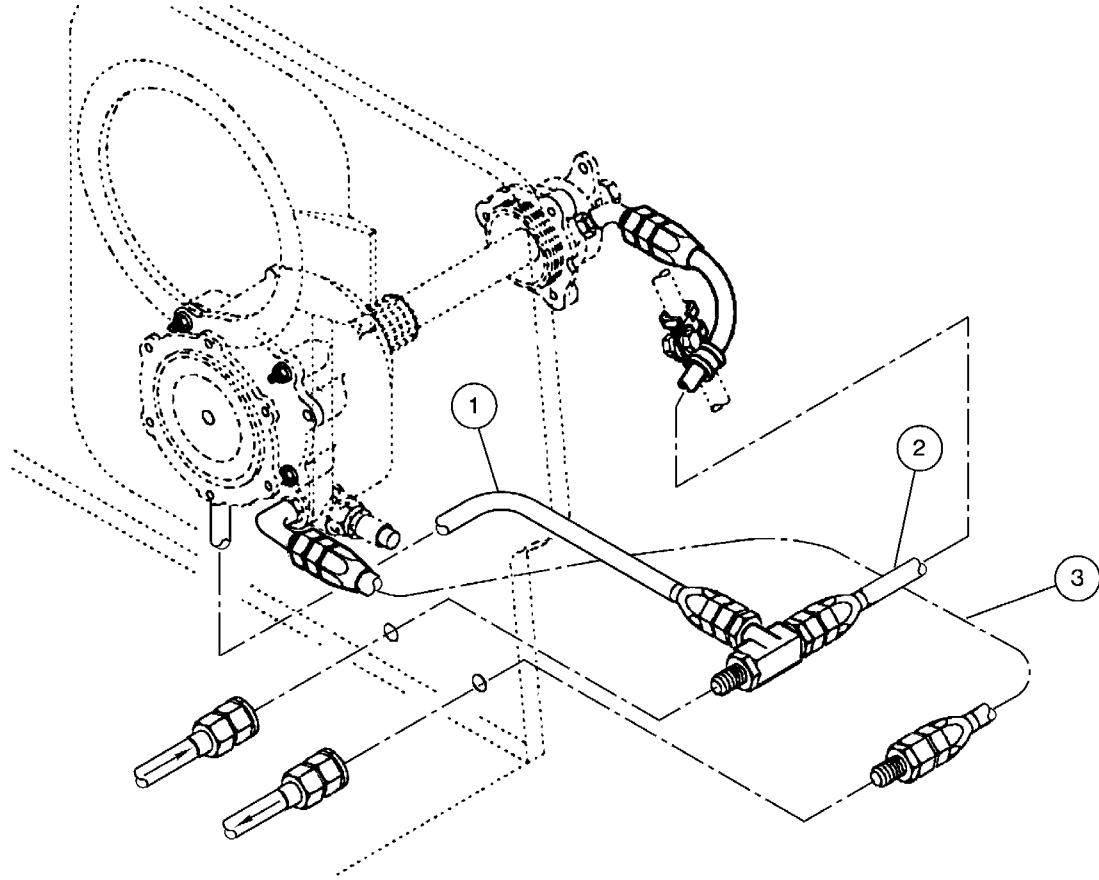
Figure 1. Re-route of Engine Bay Oil Return Hose

The freewheel housing is drained by gravity using two return hoses. Bell Helicopter has found that the oil return hoses are positioned too high; this causes a high oil level in the freewheel unit. This bulletin introduces a new freewheel hose, P/N 70-061H00T225A, and re-routes the new and the other return hoses, P/N 70-079H000D142.

3. In the engine bay, re-route the freewheel oil return hose (3), under the freewheel oil pressure hose, (1) and (2) (Refer to Figure 1).
4. Rework the transmission bay as follows (Refer to Figure 2):

Reroute the freewheel oil return hose (3) under the freewheel oil pressure hoses (1) and (2).
