TECHNICAL BULLETIN
Bell Helicopter

No. 407-08-83

MODEL AFFECTED: 407

SUBJECT: ENCODING ALTIMETER RETROFIT

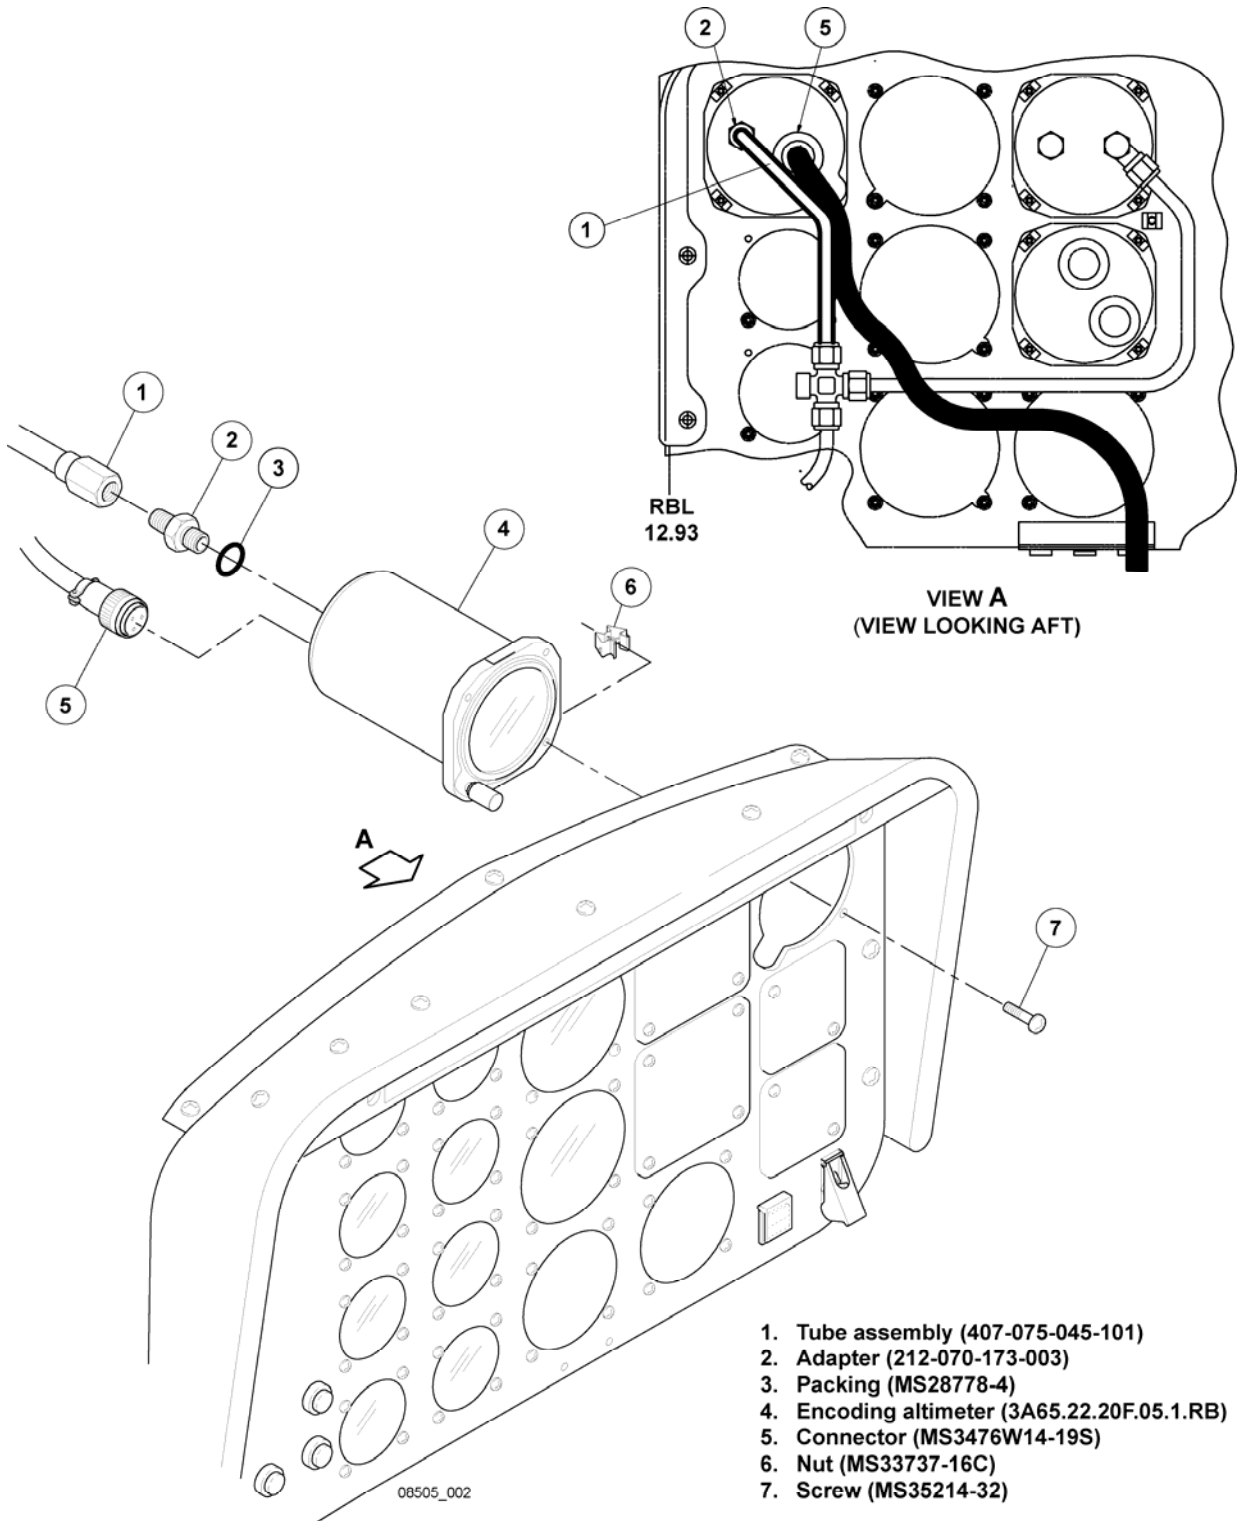
Figure 1. Installation of encoding altimeter

This Technical Bulletin provides instructions to install the new 3A65.22.20F.05.1.RB encoding altimeter in aircraft that previously had kit 407-706-001-101 installed per BHT-407-II-16.

5. Remove existing encoding altimeter (refer to BHT-407-MM-10, chapter 95).
6. Remove and discard existing 407-075-028-101 static tube assy and existing 212-070-173-001 adapter (refer to BHT-407-MM-10 chapter 95 and BHT-407-IPB chapter 95).
7. Refer to figure 1, install packing (3) and apply 48 THD seal on adapter (2) side mating with encoding altimeter ensuring first thread to be free of tape.
8. Install adapter (2) into encoding altimeter (4).
9. Install the encoding altimeter (4) in its location on the instrument panel using nuts (6) and screws (7, previously removed).
10. Install 407-075-045-101 tube assy (1) between encoding altimeter adapter (2) and static port tee.
